# What we know and what we've done about water being pumped into superconducting devices in the tunnel

TD-01-054

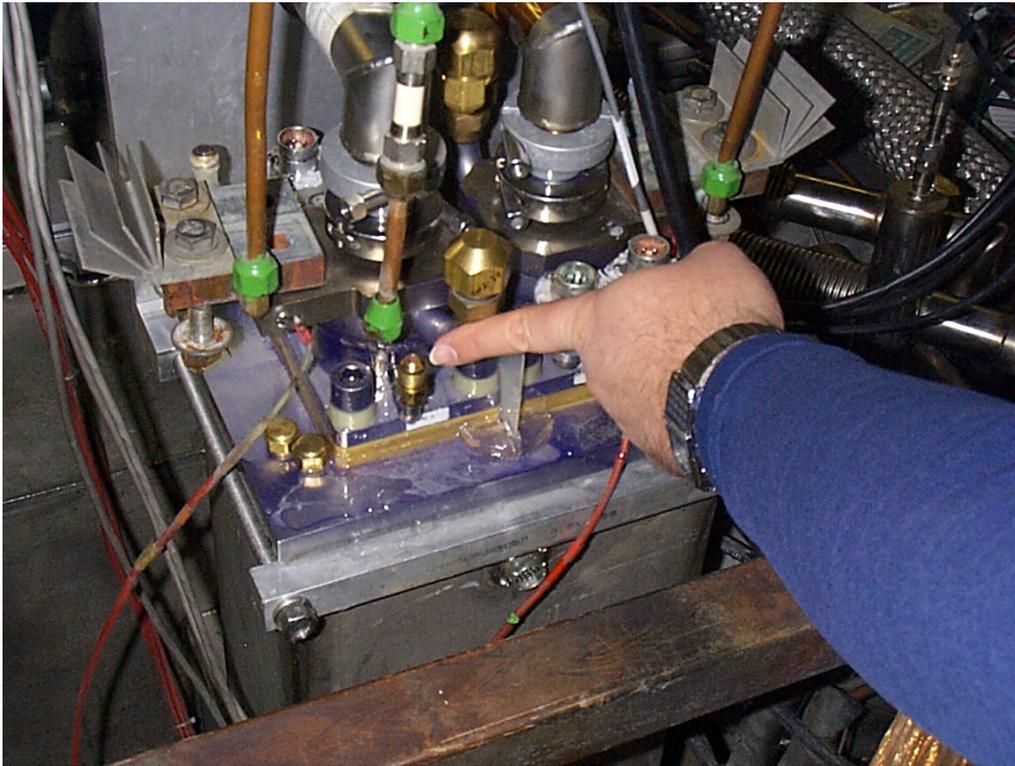
On the morning of 1-Feb-2001 a BD person took a LCW lead and connected it to a liquid helium fitting on a high-temperature lead "H" spool in house F4. The water was turned on and left on for about 40-45 minutes at around 150-175 psi. The estimated loss of LCW is about 10 gallons. The problem was discovered when someone saw water leaking out of a kautzky valve. Figure 1 below shows where the water was connected to the spool (picture complements of the BD MCR electronic logbook from 1-Feb-2001).

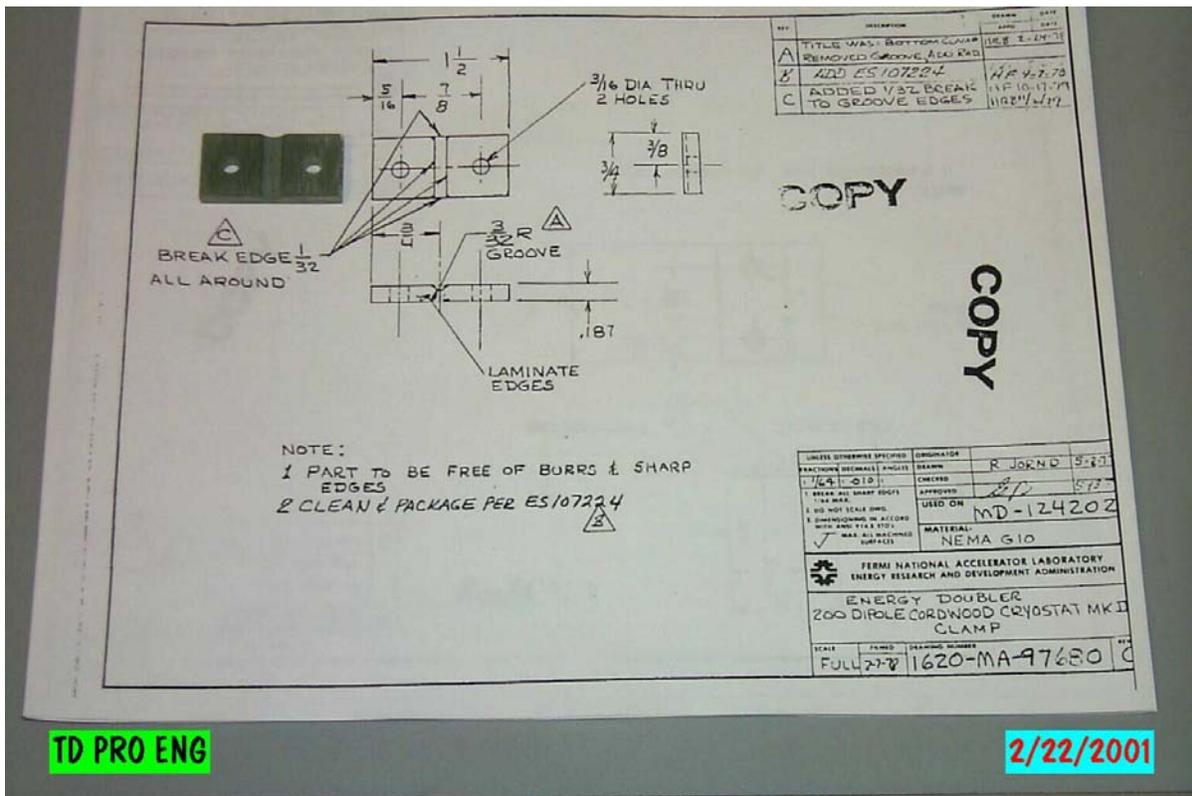
Upon tipping TB0701 by BD personnel, a small G10 piece fell out. This part was delivered to TD by Mike Petkus (2/8/01). It has been identified as a lead clamp P/N 97680. Figure 2 shows the part and its associated drawing (compliments of Denny Gaw).

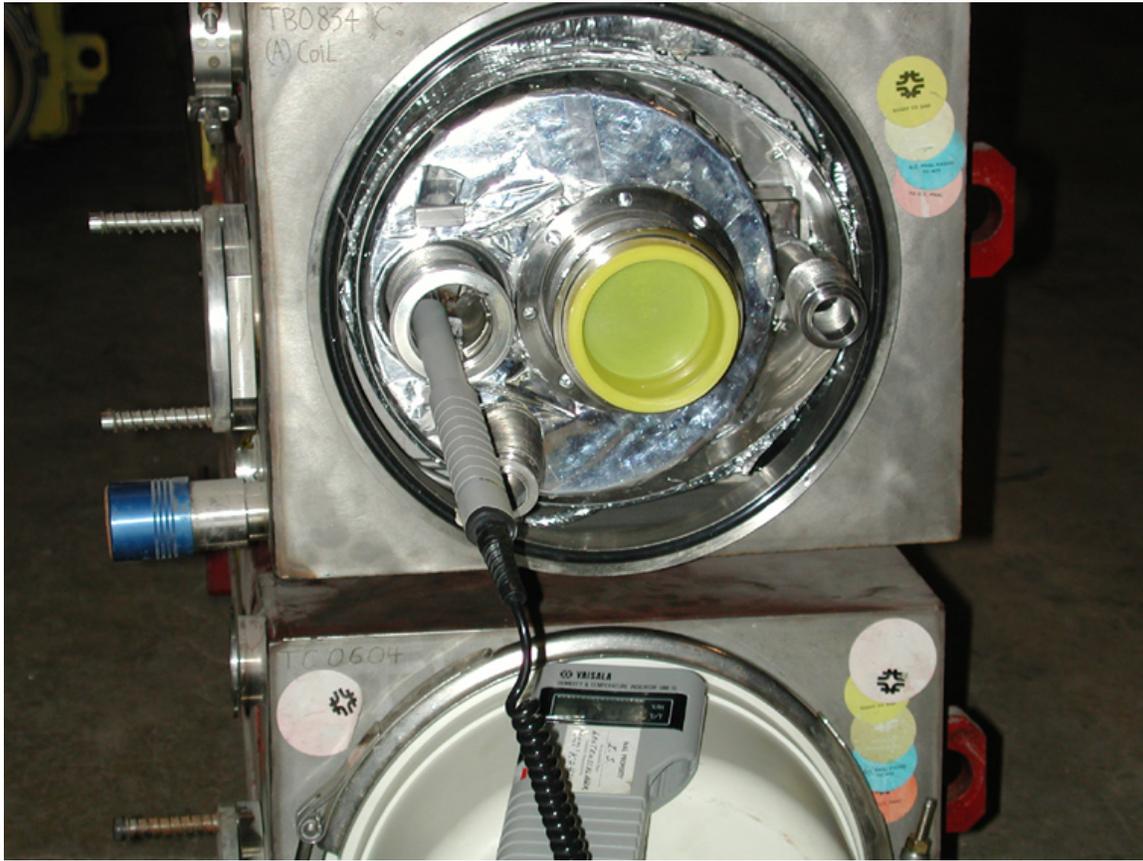
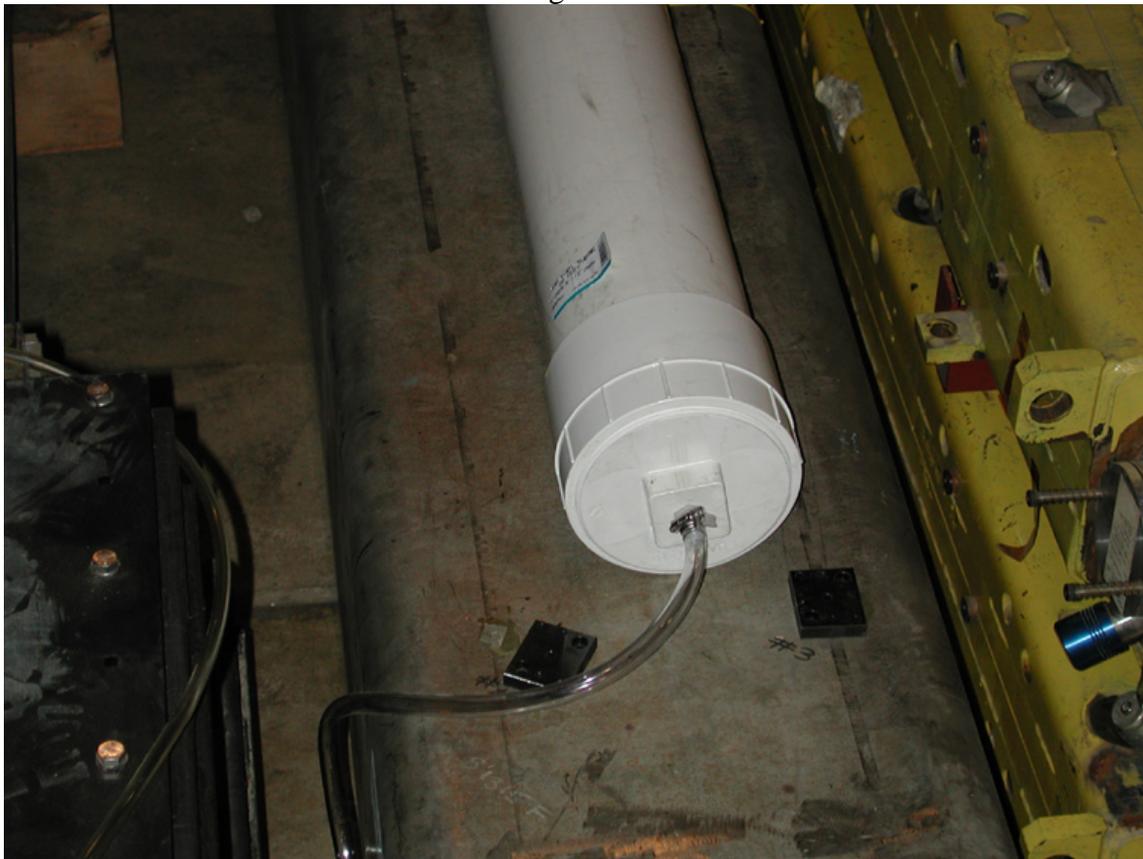
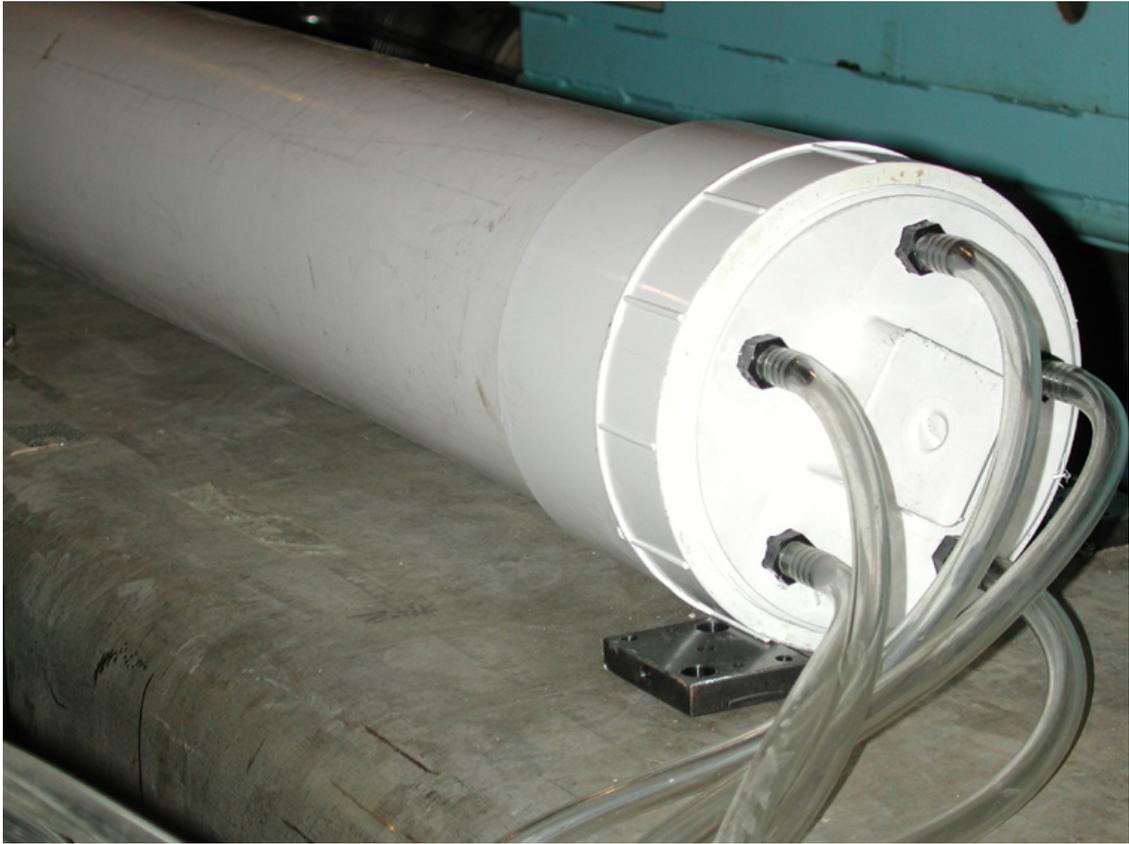
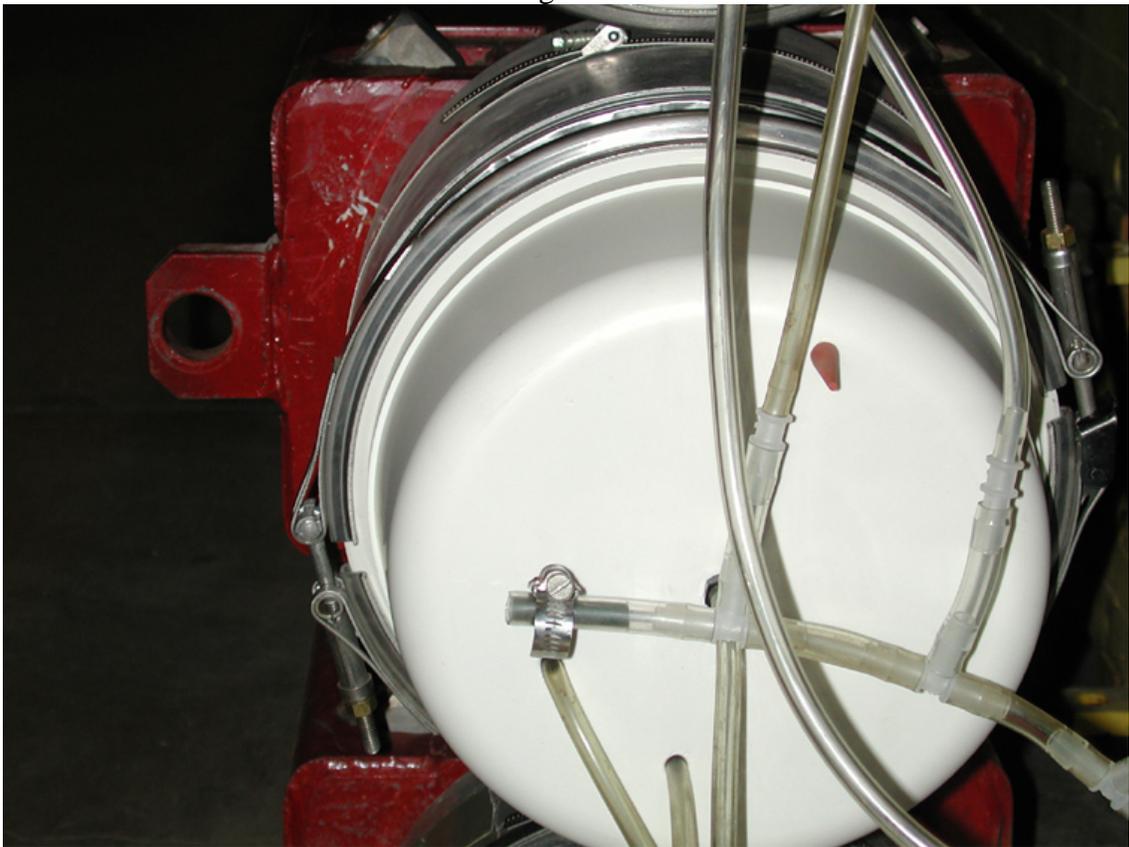
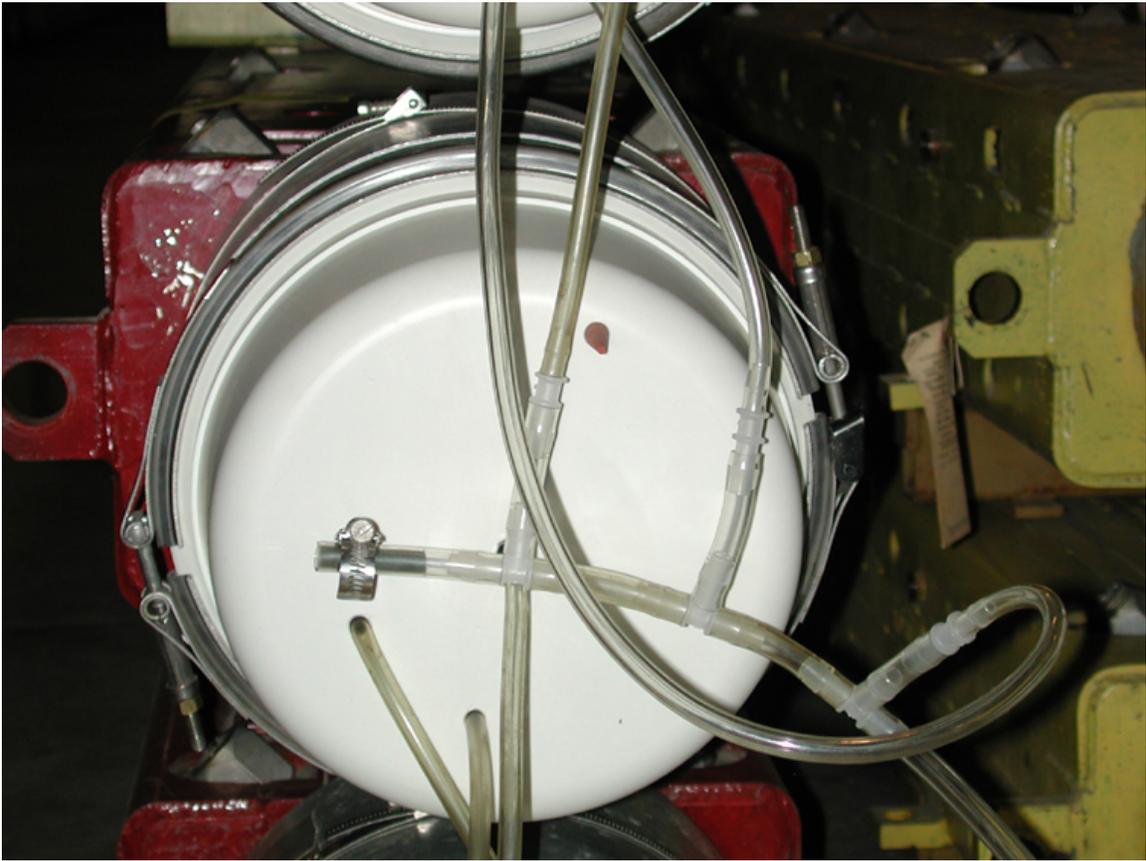
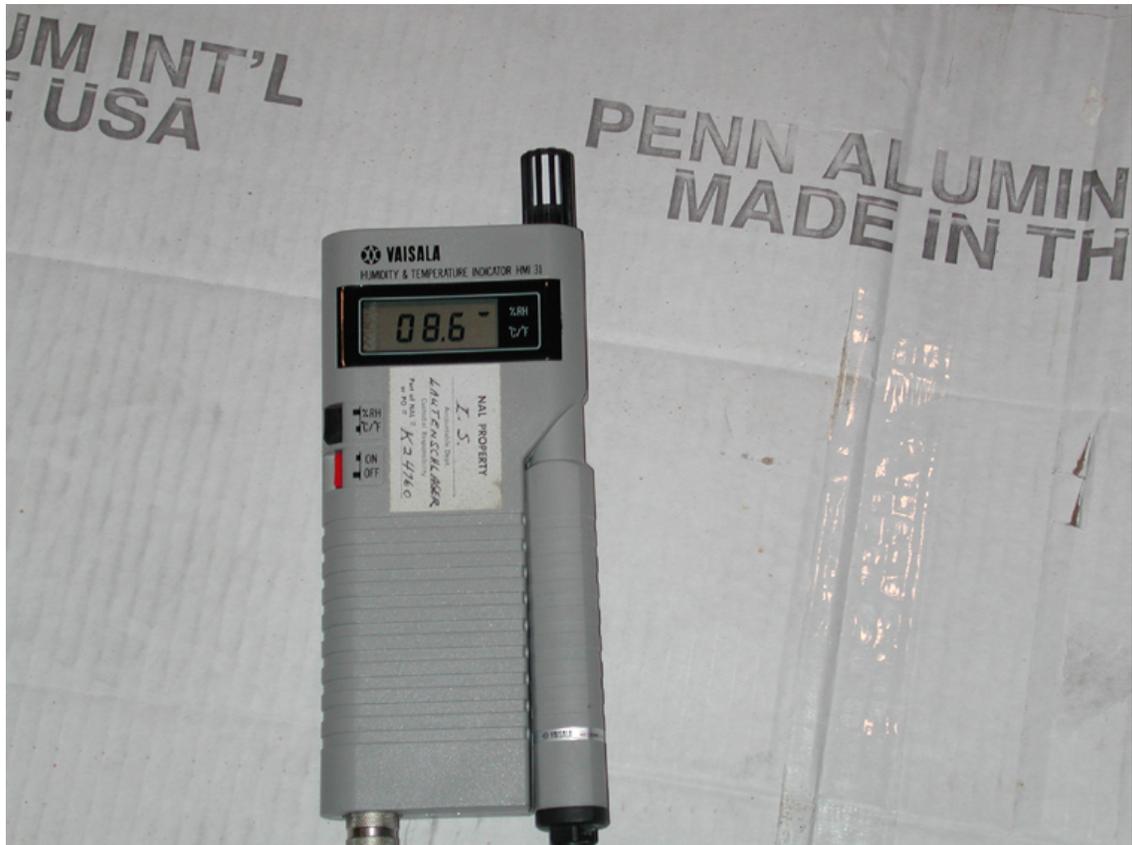
Figures 3 through 9 show the dry nitrogen purge setup. This configuration is different than was originally set up. The original setup had one purge line feeding into the I/O and one purge line feeding into the II/O. After the readings taken on 8-Feb (see chart above) both lines were fed into the I/O.

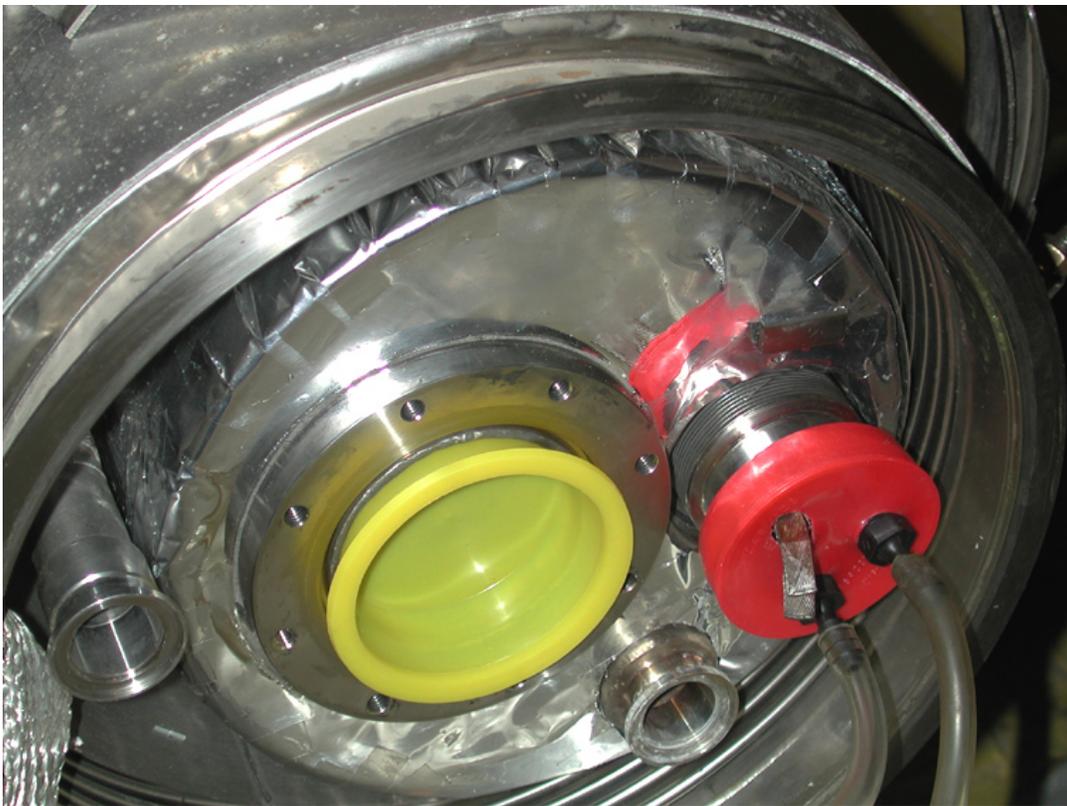
Figure 8 is a picture of the upstream end from which we fed the purge. There are two lines that were force fed into the single phase. One additional line (not shown in this photo) was fed into the large white plastic end cap which covers the whole end of the magnet. This would result in some purge going down the two phase or vacuum portions of the magnet.
