TD-04-039

## EDDY CURRENT SCANNING REPORT

### FNAL-3RDHARMONIC CAVITY #2

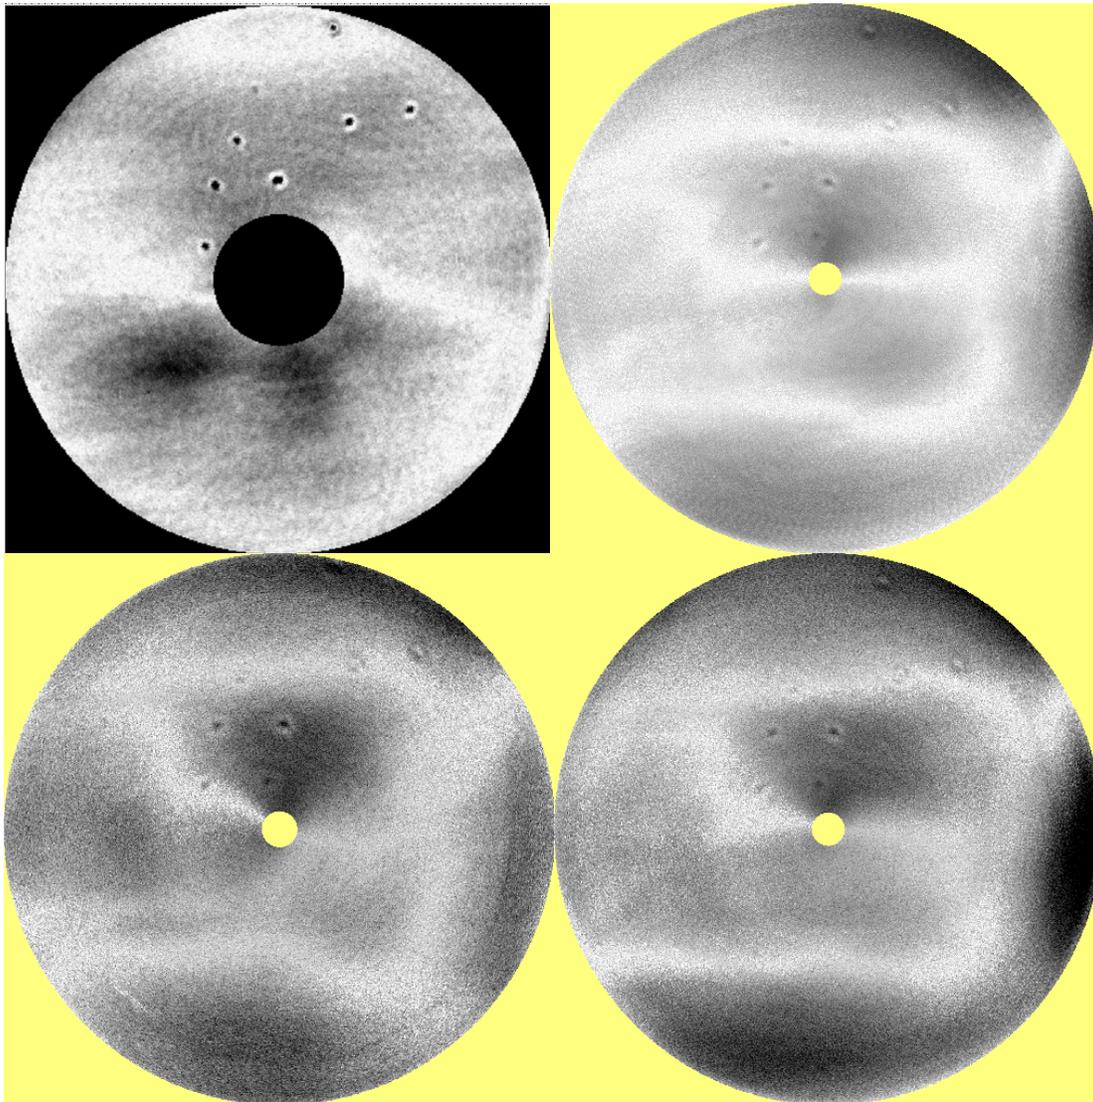
<sup>1</sup> 3<sup>rd</sup> harmonic – batch 1 – disc 22- side 2 is the disc showing the clearest evidence of defects in the DESY and FNAL scans (see **Figure 4**).

Figure 4: Example of eddy current scans performed on a niobium disc for Fermilab's 3<sup>rd</sup> harmonic cavity with the DESY scanner (top left) and SNS/FNAL scanner (top right and left & right bottom).

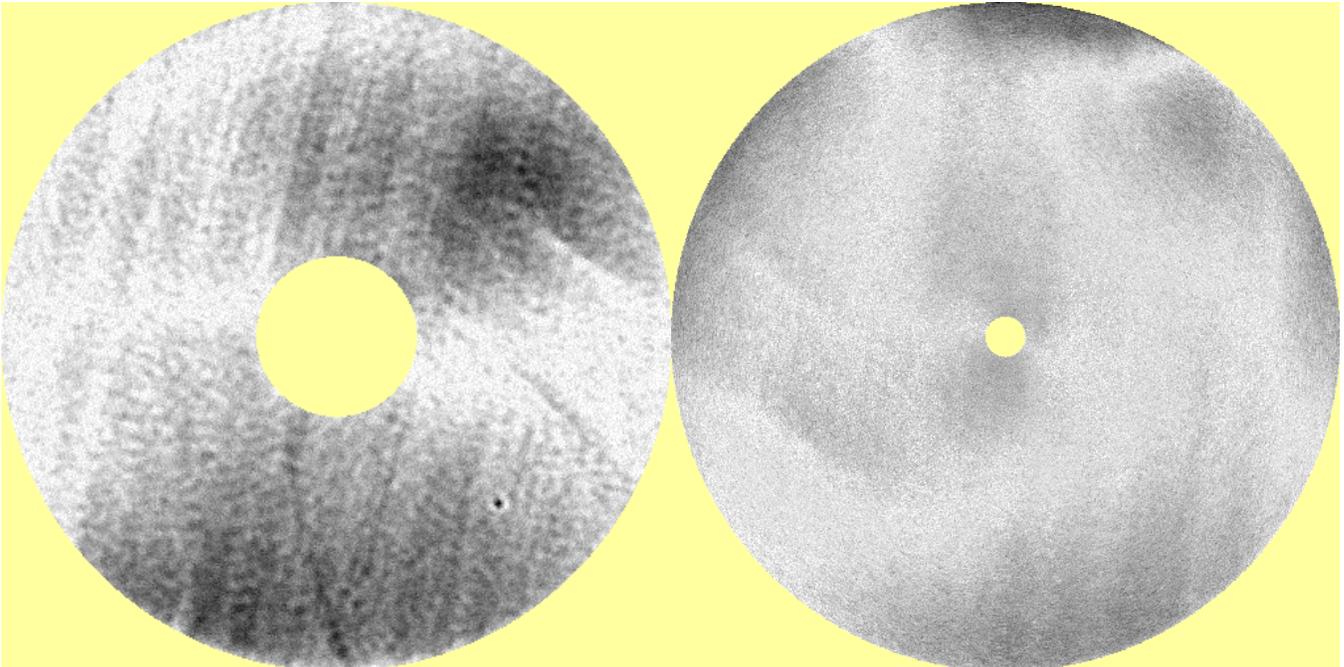
Disc 1 – side 2: DESY (left), SNS/FNAL (right), defect found in DESY scan;

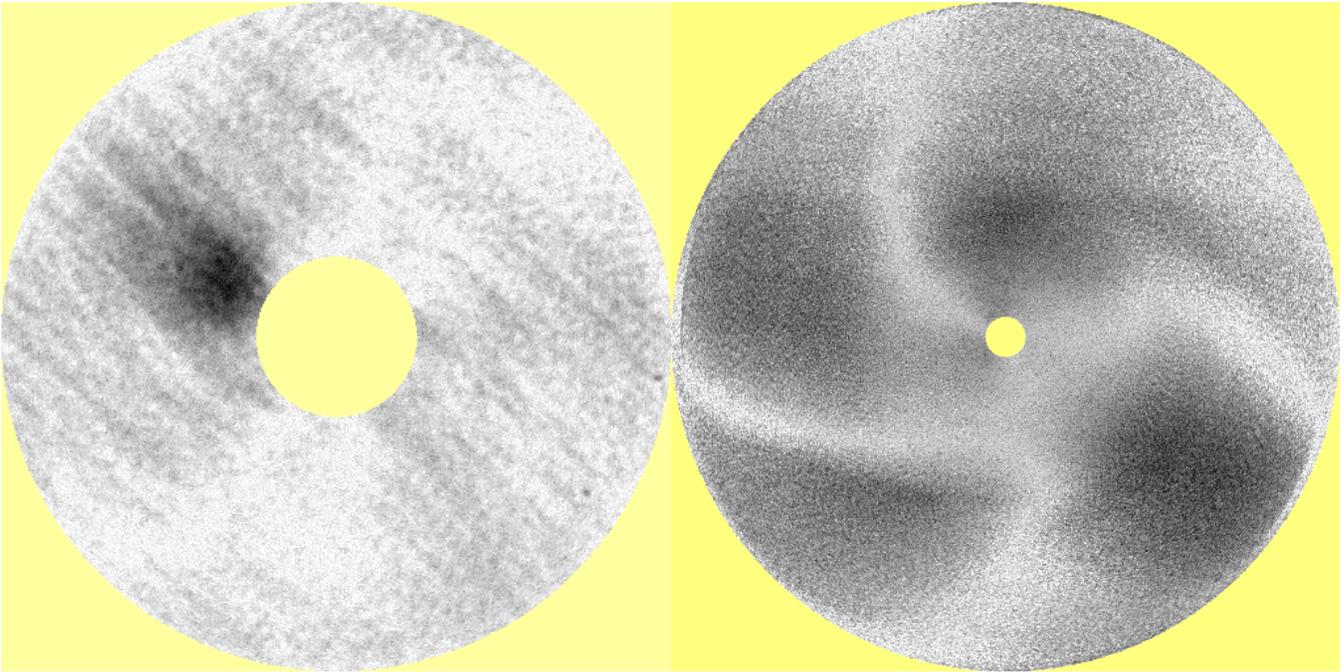
Disc 8 – side 1: DESY (left), SNS/FNAL (right), defect found in DESY scan;

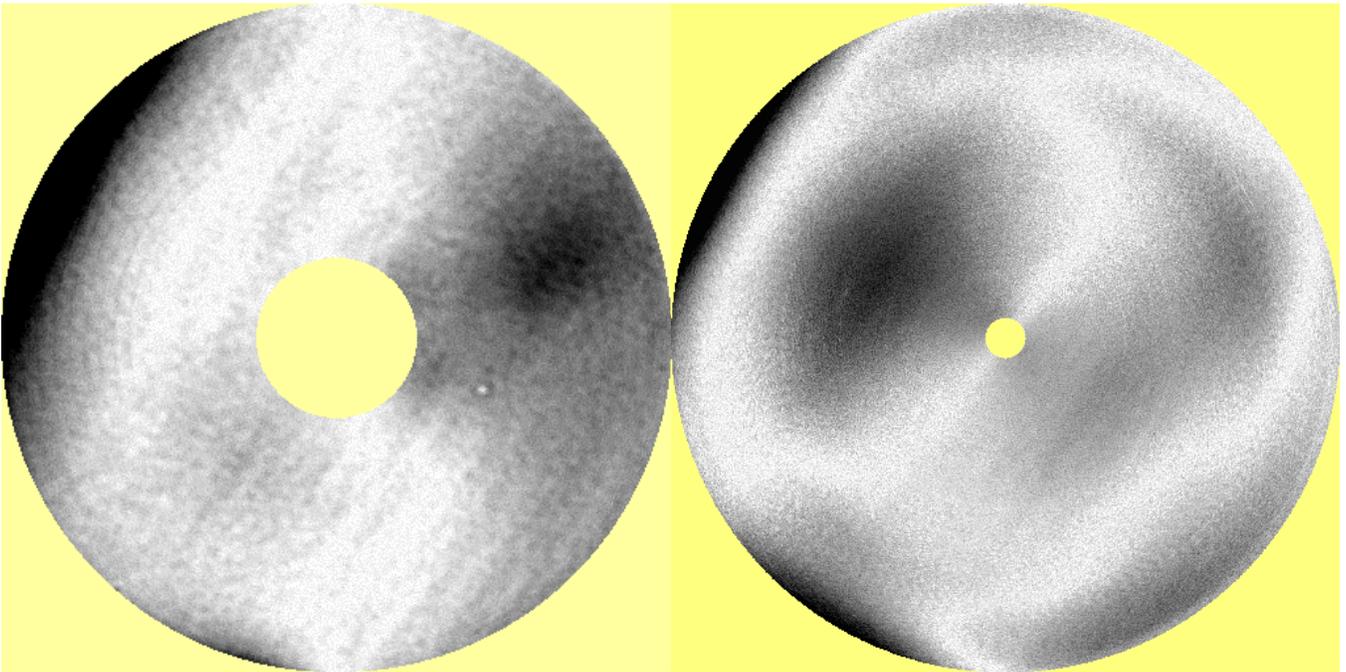
Disc 12 – side 2: DESY (left), SNS/FNAL (right), defect found in DESY scan;

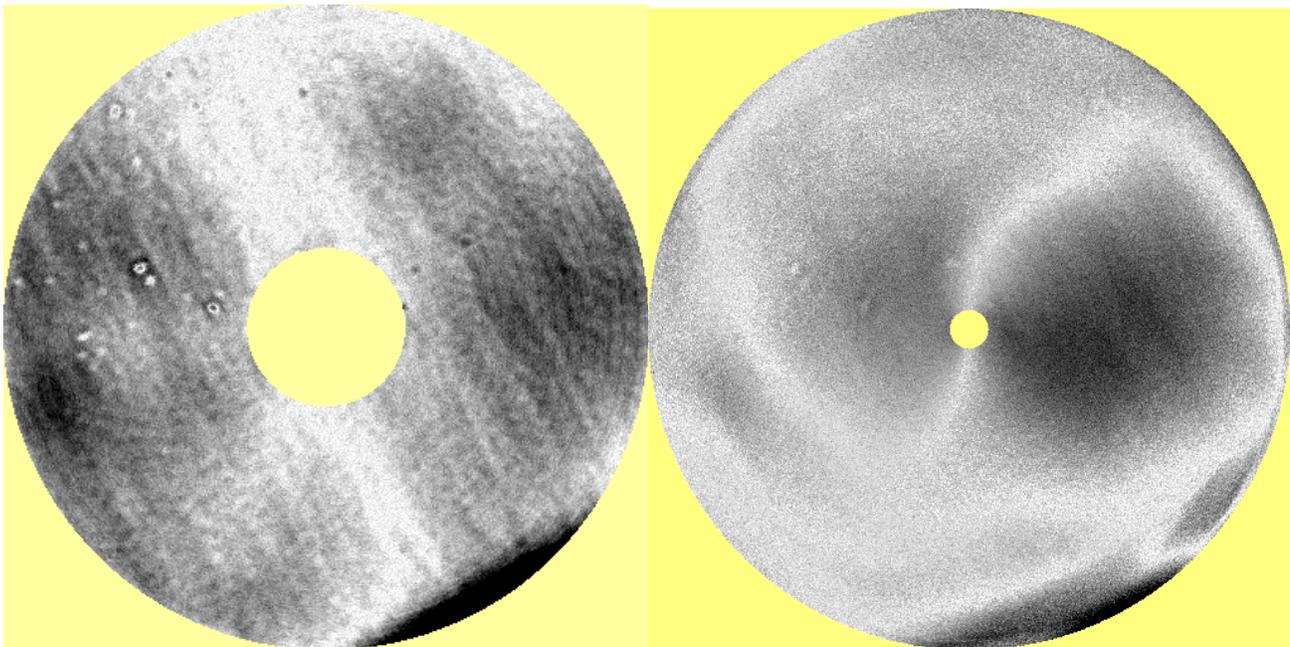
Disc 14 – side 2: DESY (left), SNS/FNAL (right), defects found in DESY scan;

Tests on disc 14 have revealed that these defects are not removed even after 175  $\mu\text{m}$  of BCP etching. Therefore it is not recommended to use these sides of the discs on the inside of the cavity, even after some pre-etching.

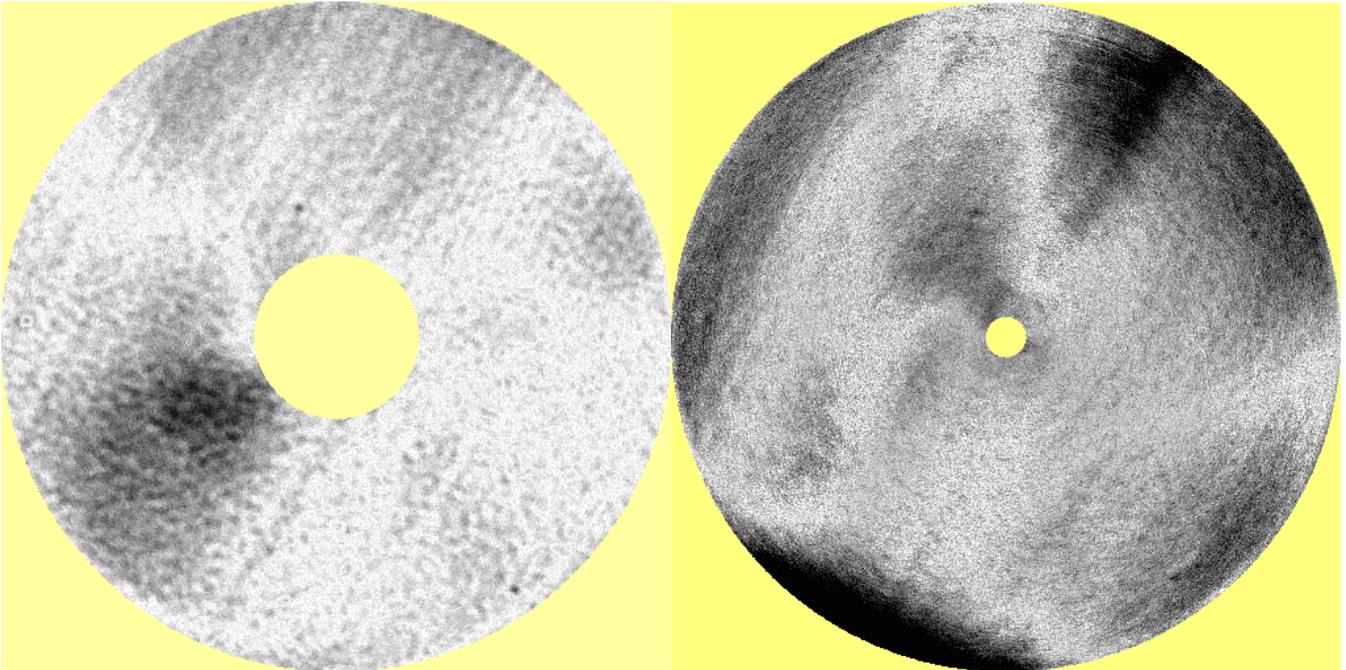
Disc 17 – side 1: DESY (left), SNS/FNAL (right), defect found in DESY scan;

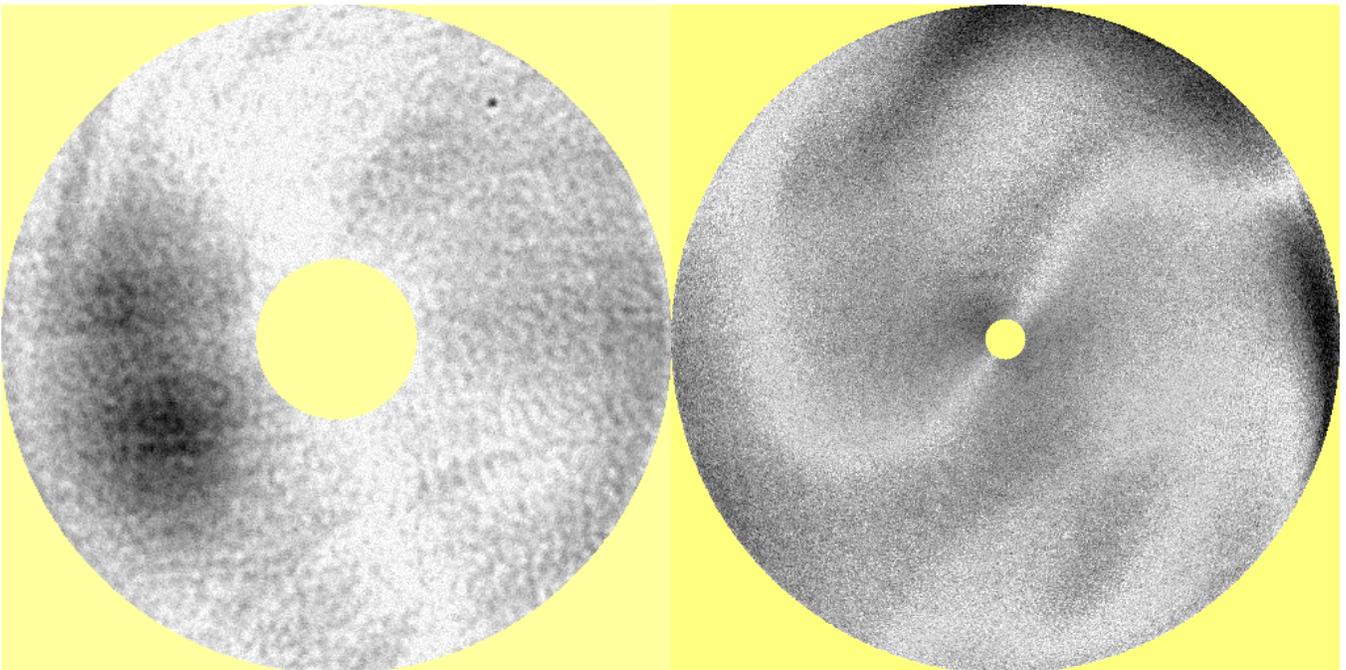
Disc 19 – side 2: DESY (left), SNS/FNAL (right), defect found in DESY scan;

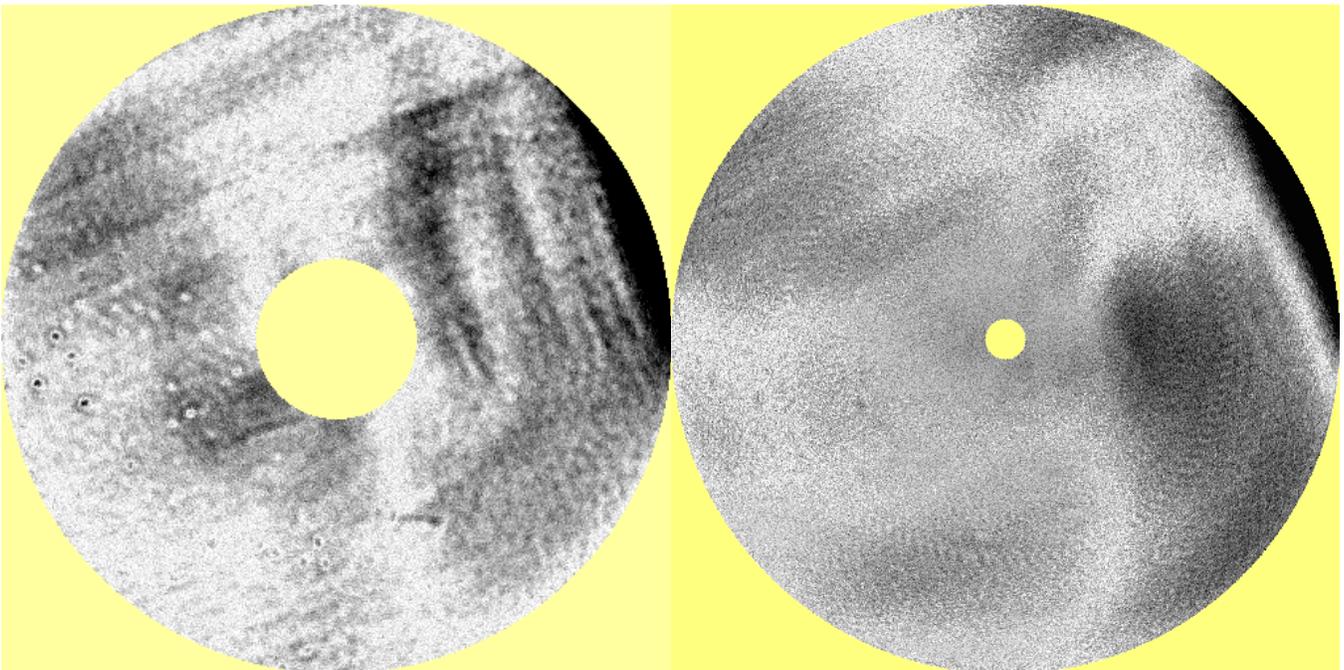
Disc 27 – side 2: DESY (left), SNS/FNAL (right), defects found in DESY scan;

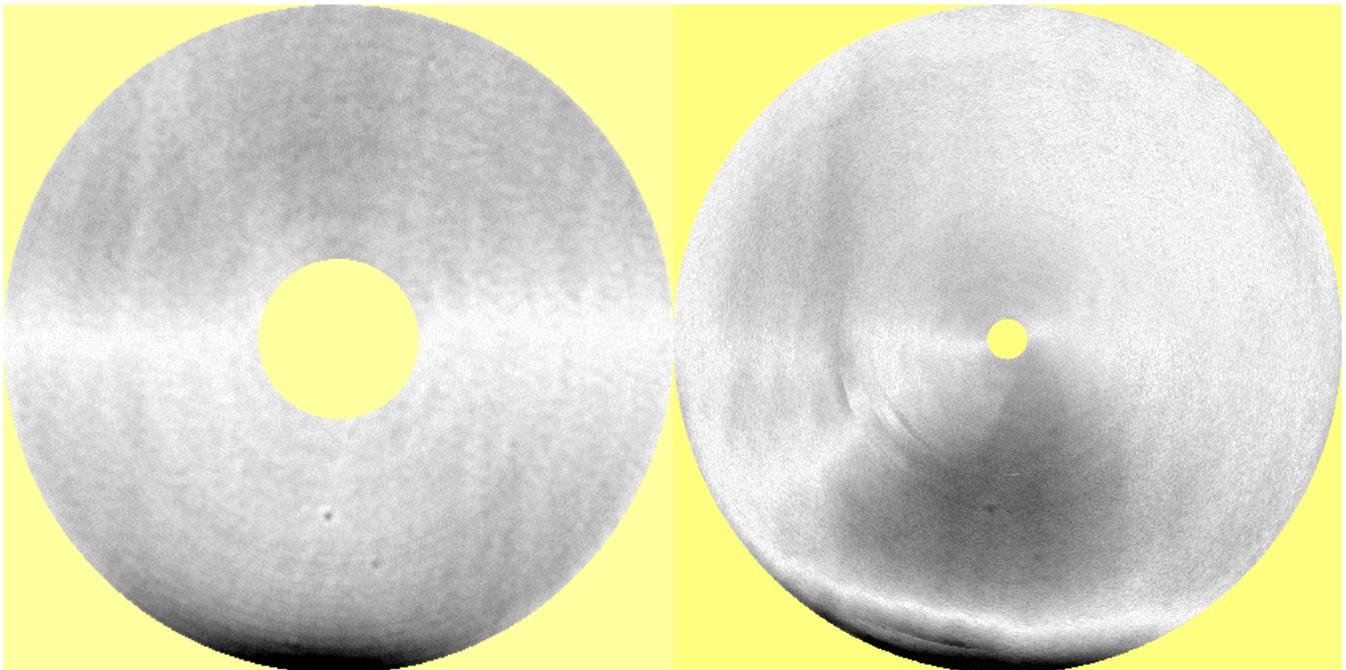
Disc 32 – side 2: DESY (left), SNS/FNAL (right), defects found in DESY scan;

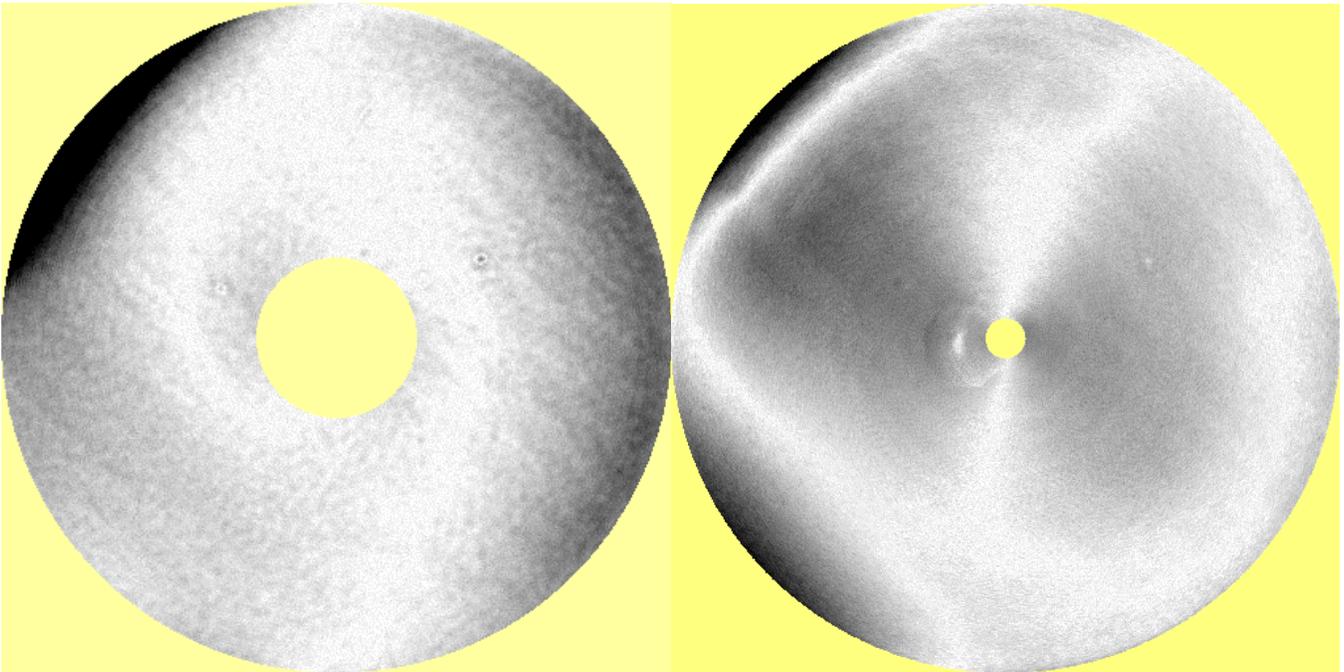
Disc 47 – side 1: DESY (left), SNS/FNAL (right), defects found in DESY scan;

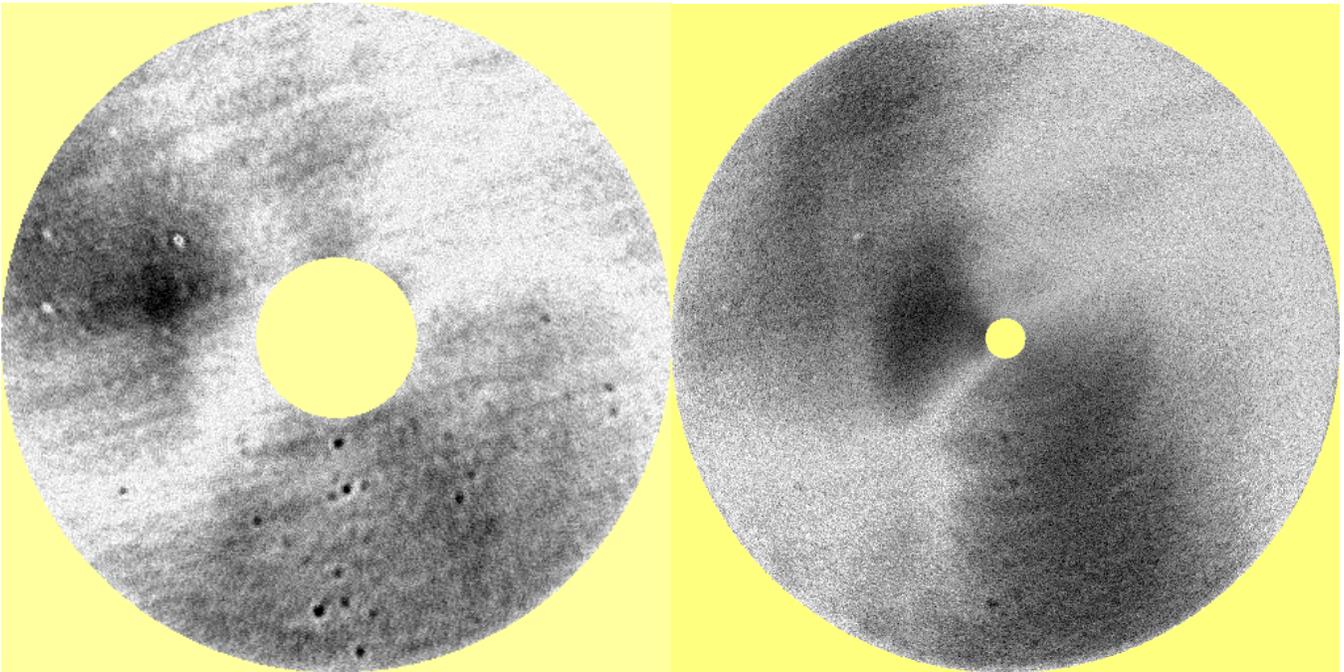
Disc 51 – side 1: DESY (left), SNS/FNAL (right), defects found in DESY scan;

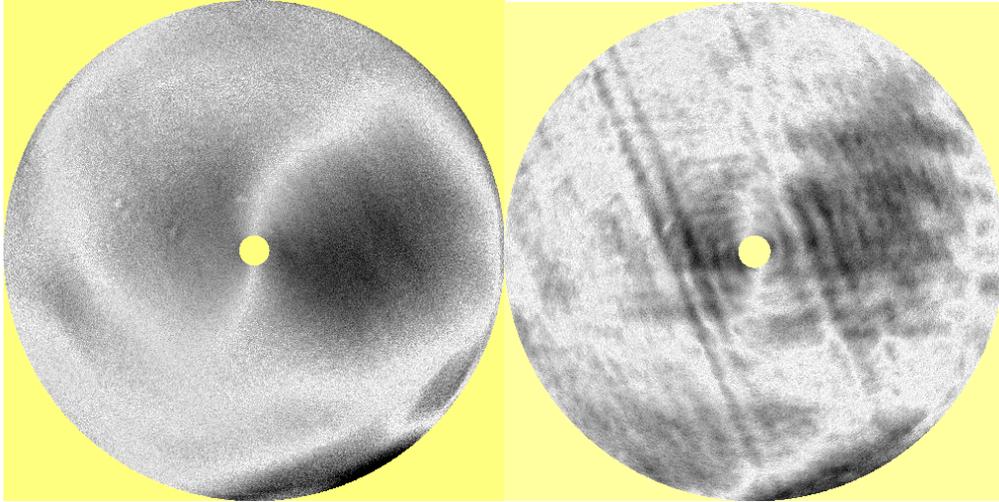
Figure 5 shows the results of eddy current scans performed with the SNS/FNAL scanner on disc 14-2 before and after removing 175  $\mu\text{m}$  with BCP etching. The plots clearly show a change of appearance of the scan, possibly a result of the increase of surface roughness due to the BCP etching. The change of surface appearance can also be seen in Figure 6, which shows a similar comparison for disc 14 – side 1 (which had not visible defects before etching) and Figure 7, which shows a similar comparison for disc 19 – side 2. Also, and this is corroborated by simple visual inspection, most defects are still present after etching. This result indicates that the defects found in some blanks from this batch will not be removed by the subsequent etching steps and that these particular disc-sides should not be used for the inside of the cavities. Since the total surface removed with BCP etching according to the current cavity fabrication procedure is 50  $\mu\text{m}$  less than the 175  $\mu\text{m}$  removed in this test, this test also addressed the possibility of an additional 50  $\mu\text{m}$  pre-etching. More than 50  $\mu\text{m}$  of pre-etching is not permitted since the thickness variations of the discs will be larger than allowable for welding and deep-drawing (one also needs to include the “natural” thickness variation of the discs of up to 100  $\mu\text{m}$ !).

**Figure 5: Scan of disc 14/2 before (left) and after (right) 175  $\mu\text{m}$  were removed with BCP etching.**
