12/06/06
Rev. 07/27/07
TD-07-016

HFDM06 Test Summary Report

The $\text{Cos}\theta$ dipole mirror magnet HFDM06 was made in the “standard” mirror configuration, using a coil manufactured using the RRP 108/127 Nb_3Sn strand (exactly the same as was used in SR03). It was tested in November 2006 at the Fermilab vertical magnet test facility (VMTF) where it was mounted to the 30 kA “HFM” top plate assembly. Data acquisition scan configurations were prepared using new configuration and version control tools; thus the preparation took several days longer than usual, and led to some minor difficulties during the test. Scans were started following electrical checkout and warm measurements on Tuesday November 7; pre-cooling with liquid Nitrogen began on 11/8. The VMTF dewar was filled with helium early on Thursday 11/9, followed by cold electrical checkout, quench/power system checks, and the first training quench that day. Quench training and ramp rate studies were conducted at 4.5 K, 2.2 K, and 3.5 K. These were followed by heater protection tests, during which an SCR in the dump switch failed and the magnet absorbed the full quench energy, resulting in a quench integral of about 18.5 MI

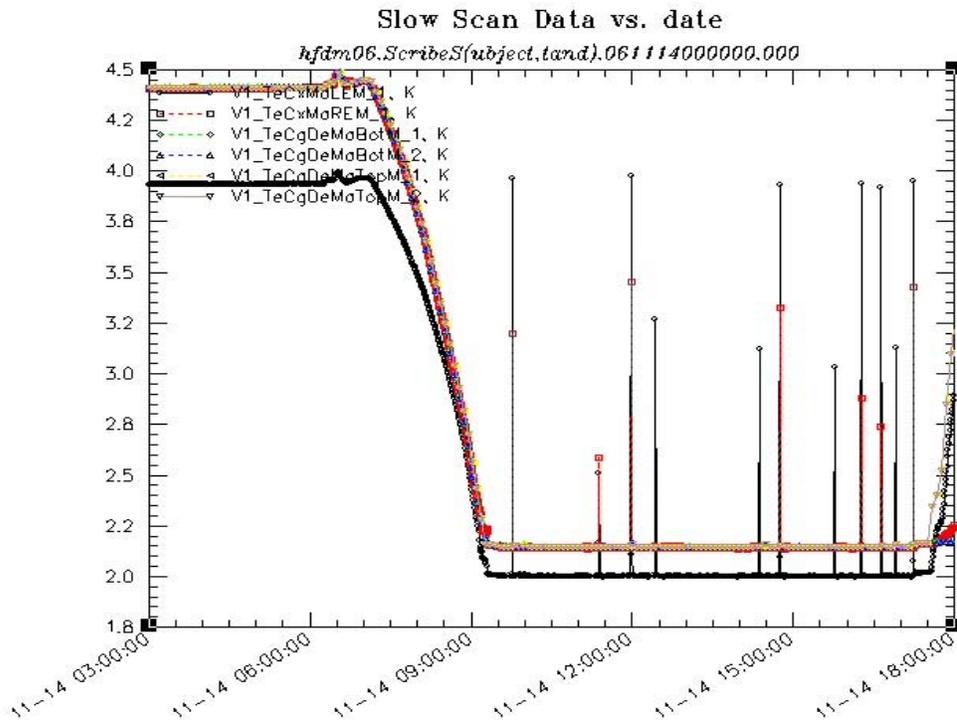
Figure 1. Temperatures in the magnet (black, red) and VMTF test dewar at 4.5K and 2.2K; the magnet LE RTD showed inaccurate readings at all temperatures.

The magnet contained an imbedded RTD at the Lead End and one at the Non-Lead end. Fig. 1 shows that the Lead End temperature sensor (CX22317) did not provide accurate temperature readings at any temperature, indicating that its calibration has changed, or that the wrong sensor was installed in this location. In addition there were many strain gauges, including several that were added specifically to gain more understanding of stress readings around the pole, and to apply this knowledge to measurements in the TQC magnet program. Configurable Voltage taps are shown in the coil map in Fig. 2.

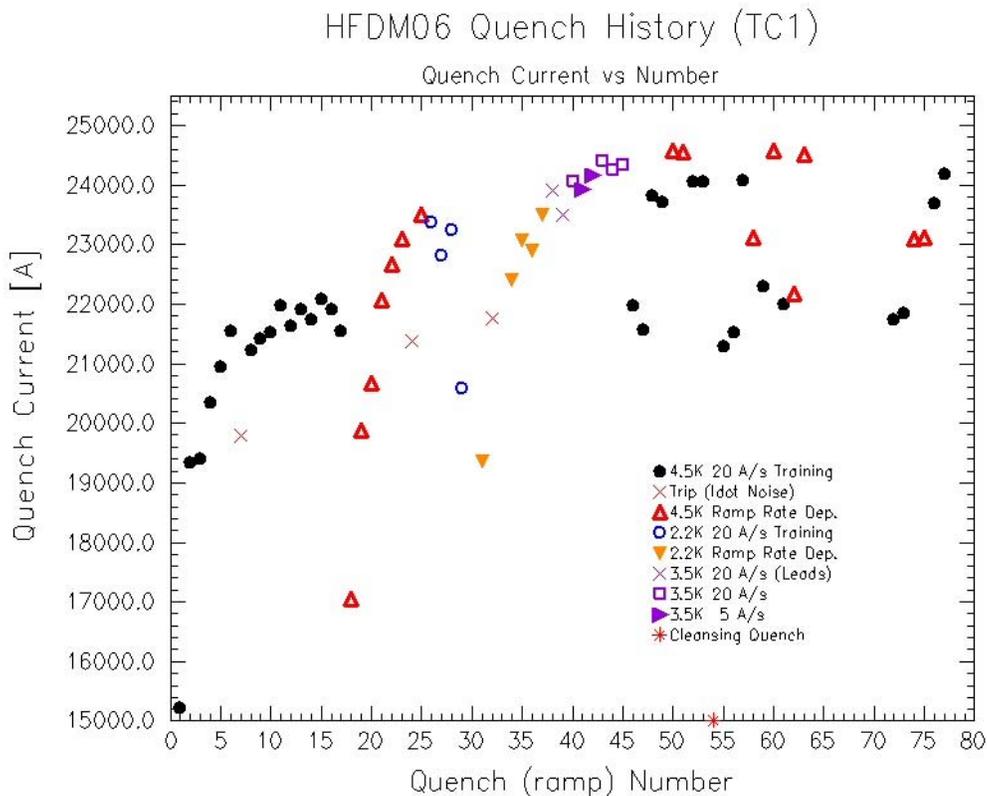
The quench performance program, illustrated in Fig. 3, started with magnet training at 4.45 K at 20 A/s, followed by 4.5 K ramp rate studies on 11/13. Training and ramp rate studies at 2.2 K followed on 11/14, and were to be continued on 11/15; however, the attempt to return to 2.2 K for additional temperature dependence studies failed due to heat exchanger contamination problems. An intermediate temperature of about 3.5 K was reached, however, and the training quenches there showed even better performance than at 2.2 K. Quench performance at 4.5 K was revisited on 11/16, at various ramp rates to explore conjectures about the apparently unstable quench currents. The full list of quench data files is presented in Table 1. Ramp rate dependence is shown in Fig. 4: The data suggest that the short sample limit (estimated from witness sample tests to be between 24.5 and 25.5 kA) was achieved at 4.5 K, but at lower temperatures was limited, presumably by either mechanical or thermo-magnetic instabilities.

A number of system trips occurred during the program, caused in part by incorrect DQD threshold settings (that were inadvertently re-established due to improper version control, or were set too low to begin with). At 3.5 K, two superconducting leads quenches occurred above 23kA; we relearned (SR03 test encountered the same issue) that the power leads require the liquid level to be raised to a higher set point (minimum of 24 cm) in order to prevent Joule heating from causing Sc Leads quenches.

Figure 3. Quench history in the first thermal cycle of HFDM06.

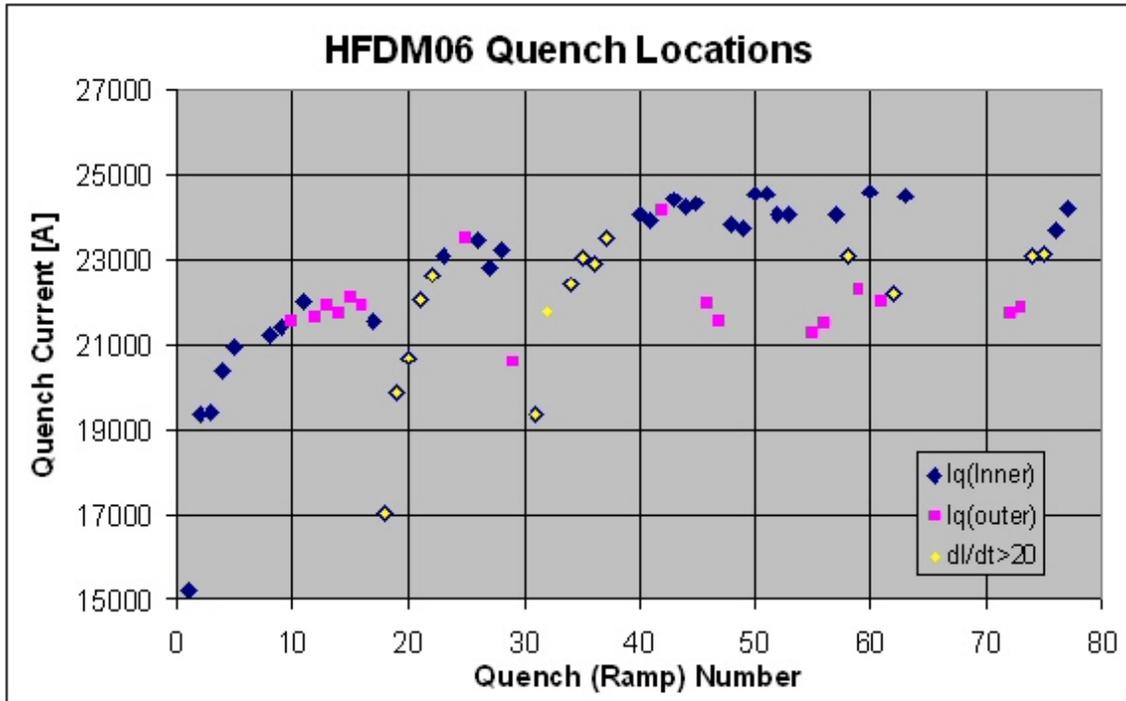
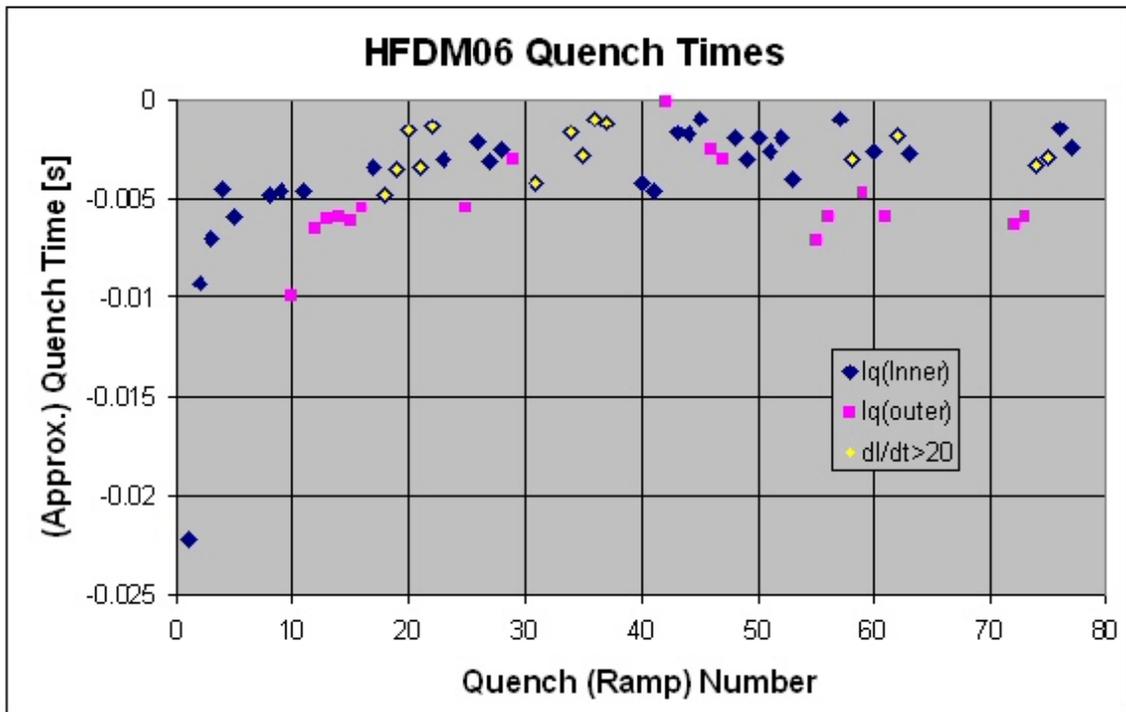
The quench currents, locations and timing are correlated, as can be seen in Fig. 5: outer coil quenches generally (but not always) develop more slowly, and at lower current. A number of events, in two different classes, stand out as especially interesting (or unusual): first, in four events (28, 35, 40, 41) the Half Coil AQD signal shows development starting in the outer coil, which is then overwhelmed by a quench in the inner coil; for these the CC_OS30 (outer coil) CVT segment, strangely, does not show anything happening. Second, eight events (20, 22, 29, 36, 37, 42, 43, 45) – two in the outer coil - seem to have developed very quickly such that either all segments show voltage growth, or the origin could not be visually determined from the CVT segments.

Figure 5. (a) Quench currents and (b) quench development time by location (inner, outer coil). High ramp rate quenches are separately identified.
