October 16, 2015

Analysis of MICE Spectrometer Solenoid magnet M1 coil failure

A. Bross, S. Feher, P. Hanlet, M. Palmer, M. Popovic

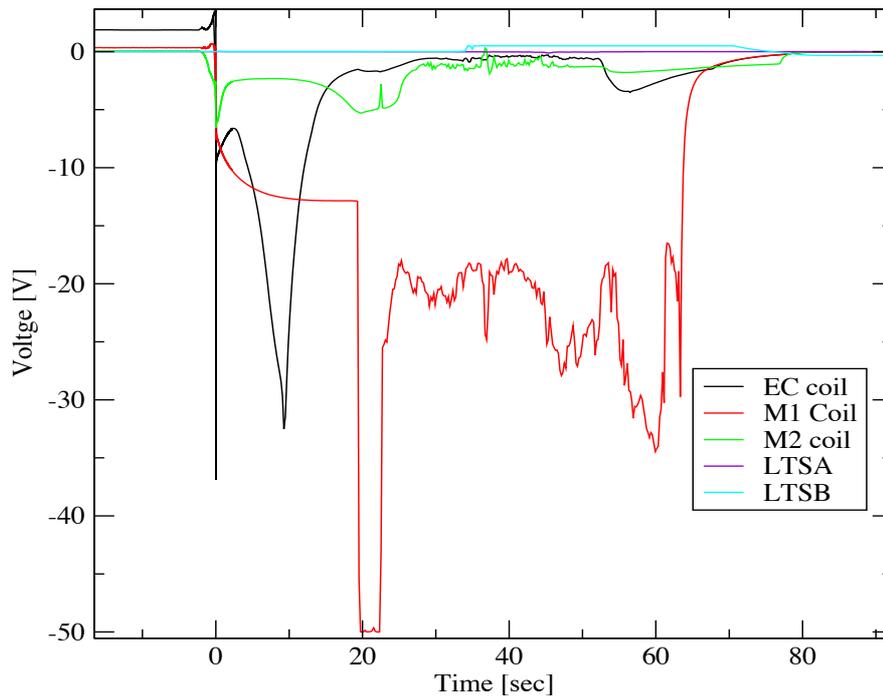
Quench on September 13th

There were many days of investigations and a full suite of measurements was completed. A detailed understanding of the event is now in hand. Not powering coil M2 caused a significant delay in the onset of the quench in coil M1. The quench initiated in ECE, was detected by the QP system and a quench signal triggered opening of all of the contactors in the power supply system for the magnet. ECE quenched immediately, but a quench in M1 had not occurred at 20 seconds into the event. An overall plot of the voltage tap data is given in Figure 1. Figures 2a and 2b present an expanded view (in V) of these data.

Figure 1. Coil and LTS lead voltages. M2 coil was not powered. EC coil had a spontaneous quench. M1 coil did not quench and the cable that connects the 8 mOhms resistor with the diode gradually overheated and opened around 20 sec after the contactor was opened. Then arc developed between LTSA and LTSA lead at the flange region. LTSA was welded to LTSA and it opened. Arc moved to ground at two locations developing a double ground fault. Finally the current decayed to zero.

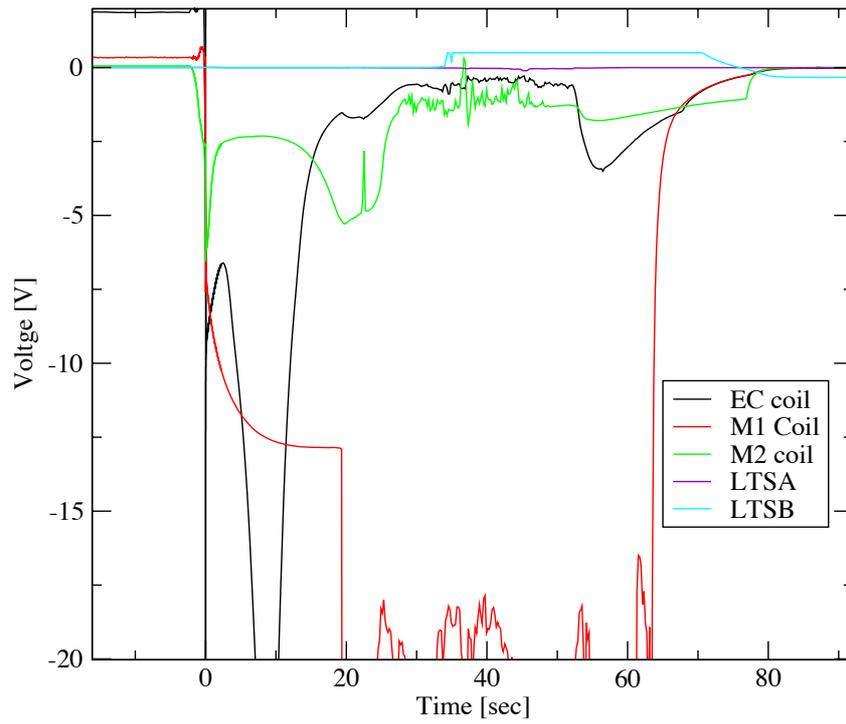
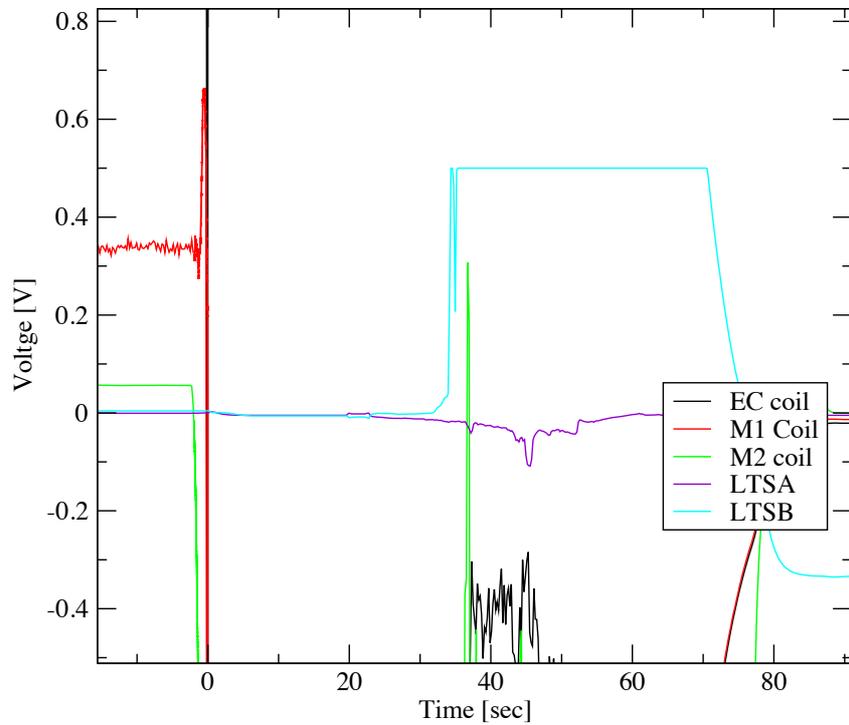
Fig 2a and Fig 2b. Coil and LTS lead voltage traces enlarged.

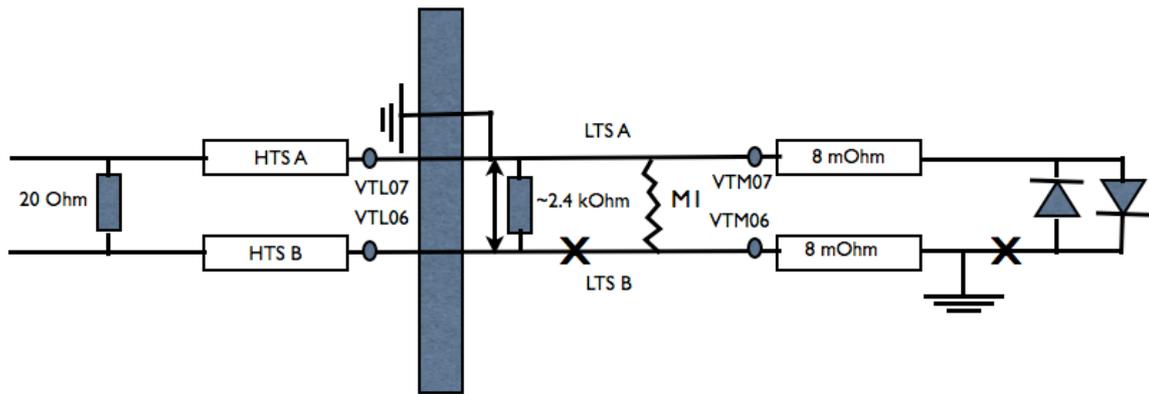
From an analysis of the QP data and all measurements on the voltage taps, an understanding of the resultant condition of the M1 coil circuit has been developed. It is shown in Figure 3.

Figure 3. Diagram of the M1 circuit after the quench of September 13th. Resistance (four wire and two wire) measurements revealed: i) Lead A has hard short to ground, ii) LTSB is shorted to LTSA through 2.4 kOhms and LTSB is not connected to the M1 coil on the Lead B side.

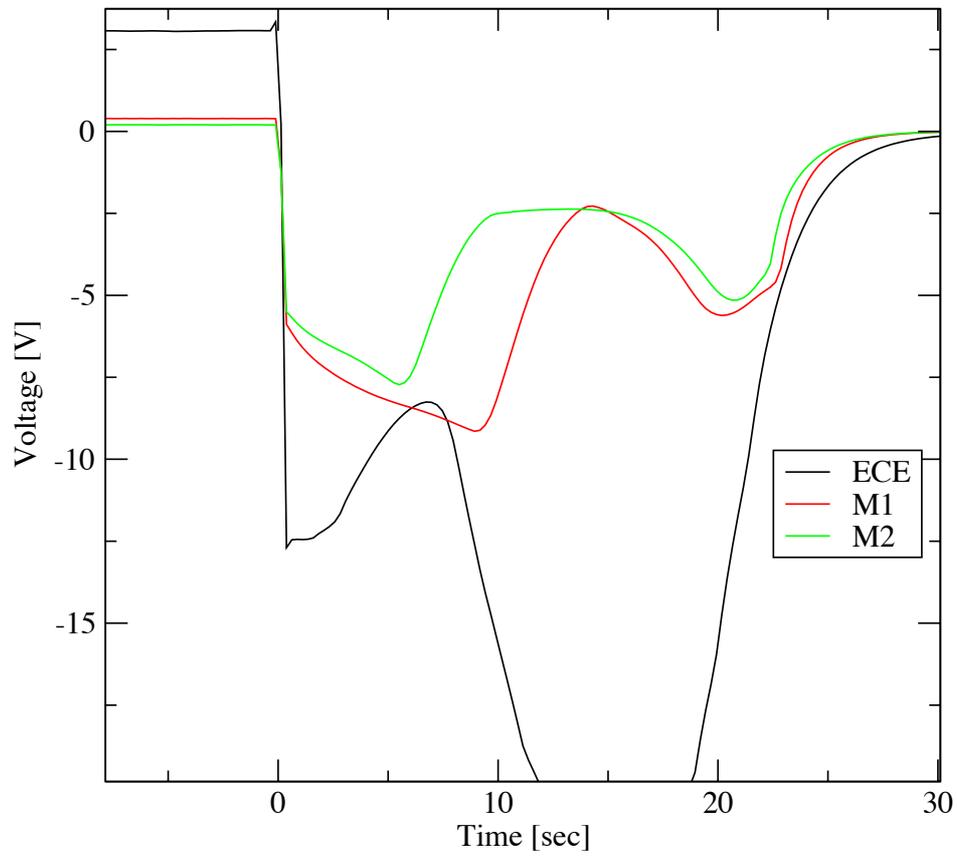
Normal quench event

For comparison, data from the QP system for a ramp in which all the coils were powered are shown in Figure 4. In this event, a quench was detected in ECE and the QP system fired. Quench propagation was normal ECE, then M2 and finally M1.

Fig 4. Normal quench event. Quench initiated in ECE. First EC quenched then about 6 sec later M2 and finally around 10 sec later, M1.

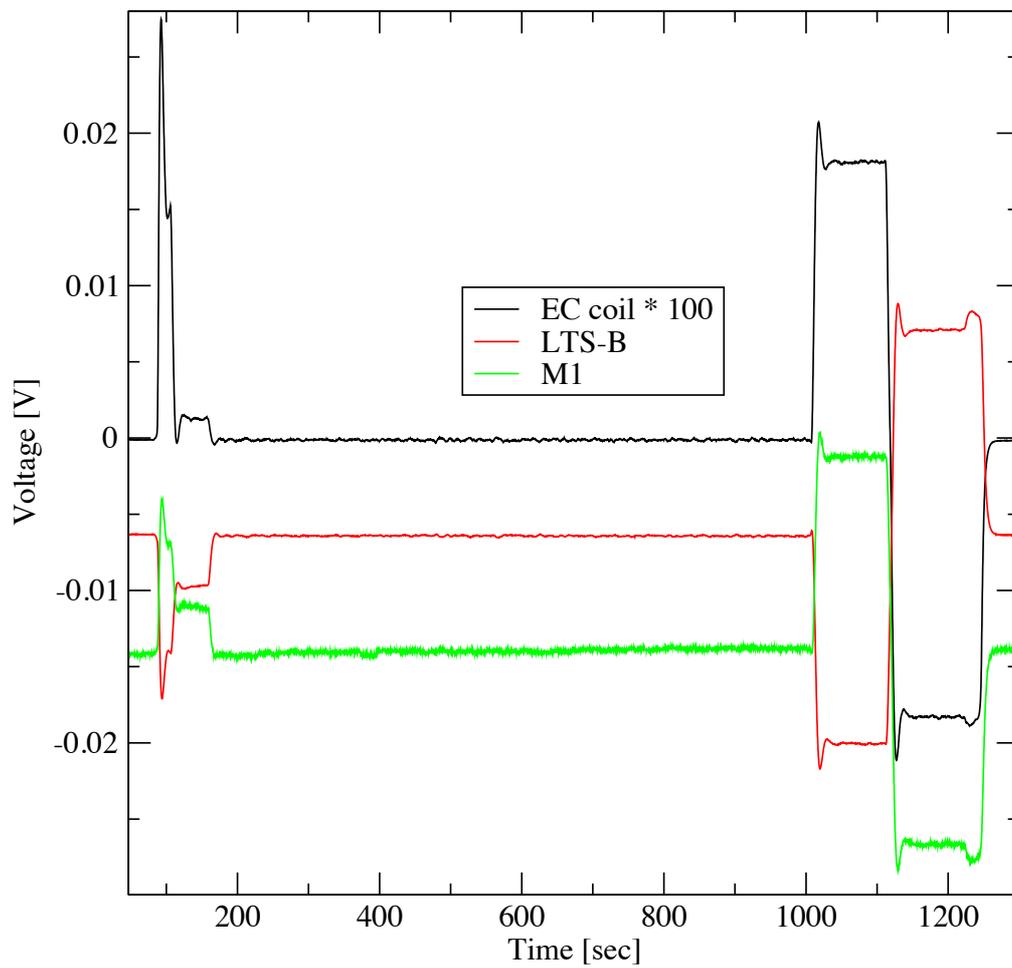
Finally, after the event of September 13th, we looked at voltage signals induced on the M1 coil and lead when the ECE coil was ramped (see Figure 5). The M1 coil was disconnected from its power. The voltage signals across the M1 voltage taps and across the M1 LTS-B lead voltage taps were recorded. The recorded data are consistent with the circuit diagram presented in Figure 3.

Fig. 5. Test of induced voltages on M1. M1 is disconnected from its power supply and the ECE coils were ramped to 5A. As can be seen, voltage (as seen on the voltage taps) is seen on M1 due to mutual inductance. The LTS-B voltage taps clearly measure the inductive voltage with opposite polarity, which is expected, based on the explanation given in caption of Fig 1.
