Fermi National Accelerator Laboratory
P.O. Box 500 • Batavia, Illinois • 60510

TD - 03 - 001
December 20, 2002

Nb₃Sn Shell-Type Mirror Magnet, HFDA-03A Production Report

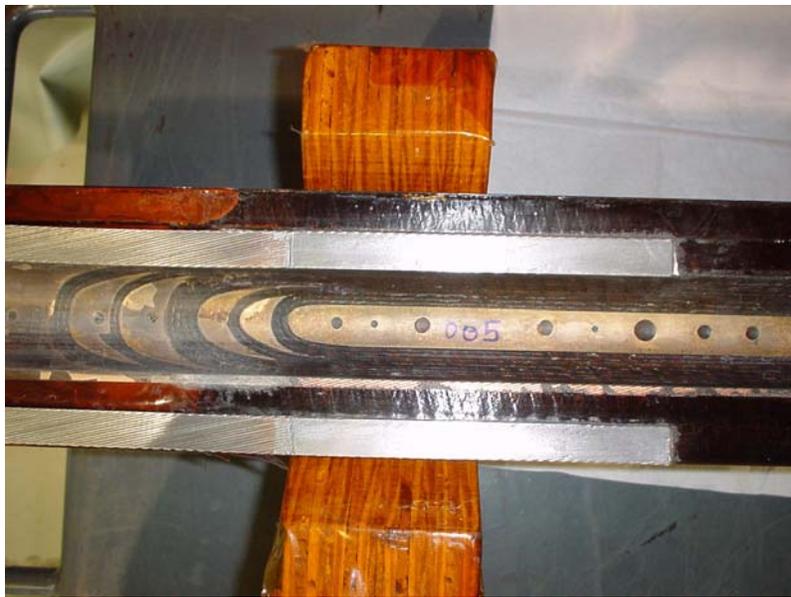
Fig. 1: Photograph showing the LE splice joints with long leads.

The fabrication of half coil, HFDAH-05 has been outlined in HFDA-03 production report¹. Four splices, two in the inner layer and two in outer layer were added in the mid-plane of the coil. These splice joints would increase the current sharing between the strands thus reducing the eddy current effect. Two splices per layer – one near the LE and the other near the RE - were joined. The splice joints at the LE for both the layers of the half-coil have a long lead, which could be used as power leads instead of the original ones. This would aid us in understanding whether the poor quench performance is due to cable degradation occurred during splicing or due to the proposed eddy current effects. Figs. 1 and 2 shows the half coil with the LE and RE splice joints respectively –

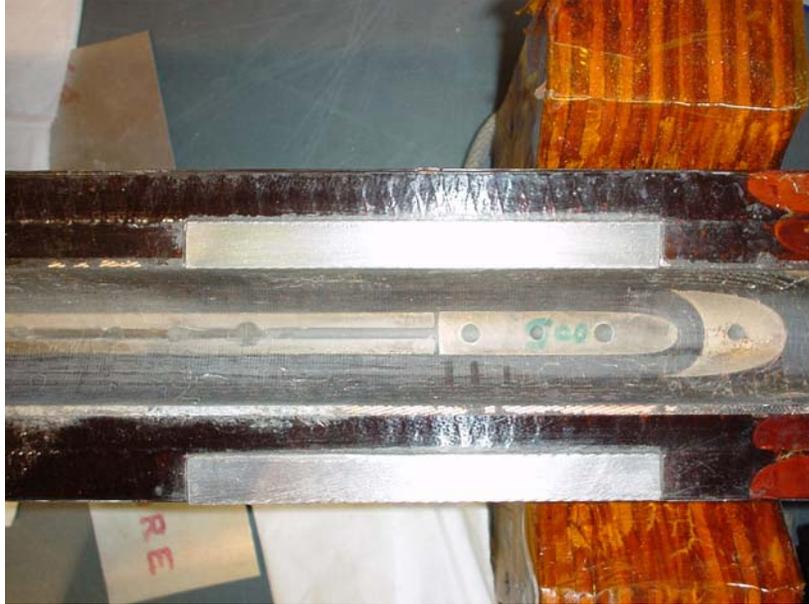
Fig. 2: *Photograph showing the RE splice joints*

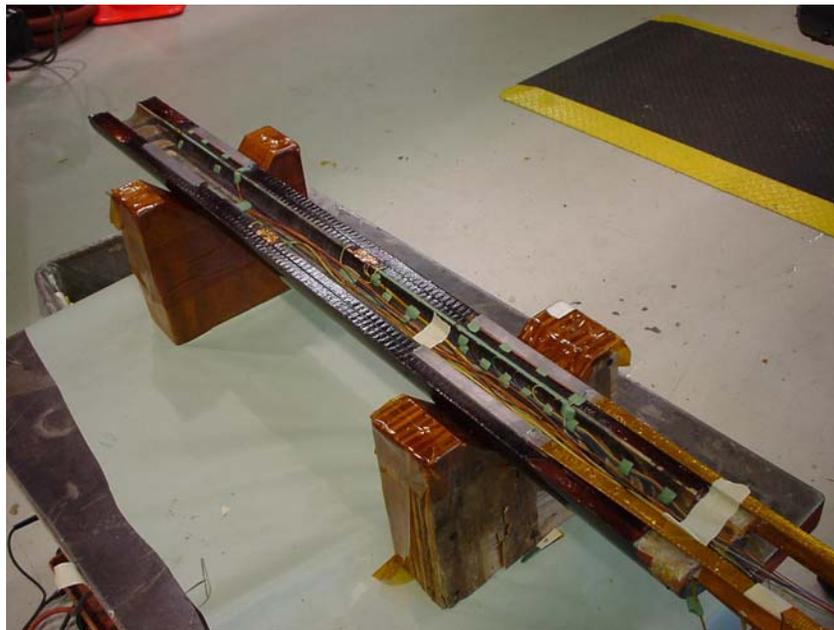
Fig. 3: *Half coil with all the instrumentation*

The next step was to instrument the half coil. Fig. 3 shows the coil with instrumentation. Fig. 4 shows the voltage tap, temperature sensor and spot heater lay out. The rest of the mid-plane was filled with G-10 shims and were glued in place using the epoxy impregnation fixture. Fig. 5 shows the half coil after this operation.

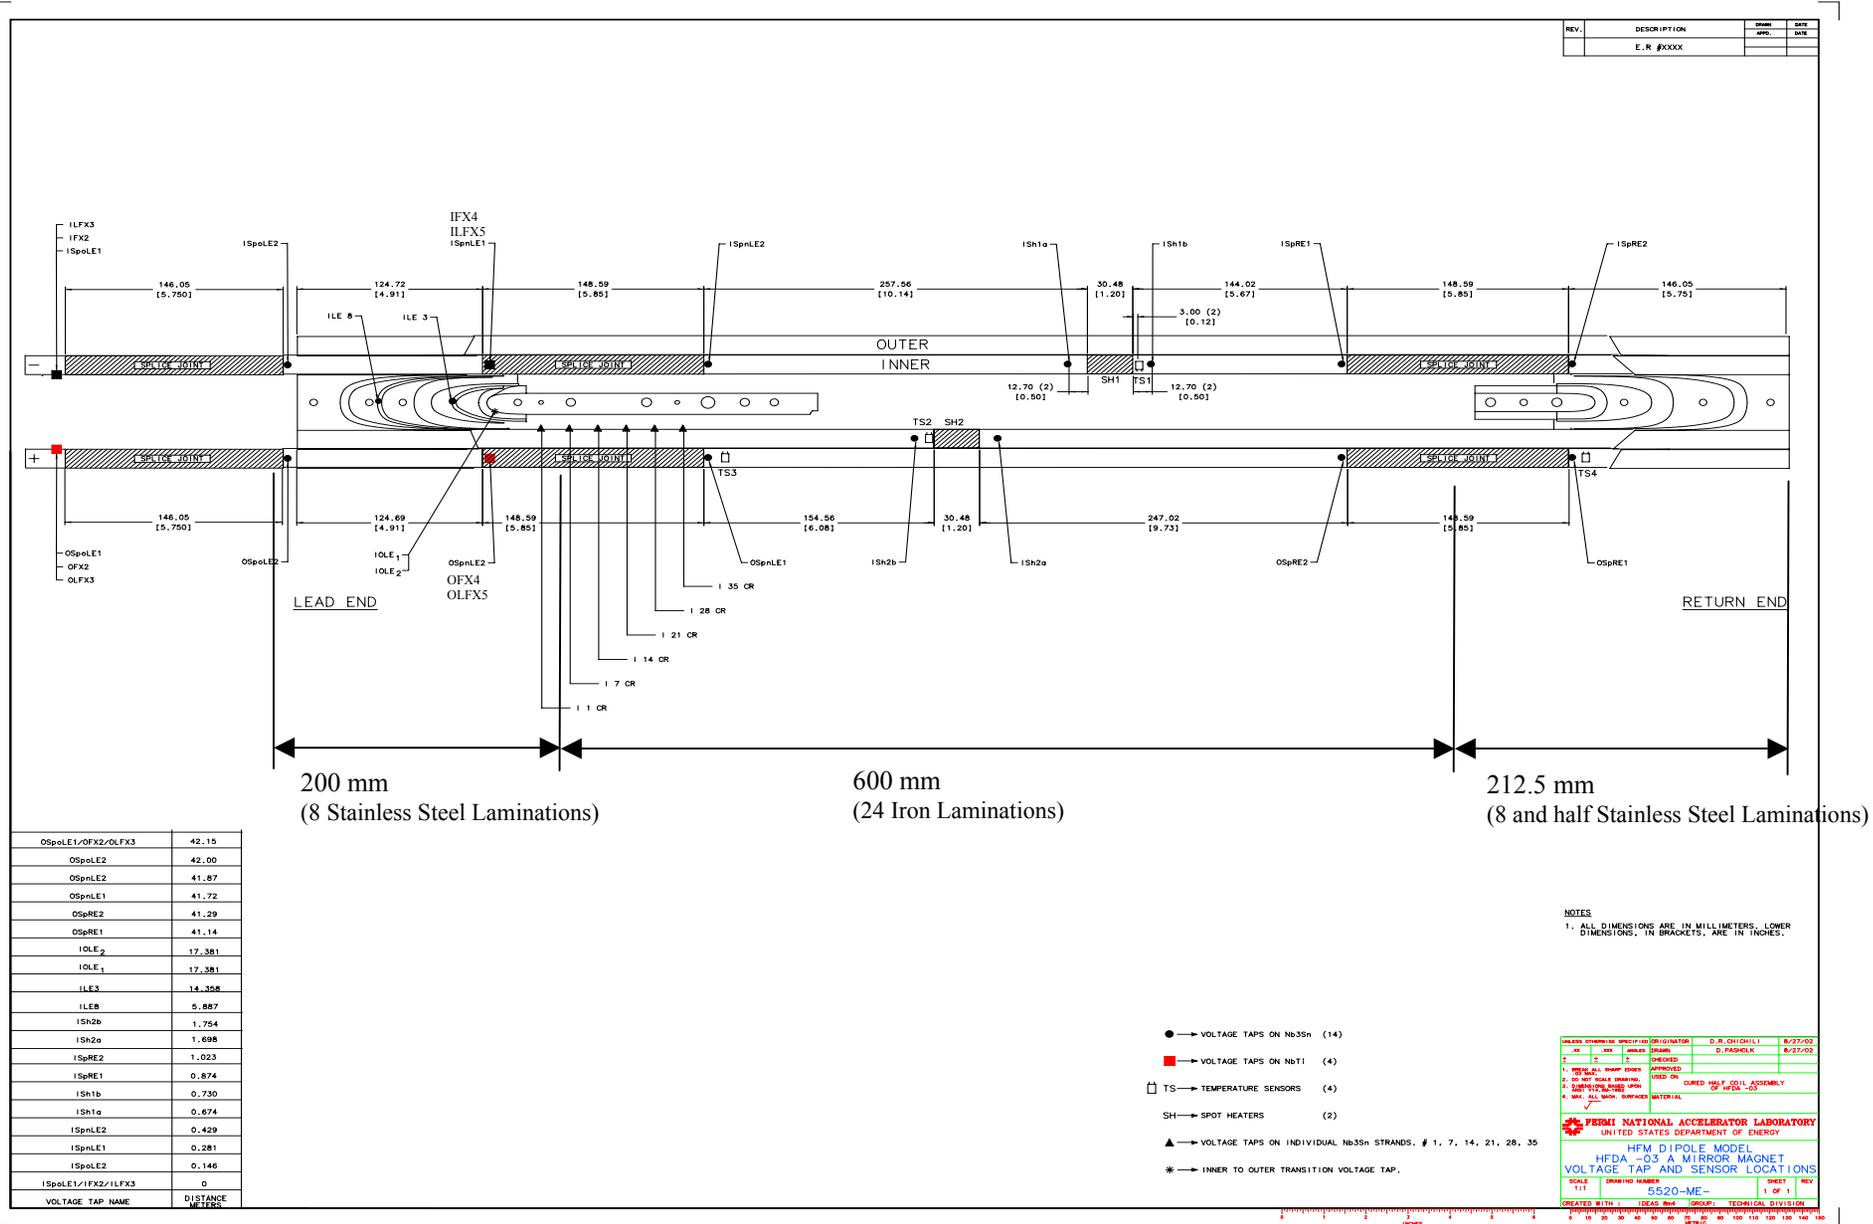
Fig. 4: Instrumentation layout

The coil was instrumented with 4 temperature sensors (Cernox CX-1050-SD) and two spot heaters. Two temperature sensors, TS1 and TS2 were set very close to spot heaters SH1 and SH2 respectively. Together they will be used for local temperature margin measurements. This technique, introduced during the tests of HFDB-02 and described in TD-02-024, allows an estimation of the local critical current of the cable in case the current is limited by damage in another location.

Several voltage taps were attached to measure the resistance of different splices and to locate the quench origin. Six voltage taps were also attached on single strands on the first turn of the inner layer. These six wires have been twisted together and the signals will be compared in an attempt to detect uneven current distributions in the cable due to BICCs. The voltage taps were set on the cable edge toward the aperture. There is a voltage tap every seven strands (i.e. strands 1, 7, 14, 21, 28 and 35).

The coil assembly was then placed in the yoke. Fig. 7 shows the coil in the yoke assembly. The layout of the iron yoke and stainless steel laminations with respect to the coil is shown in Fig. 4. There are 8 stainless steel laminations in the LE, 24 iron yoke in the straight section and 8 and half stainless steel laminations in RE per half magnet. Note that each lamination is 25 mm thick. The yoking/clamping procedure followed was similar to that of the previous dipole magnets. The spacers were instrumented with strain gauges to measure the azimuthal stress and two capacitance gauges were inserted in the outer layer pole region. The layout of the gauges is similar to that of HFDA-03. Figs. 8 and 9 show the evolution of azimuthal stress in the outer layer pole region and the spacer during yoking with and without the radial shim on the coil. Note that the radial shim was added to minimize the contribution of the pre-stress to the coil due to the skin during bolting operation. With the addition of the radial shim, there is more transfer of load to the coil thus reducing the stress in the spacers. During the entire operation, 50 mil shim was placed between the yoke halves in the LE and RE to prevent over-compression especially the lead cable and splice joints in LE.

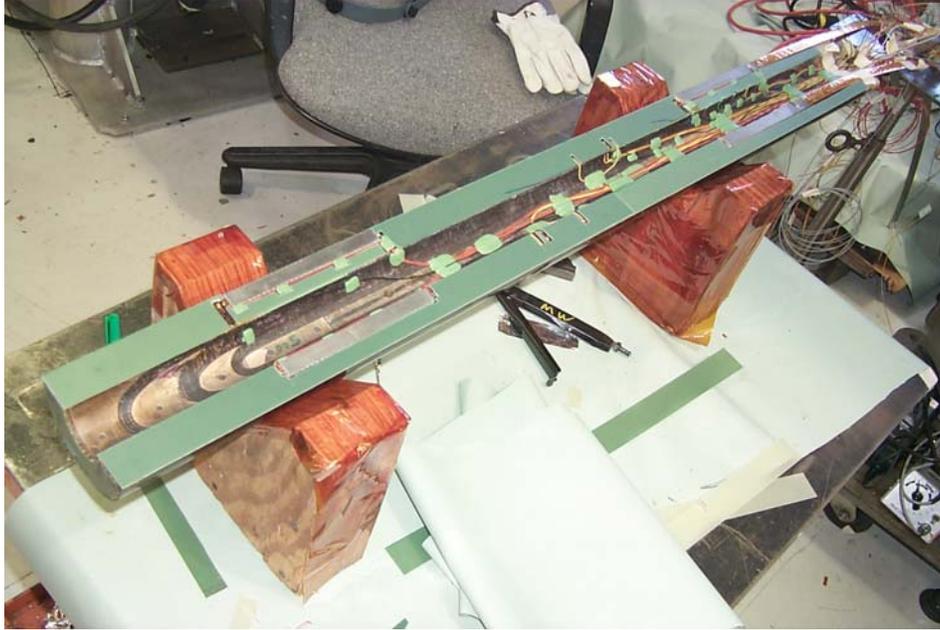
Fig. 5: *Mid-plane of the coil filled with G-10 shims and glued using impregnation fixture*

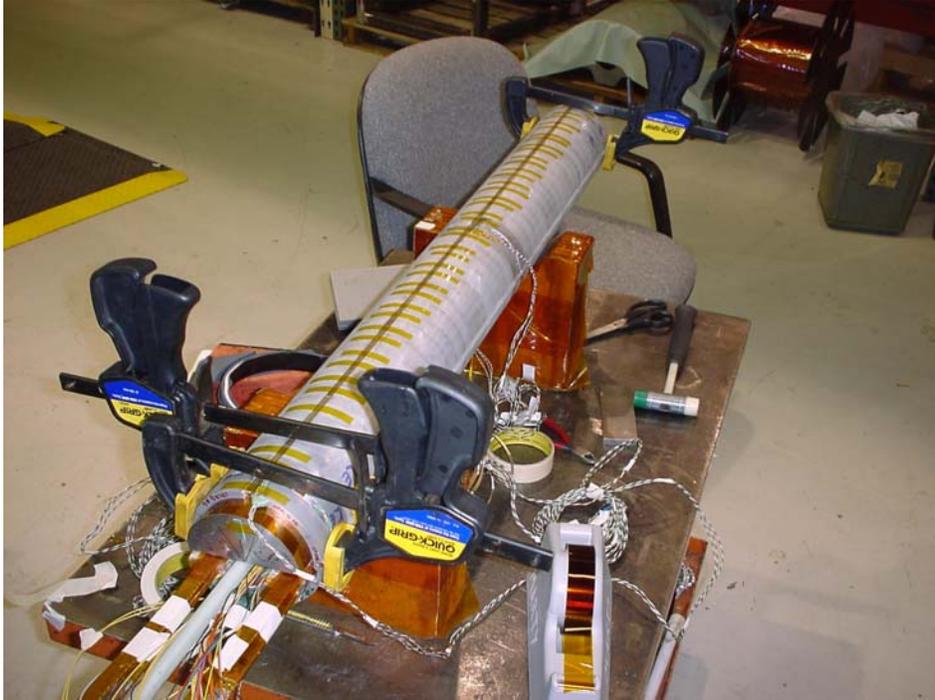
Fig. 6: *Half-coil with iron mirror and aluminum spacer*

Iron mirror was first placed on top of the half coil and then aluminum spacers were used to hold them together as shown in the Fig. 6. Two Kapton layers totaling 50 μm were placed on the radial surface of the half coil to create interference between the coil surface and the spacer. Kapton layers were also placed on the outer surface of the iron mirror such that there is a clearance of 0.1 mm between the spacer inner radius and the mirror outer radius. Note that the nominal ground insulation thickness on the iron mirror is 0.5 mm.

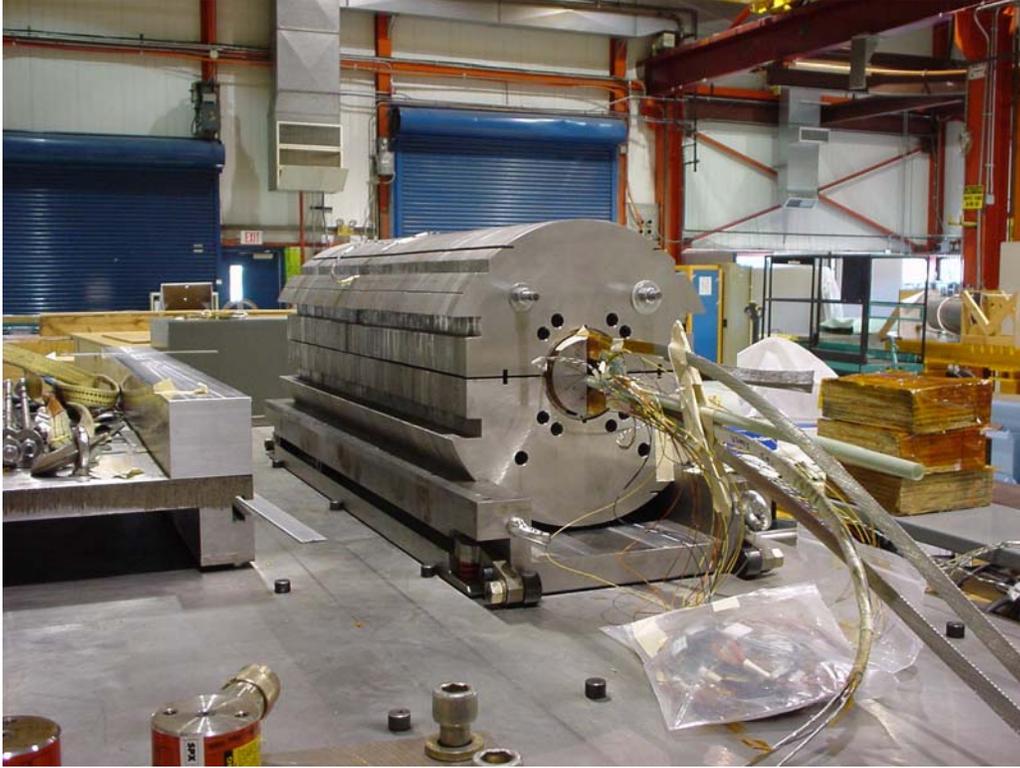
Fig. 7: Coil + iron mirror in the yoke assembly

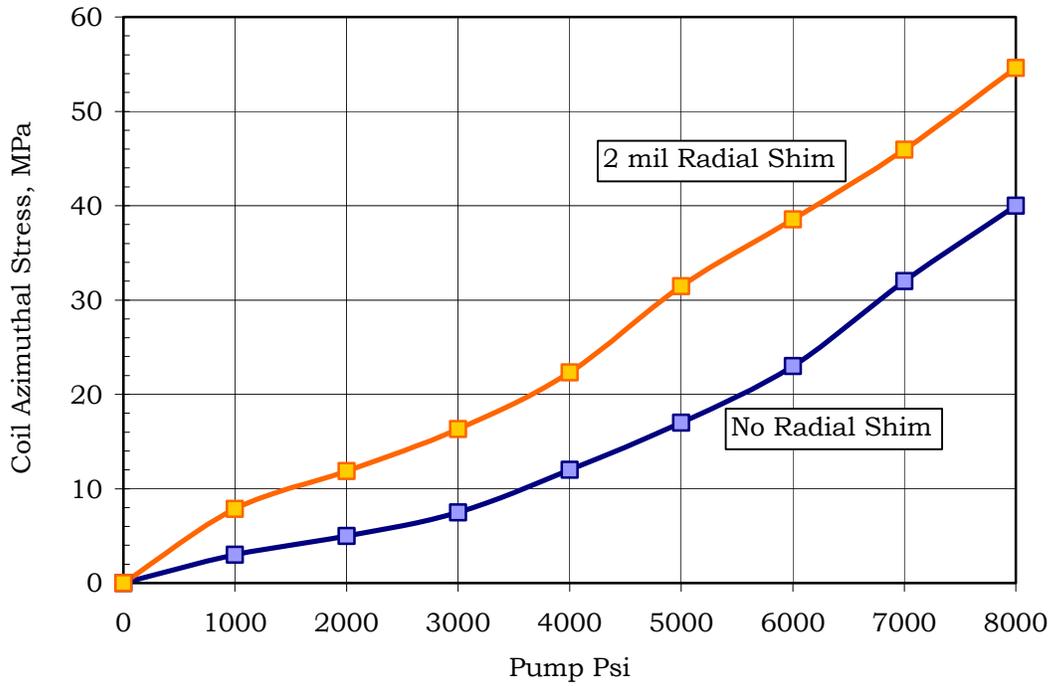
Fig. 8: Evolution of coil azimuthal stress during yoking operation

At 8000 Pump Psi, the clamps were inserted using a separate set of pusher blocks. Two clamps one on each side were inserted simultaneously starting from the middle of the magnet. The coil resistance was monitored during the yoking/clamping operation to detect any possible coil to ground or heater to ground shorts. Table 1 shows the data along with ANSYS predictions. After spring back, the azimuthal stress in the coil is about 17 MPa compared to 25 MPa predicted by analysis.

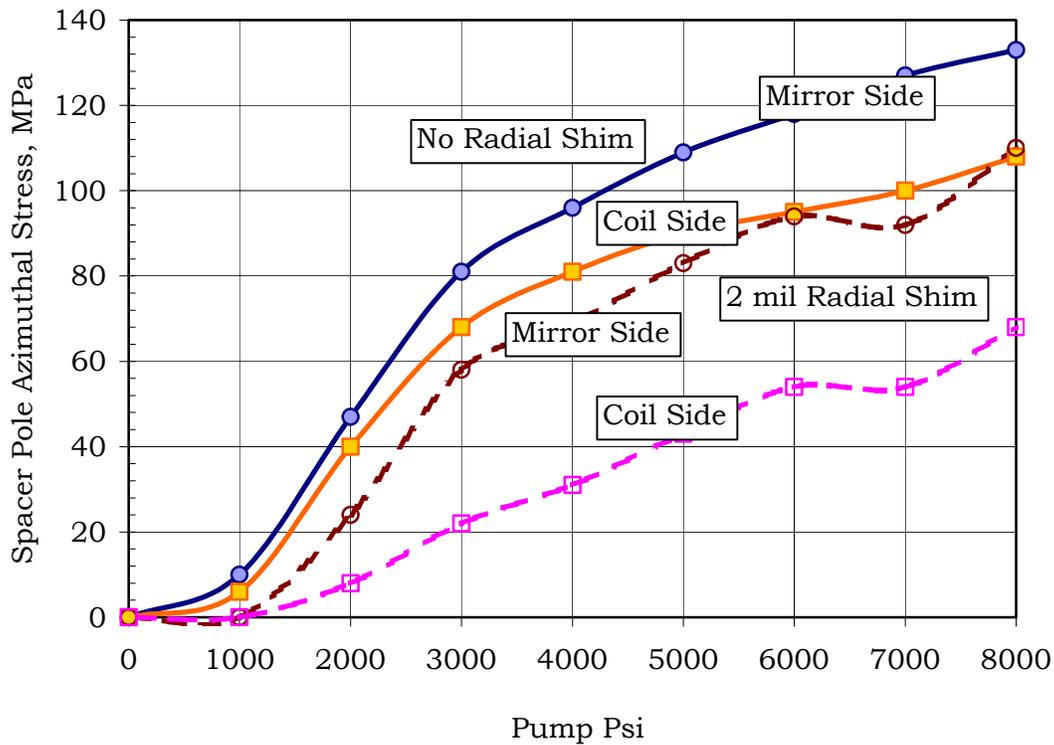
Fig. 9: Evolution of azimuthal stress in the spacer during yoking operation

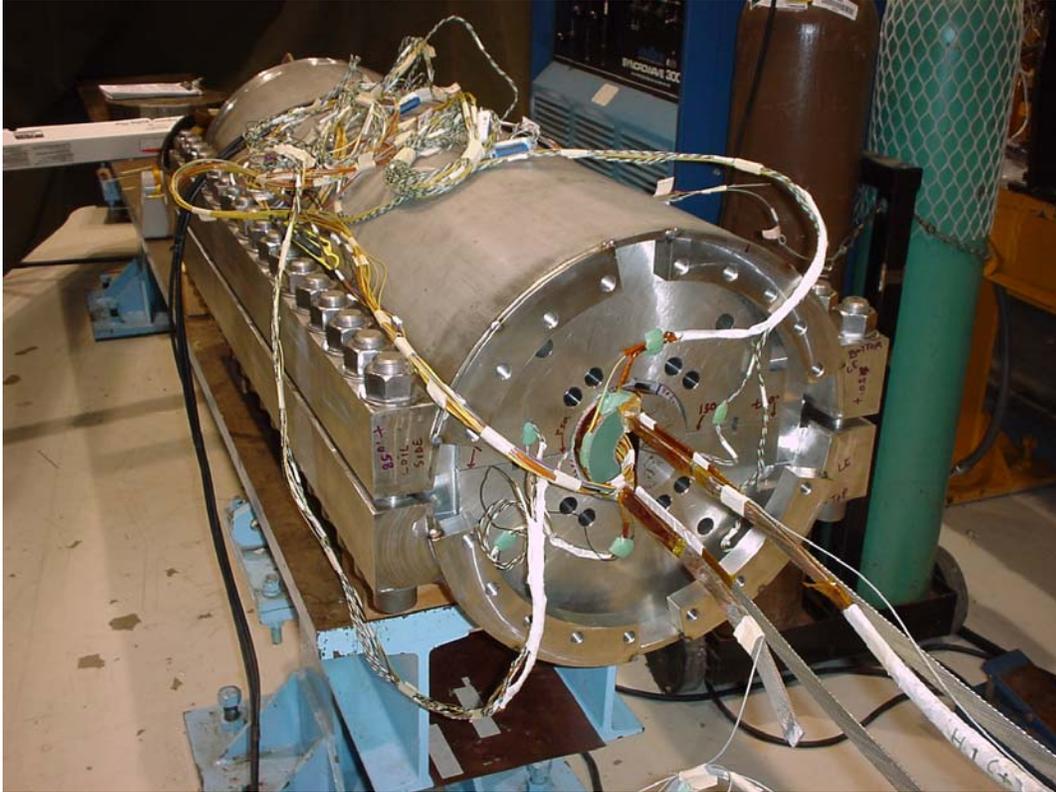
Fig. 10: *Mirror magnet with bolted skin*

Skin halves were placed around the yoked assembly. Note that the bolted skin structure had to be formed into shape atleast for the first time since it was bend slightly out of shape due to the welding of the flanges. Smaller diameter bolts were first used to get the skin in shape and then they were successively replaced with the correct size bolts. Fig. 10 shows the coil with the bolted skin around.

The next step was to install the end plates. For this the flanges were first welded to the bolted skin as shown in Fig. 10. The end plates were then bolted to these flanges and the final assembly is shown in Fig. 11. The lead cables coming out were secured in a G-10 plate before bending and routing them through the hole in the standoff plate as shown in Fig. 12.

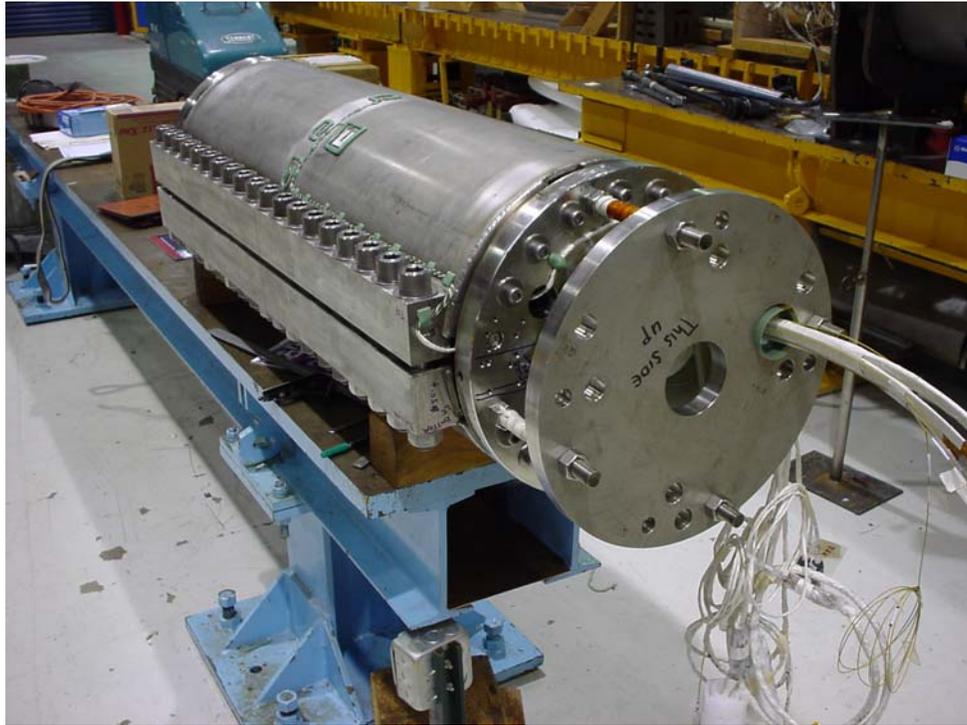
Fig. 11: *Final assembly of the magnet.*

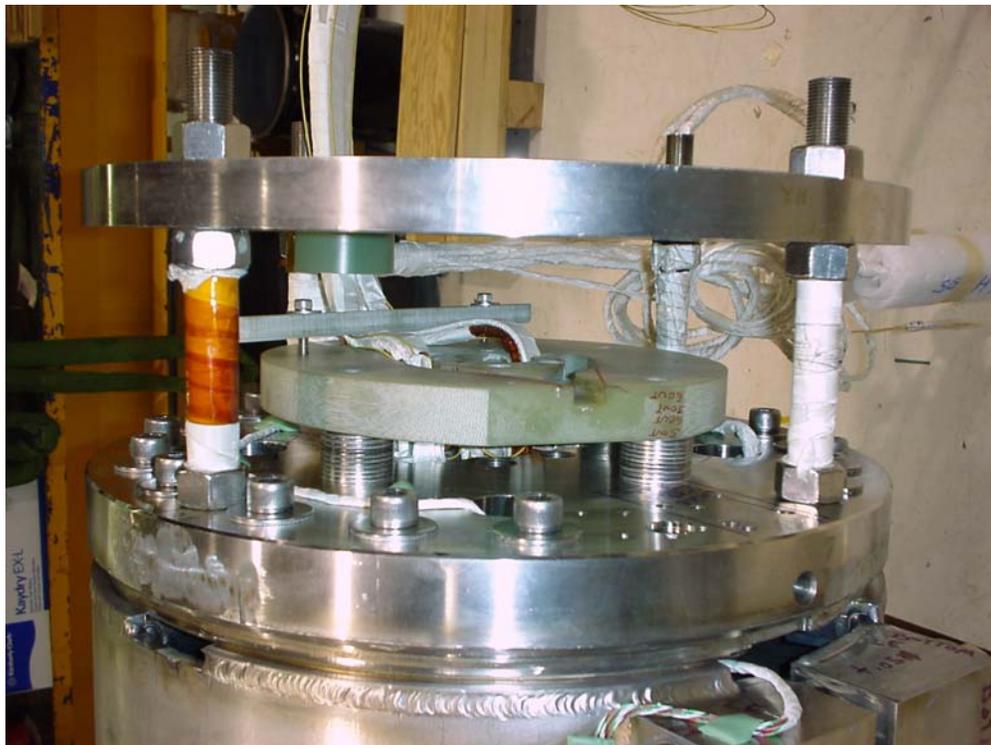
Fig. 12: *Close-up view of the power leads and standoff plate.*
