Summary of the Effects of the Magnet Support Steel on a BMA Magnet

J. Blowers, J. DiMarco, J. Szal

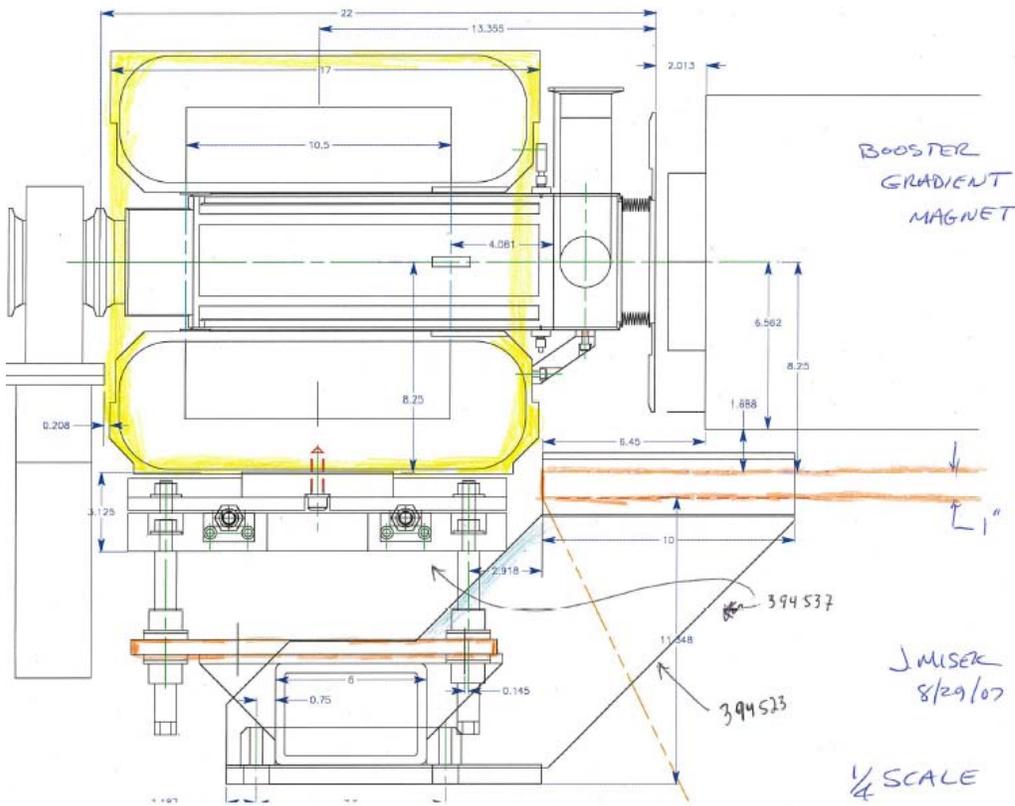
Figure 1 – Sketch of installed BMA magnet

In order to closely replicate the as-installed environment, we borrowed the prototype support structure (AD assemblies MD-394523 and MD-394537). We did not want to move the SSW stages, and there was not enough room under the magnet to allow us to fit the support structure in its as-installed position. Since we were interested only in the magnitude of the effect, we chose to put the support structure on its side adjacent to the magnet. We used steel bar stock 1” x ¾” to simulate the end of the girder. The support structure was placed in a position that matched closely the sketches provided by AD. See figures 1 – 4 for visuals.

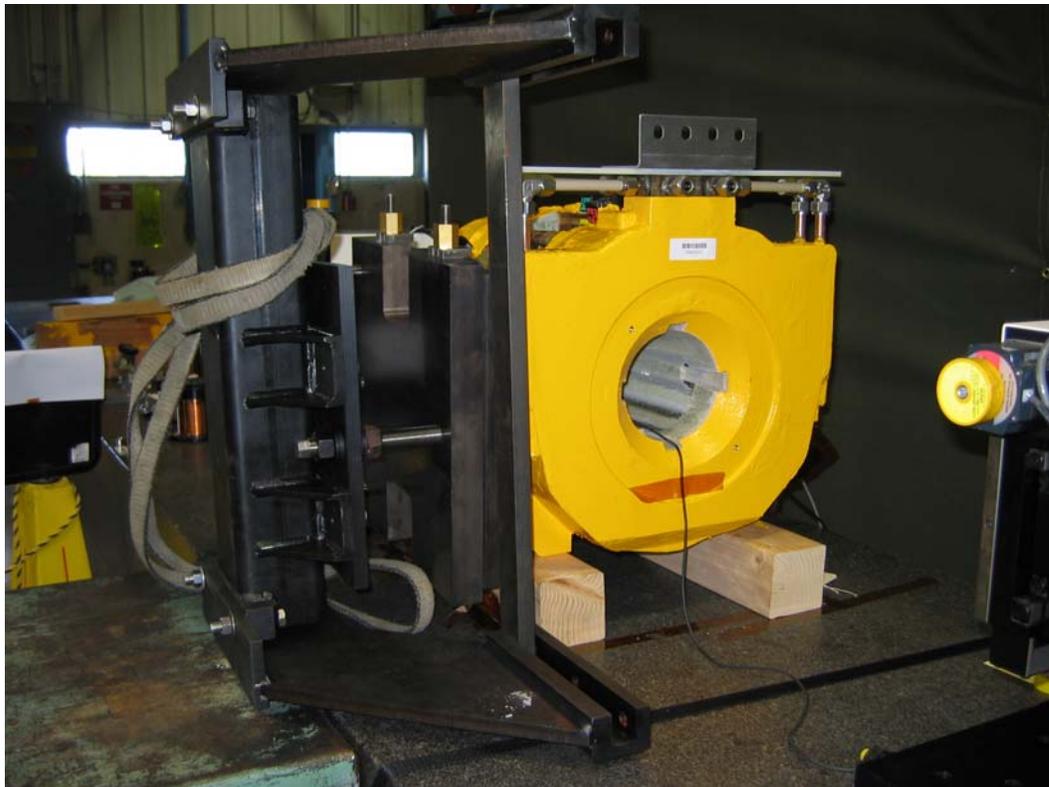
Figure 2 – Test Setup

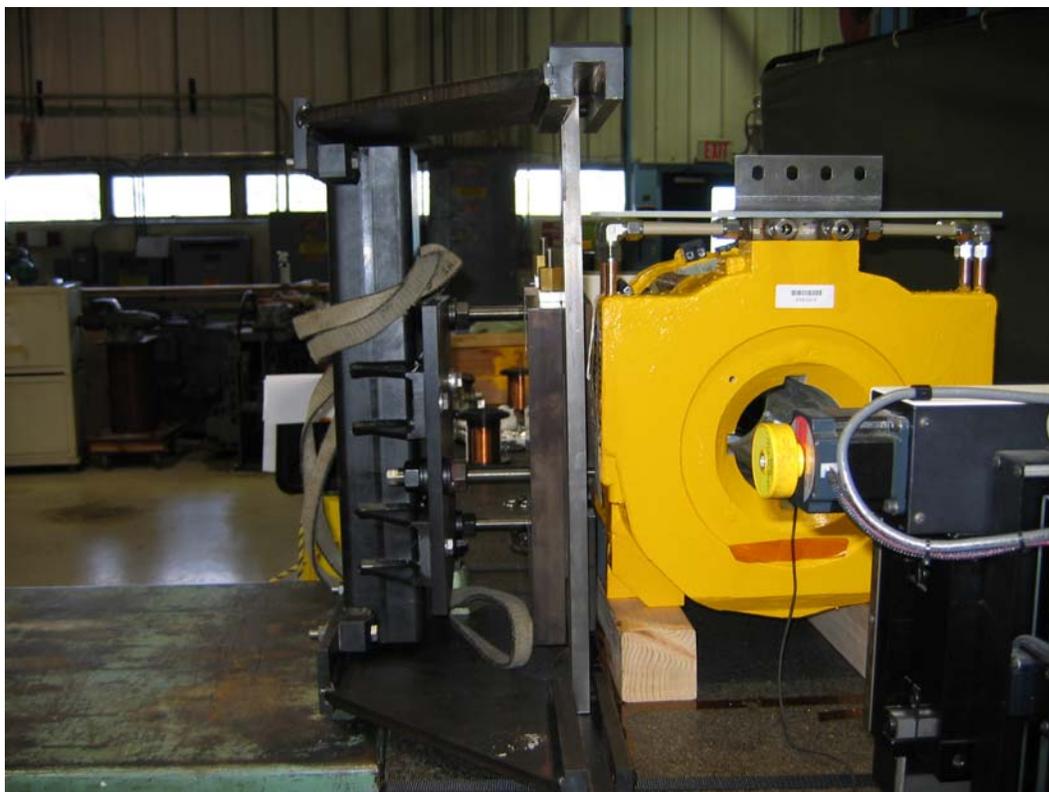
Figure 3 – Test Setup

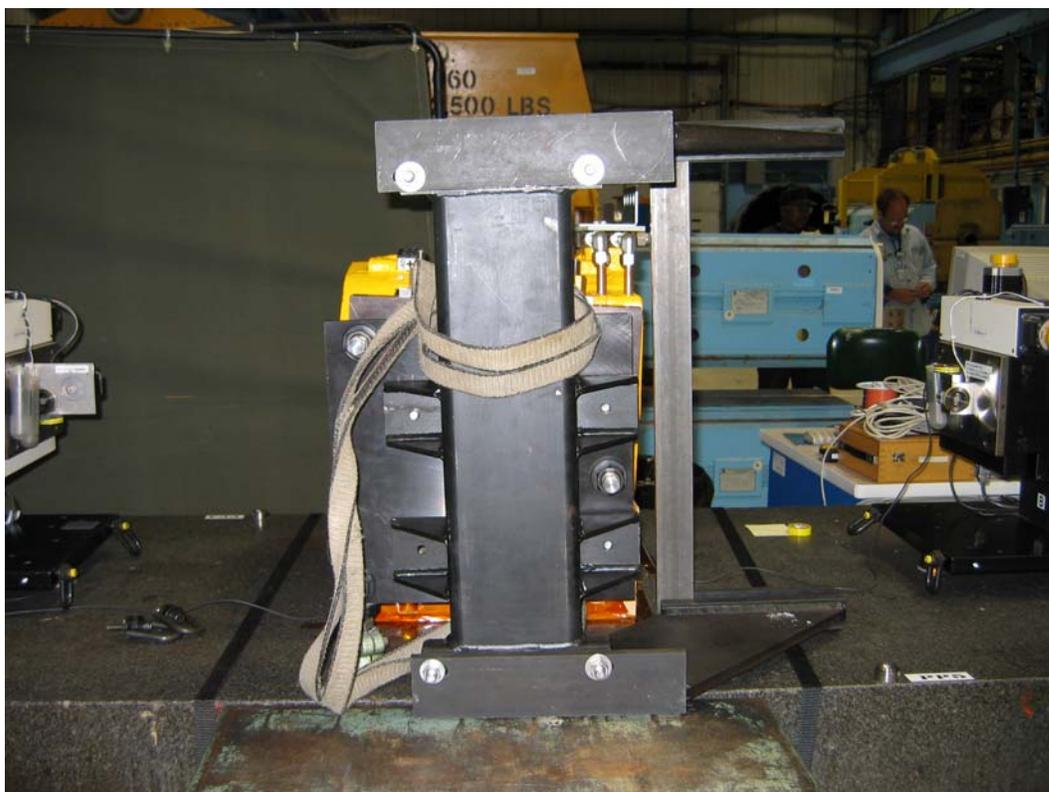
Figure 4 – Test Setup

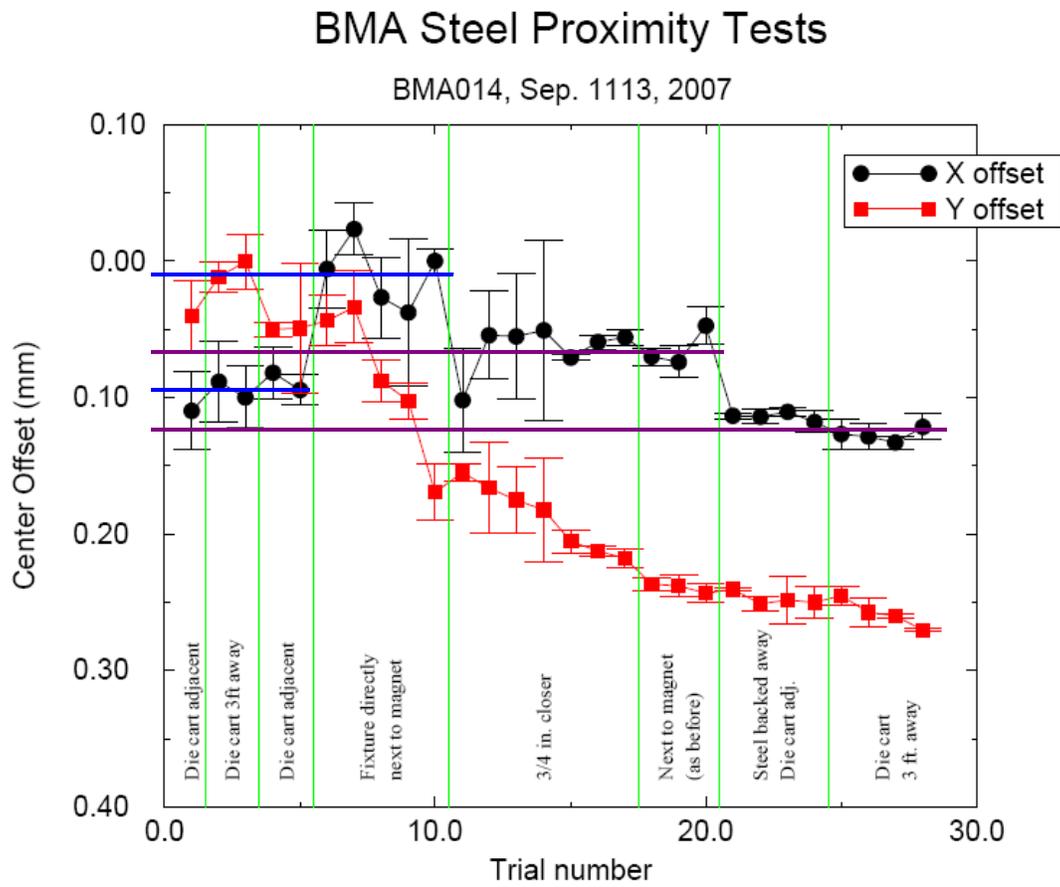
Figure 5 – Plot of Quadrupole Field Center with Error Bars

Table 1 shows the data and descriptions of the environment for each measurement. Figure 5 is a plot of the results. Since the flux would be pulled towards the side of the magnet in our test configuration, we would expect to see a shift in the x plane. In comparing the appropriate sections, we see that the shift in the x plane is less than 0.1mm.

First comparison (blue lines):

Points 1 – 5 (no steel) with points 6 – 10 (steel present) is ~ 0.09mm

Second comparison (purple lines):

Points 11 – 20 (steel present) with points 21 – 29 (no steel) is ~ 0.06mm.

The large shift between points 10 and 11 is very apparent. It is possible that the unknown cause of this also resulted in the shift in average between points 8 – 10 and points 12 – 20. As a result, at least in part, the magnetic center at the end of the test was not the same as it was at the start of the test. It's possible that the power cycling of the motor contributed to this. Also, the measurement errors greatly decreased after we changed the voltage mode switch to the "off" position at point 15.

One interesting outcome from this test is the visible drift in the y coordinate. Since we are interested in the x plane, the drift in y is not a concern for this steel test. However, it did raise a question over the main use of the SSW system, which is for establishing the quadrupole center for purposes of alignment in the tunnel. It is believed that the drift is a consequence of cycling the power off on the motors. Extra counts are sent and the positioning gets shifted (measurements indicate this shift is ~ 3 microns for each y coordinate measurement). The standard alignment test does not repeatedly cycle the motor this many times, so it is believed that this is not a concern for the regular alignment measurements.
