**Test of Four Coil Helical Solenoid Magnet HSM01 TD-09-011**

M. Tartaglia, G. Chlachidze, V.S. Kashikhin, F. Lewis, M. J. Lamm, A. Makarov,  
I. Novitski, D. Orris, C. Sylvester, J. C. Tompkins, D. Walbridge, M. Yu

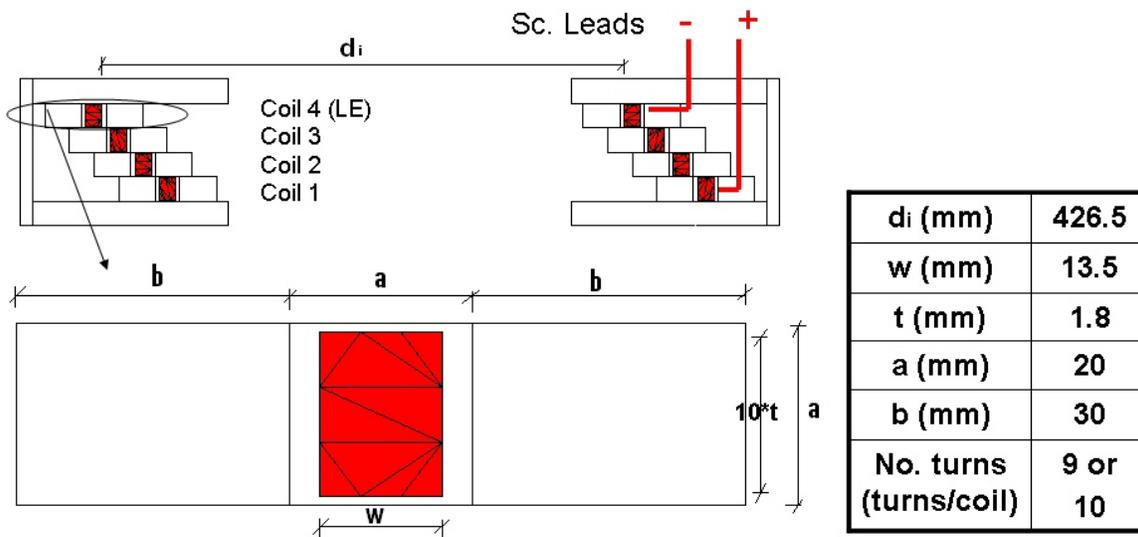
Fig. 2.1. HSM01 structure, coil cross sections, and dimensions

The helical solenoid design parameters are given in Table 1. A cross sectional view of the magnet with as-built dimensions is shown in Figure 2.1. Three of the coils were wound with 9 turns of SSC-inner cable; the fourth (coil 3) was (believed to have been, based upon resistance measurements, but not confirmed by coil inductances) wound with one extra turn. Coils are sequentially numbered 1 through 4, with coil 1 at the Lead End (LE) and coil 4 at the non-lead end. Electrical, mechanical, and magnetic details and a test overview were captured in the Magnet Description Document in preparation for testing the magnet in the Test & Instrumentation Department Vertical Magnet Test Facility (VMTF), which is available on the T&I web site at

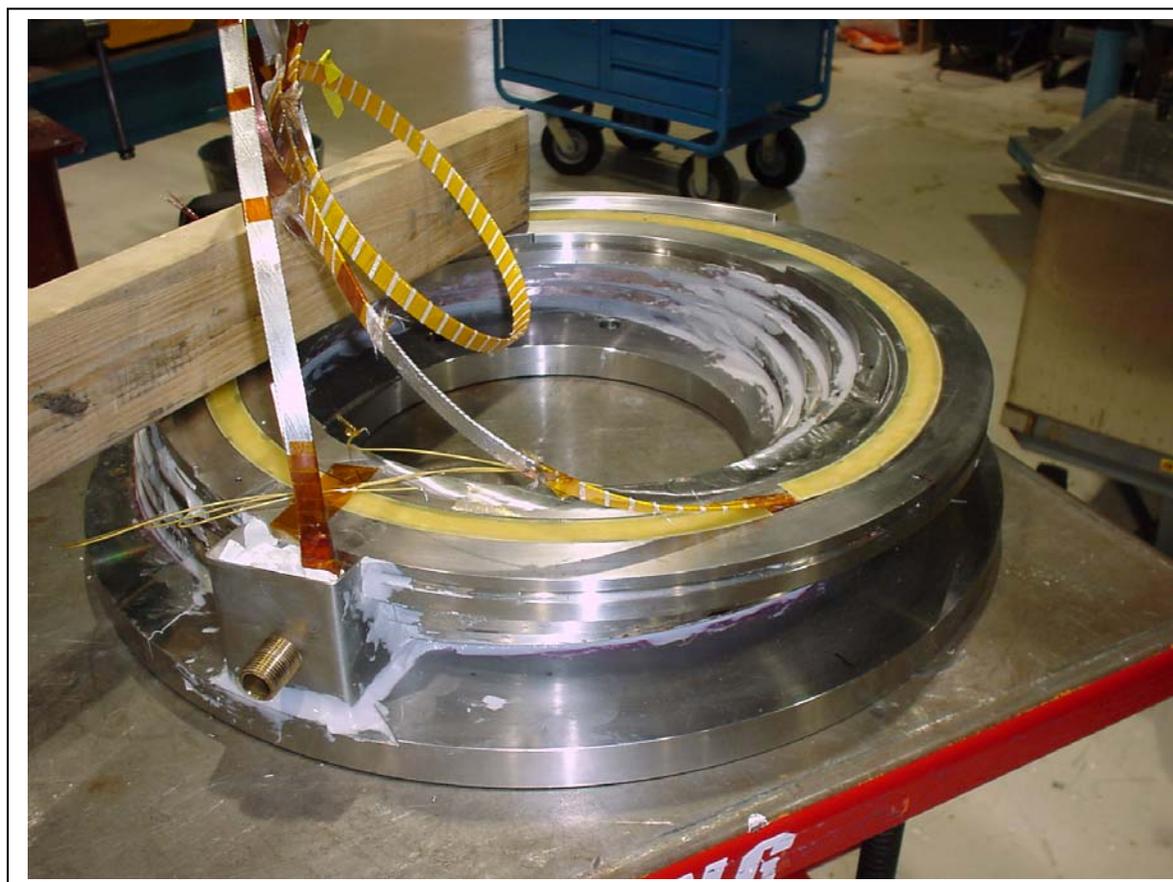
Figure 2.2 shows the solenoid under construction, with the positive and negative superconducting leads emerging from the coils; the positive lead (connected to coil 1) emerges straight out, while the negative lead ramps up from the final winding. This figure indicates the direction of the coil windings within the solenoid, which defines the field direction. It also shows the offsets of the individual coils (with respect to the leads, and other physically identifiable features on the structure).

Fig. 2.2. HSM01 coils during solenoid fabrication.

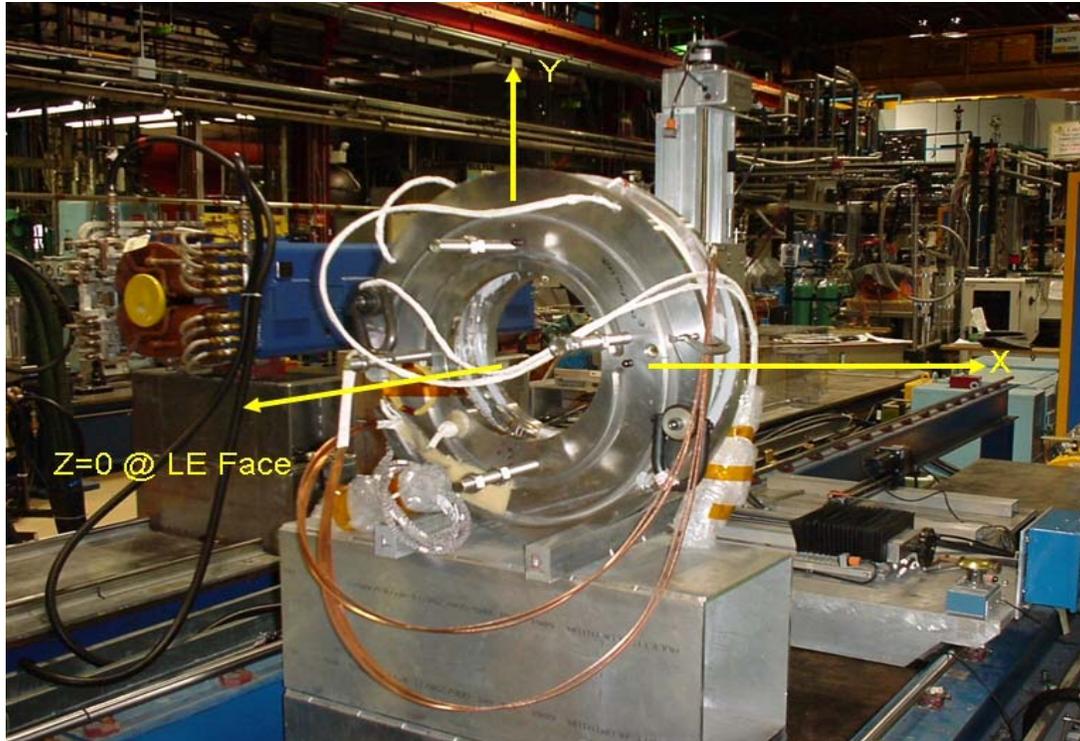
Figure 4.1 shows the Helical Solenoid mounted on test stand B in MTF, with the coordinate system for magnetic measurements shown. The X and Y axes were defined by tooling balls and scribe lines on the Lead End (LE) surface; since the coils are offset rings, there is no “center” or axis of symmetry, so  $X=Y=0$  is somewhat arbitrarily chosen in the aperture middle. The same LE top surface also defines the reference plane for  $Z=0$ , and the right-handed coordinate system puts the body of the magnet (and peak field) at negative Z. It should be noted that this coordinate system was added late in the fabrication – it had not been planned for earlier in the design – and therefore the circular coil center positions were not known in advance of the measurements; also, it was not recognized what difficulties would be encountered in setting up to perform the measurements, or in relating the coordinates later to the magnetic model. Trying to finally get this right required scrutiny of fabrication photographs, study of drawings of the 3D probe, correction of drawings made from inspection measurements, and adjustments of model geometry. Thus, if magnetic measurements are important in future helical magnets, it is necessary to focus on these details early in the process.

Fig. 4.1. HSM01 mounted upright on test stand B for 3-axis warm Hall probe warm measurements, and illustrating the coordinate system.

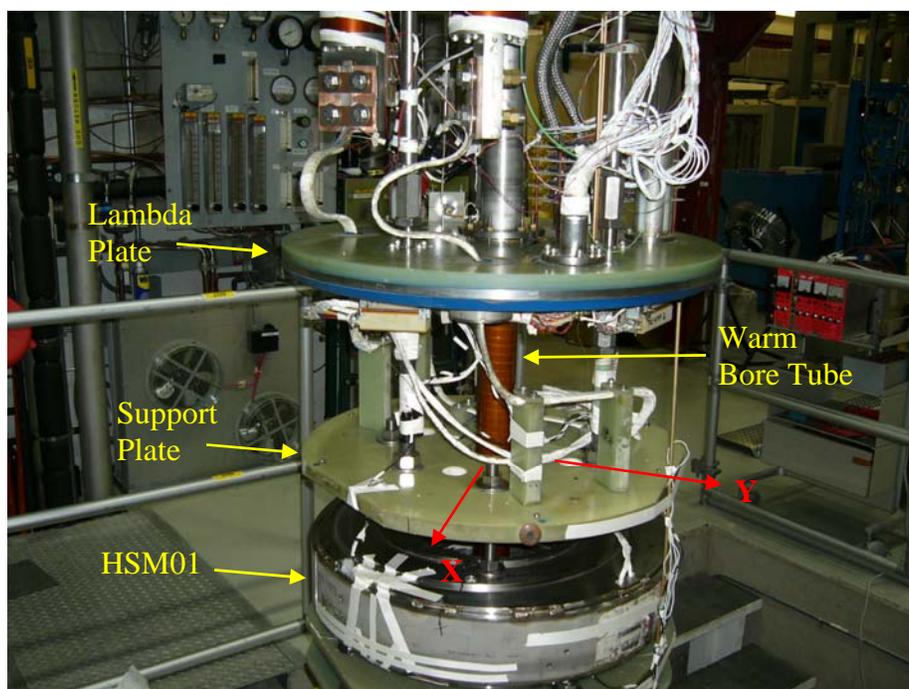
It is hard to know the precise transverse probe position with respect to the magnet coordinate system. Figure 4.2 shows the solenoid suspended on the VMTF top plate assembly with the insulated warm bore tube passing through the magnet aperture. The

Fig. 4.2. HSM01 suspended from the VMTF top plate assembly prior to cold testing.

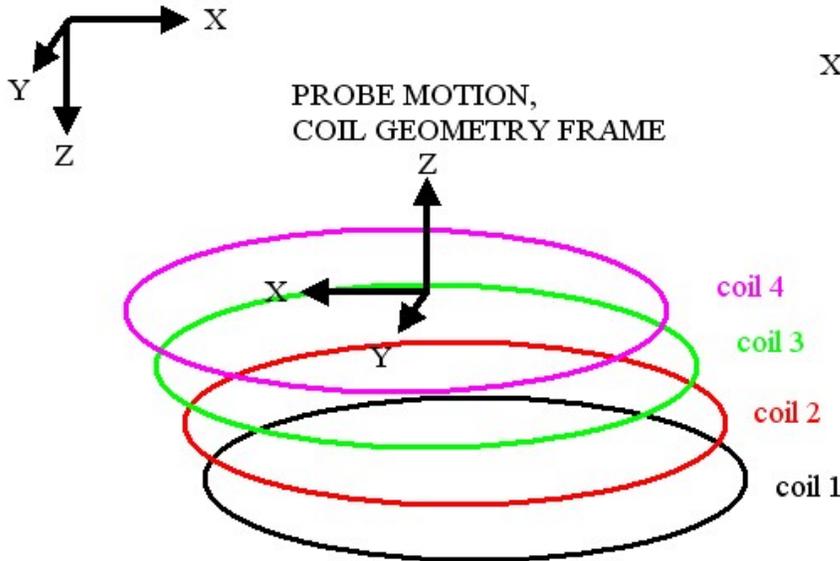
Figure 4.3 illustrates the coordinate systems for the magnet, motion, warm and cold Hall probes, to help clarify the relationship between the various elements. Note that the axial field direction,  $B_z$ , is directed towards  $-Z$  when the magnet is excited by a positive current (Positive lead connected to Positive PS terminal). In order to compare measurements to the magnetic model predictions (described in the next section), we need to choose a consistent polarity for the current. Since the magnetic model predicts  $B_z$  as positive, we present data for the case of negative current (thus, labels are  $-B_z$ ,  $-B_x$ ,  $-B_y$ ).

Fig. 4.3. HSM01 Coil Geometry, Probe motion, and Hall probe coordinate systems.

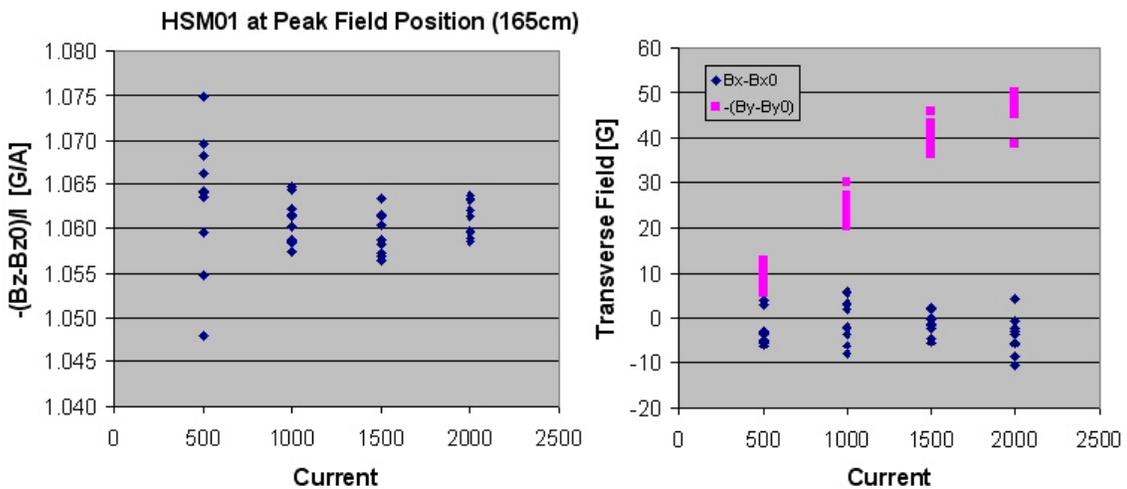
Figure 4.4 shows the axial and transverse field transfer functions as a function of current when the probe was positioned at the location of the peak axial field. Measurements were taken early in the cold test, first at 0 A and then on plateaus every 500 A up to 2000 A. Higher currents were not explored due to hi-pot and ground current concerns, and due to the expectation of linear behavior with current (lacking an iron flux return). The field offset levels for all three directions were all about -0.3 mV (they have been subtracted from these plots), and the noise levels are about 1 mV corresponding to ~10 G. The peak axial field is linear with current, and the transfer function is 1.060 G/A.

Fig. 4.4. Cold axial field transfer function (left) and transverse field strength (right) versus current at the peak field position.

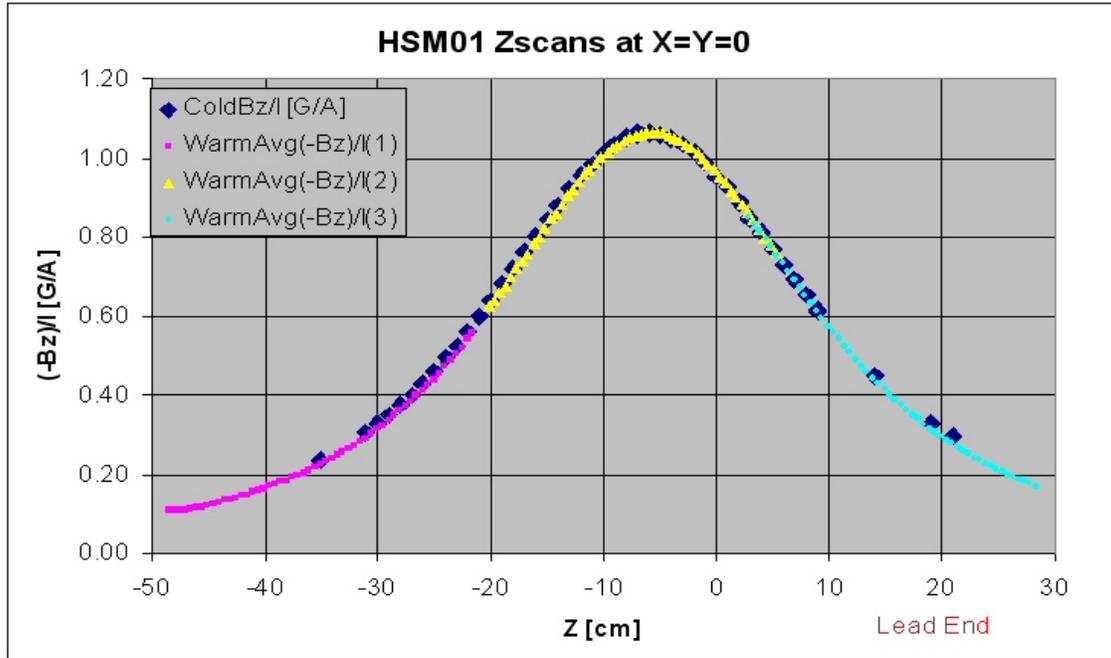
The Z position of cold measurements is shifted by a constant offset to match the peak axial field position from warm magnetic measurements. The resulting overlay is shown in Figure 4.5, for cold profile scan at 2000 A compared to the average of warm scans at  $\pm 10$  A, for data taken along the Z axis. The warm off-axis axial transfer function measurements are shown in Figure 4.6.

Fig. 4.5. Bz vs Z on the X=Y=0 central axis. Note that for positive current, the axial field is directed towards negative Z (hence the axis is labeled as -Bz/I).

Figure 4.10 illustrates the coordinate system for one model, and Table 1 lists the coil center coordinates relative to the measurement system (although reflections in X,Y are possible and may explain polarity discrepancies). Fig. 4.11 shows the model geometry and predicted flux density on the coils. Transfer functions are shown in Figures 4.12 to 4.14 for the individual field components, which should be compared directly to data plotted in Figures 4.5, 4.6, 4.8, and 4.9.

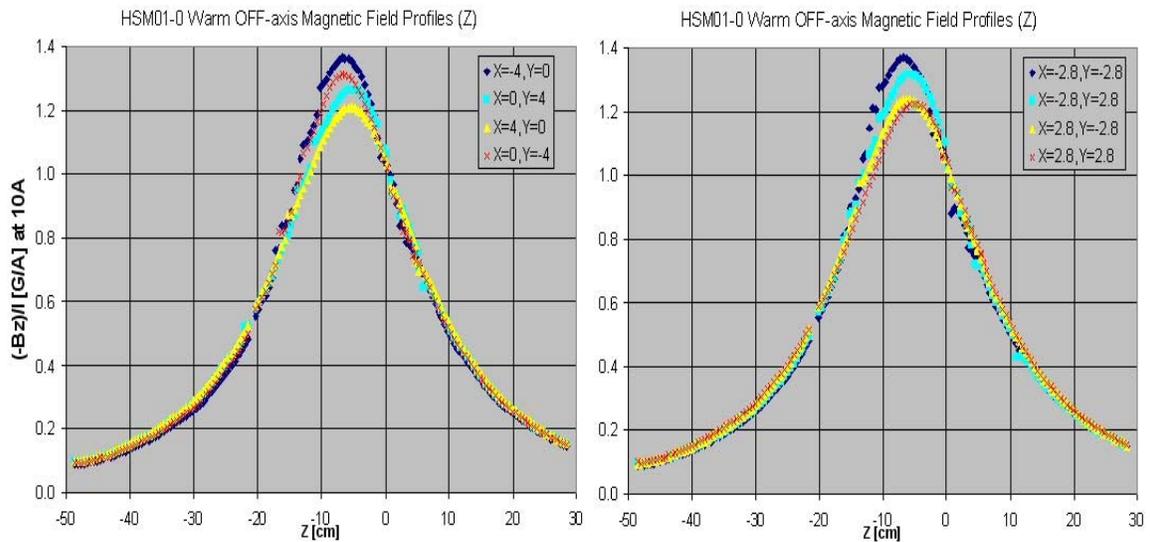
Figure 4.6. Axial field transfer function  $(-Bz)/I$  vs Z at radius of 4 inches, along the X and Y axes (left) and along 45° diagonals (right).

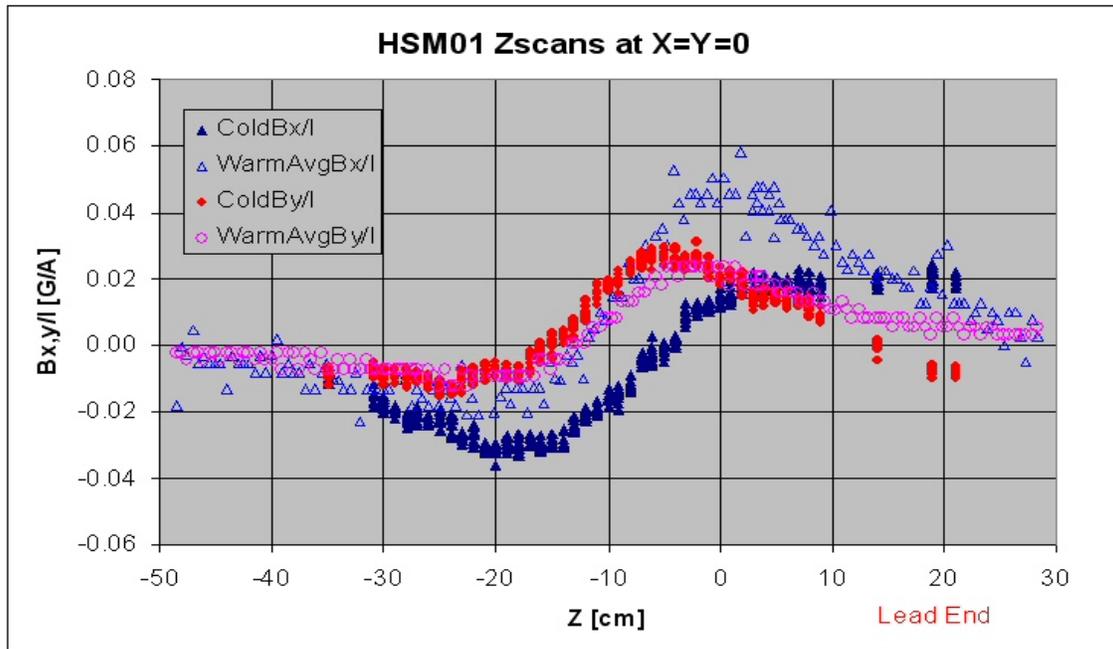
The transverse field measurements are shown in Figures 4.7 (warm and cold overlay for data on the Z axis), 4.8 (warm  $B_x$  data at 4 inch radius), and 4.9 (warm  $B_y$  data at 4 inch radius). While the warm and cold  $B_y$  terms agree pretty well, there is some slight but apparent disagreement between the warm and cold  $B_x$  profiles; this might be the result of cold measurement probe having a slight tilt (hence measuring a small fraction of the axial field), or being slightly off-center in the X direction.

Figure 4.7. Warm and Cold  $B_x/I$  and  $B_y/I$  vs  $Z$  on  $X=Y=0$  axis.

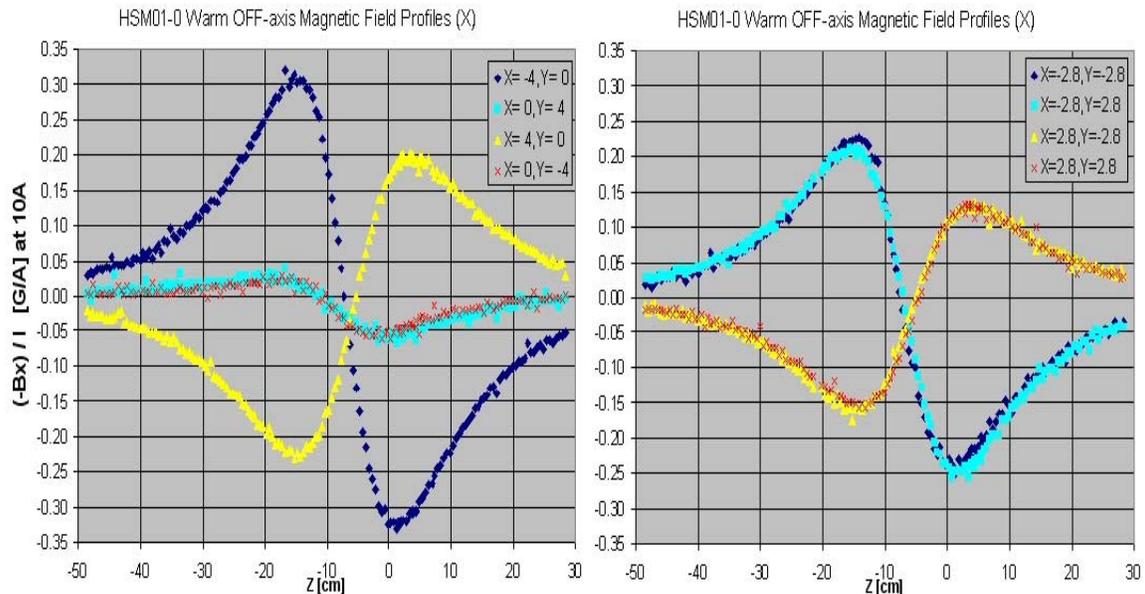
Figure 4.8. Warm transfer function  $(-B_x)/I$  vs  $Z$  at 4 inch radius on  $X$  and  $Y$  axes (left) and along  $45^\circ$  diagonals (right).

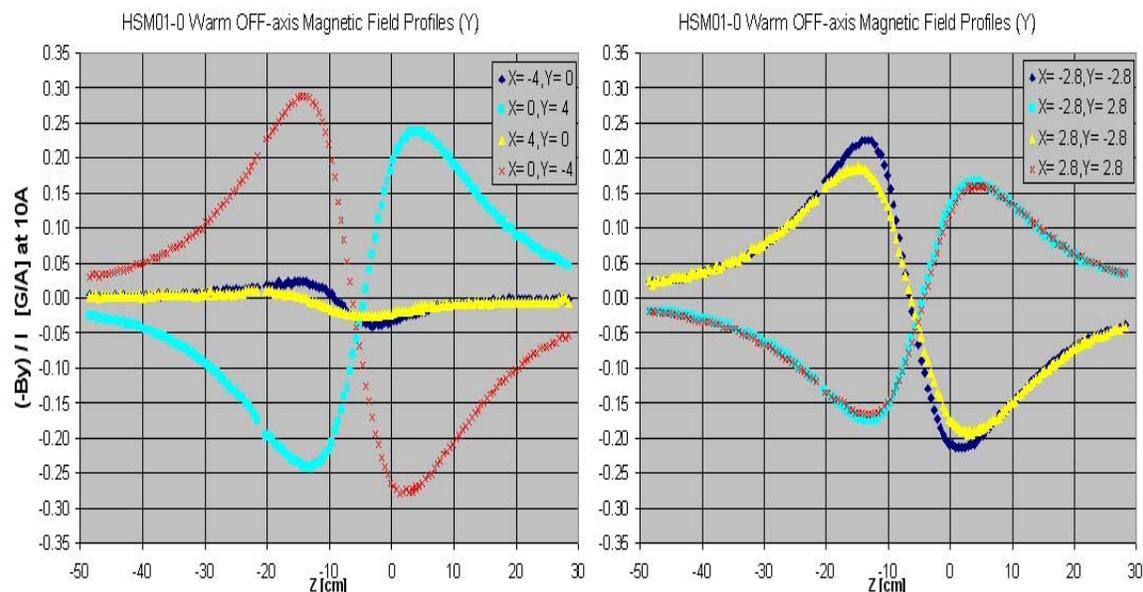
Figure 4.9. Warm transfer function  $(-B_y)/I$  vs  $Z$  at 4 inch radius on X and Y axes (left) and along 45° diagonals (right).

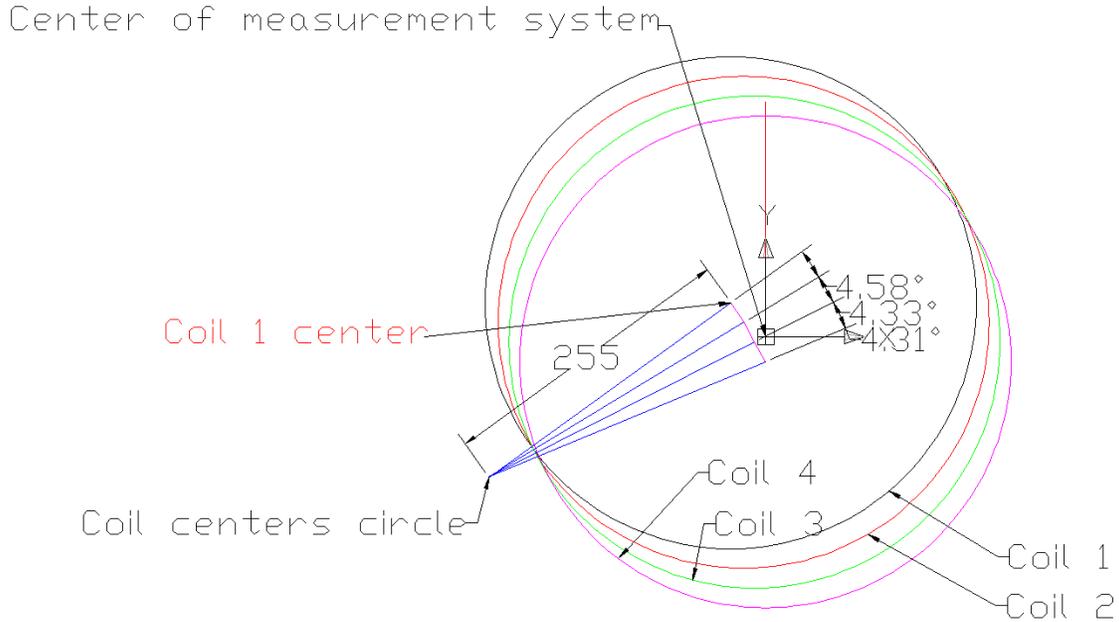
Fig. 4.10. Coil positions relative to center of measurement system

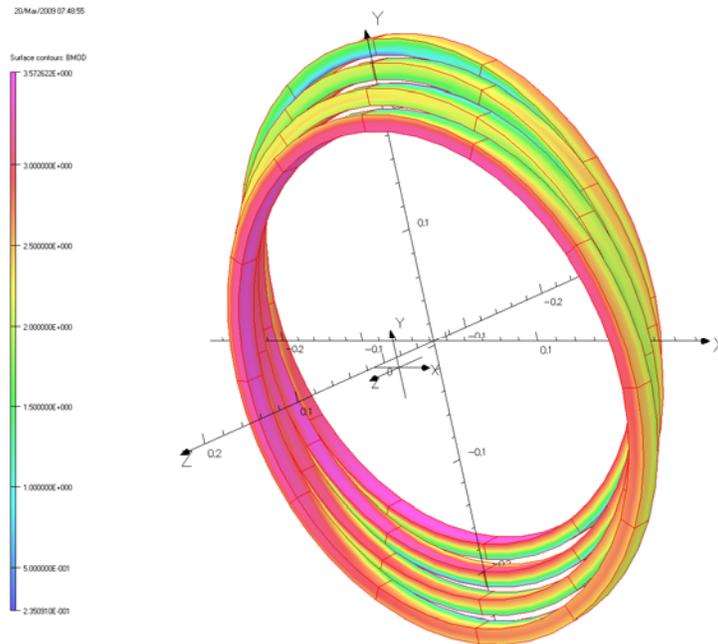
Fig. 4.11. Model geometry and flux density on coils at 10kA current.

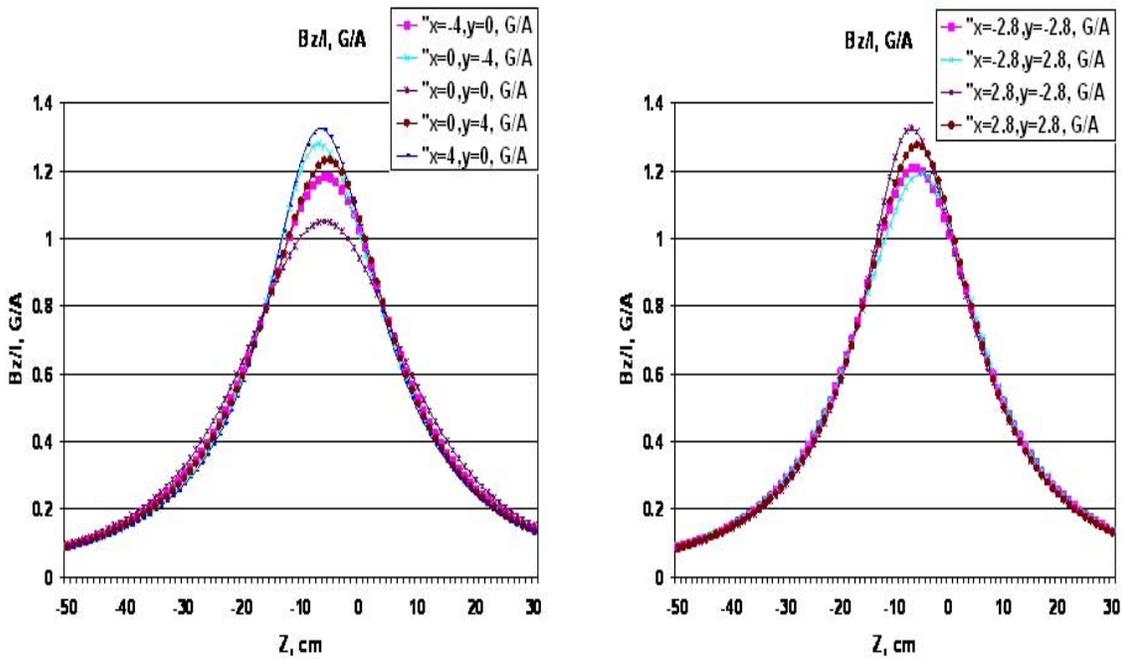
Fig. 4.12. Model predicted  $B_z/I$  field distribution along Helical Solenoid model Z-axis.

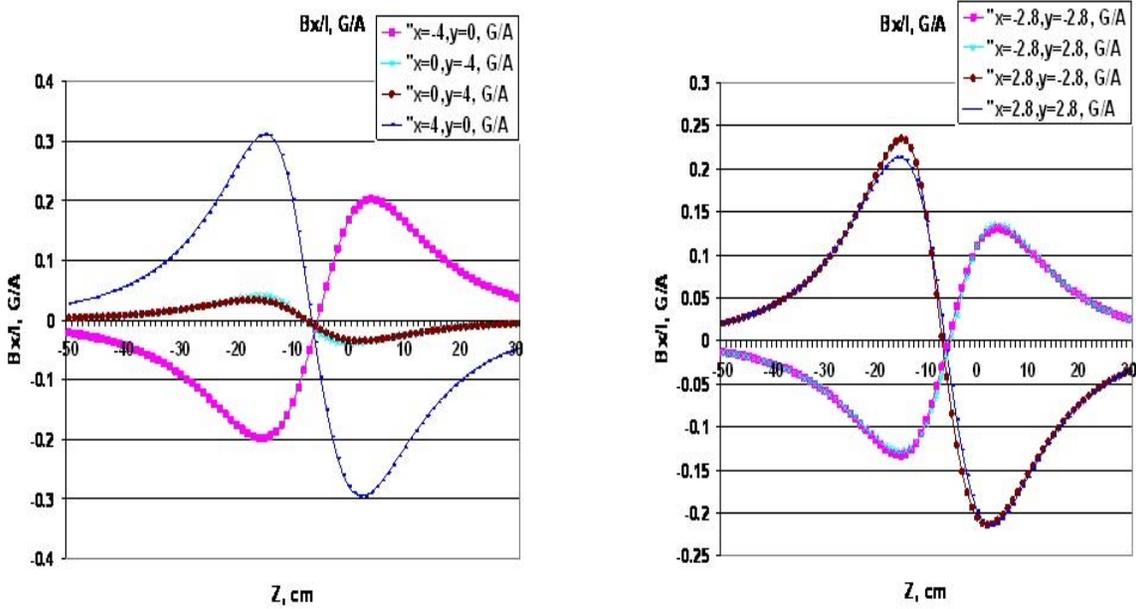
Fig. 4.13. Model predicted  $B_x/I$  field distribution along Helical Solenoid model Z-axis.

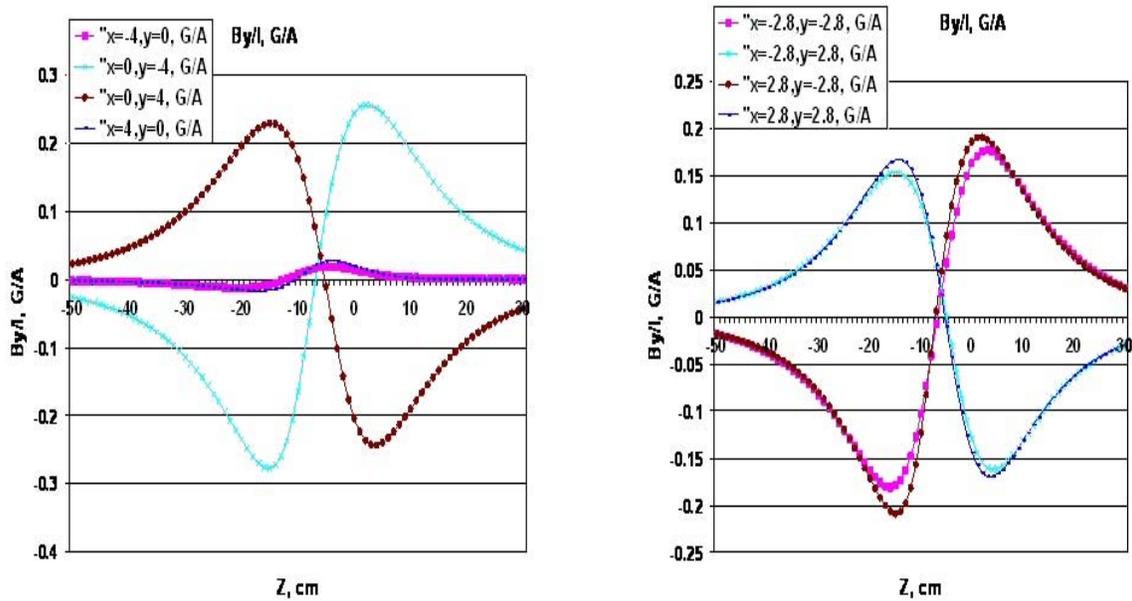
Fig. 4.14. Model predicted  $B_y/I$  field distribution along Helical Solenoid model Z-axis.

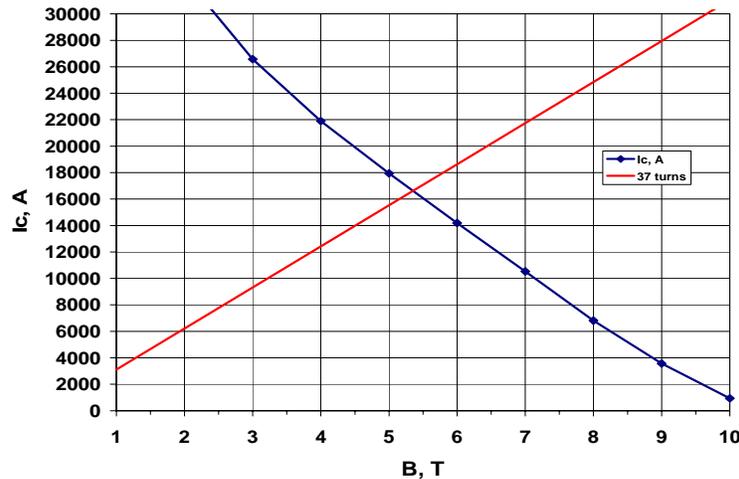
Figure 5.1 shows the quench prediction for the as-built helical solenoid, with a total of 37 turns of 30 strand SSC inner cable in the 4 coils defining the load line. The short-sample performance of the strand was measured at 4.2 K in the TD Short Sample Test Facility. This measured performance is somewhat better than that specified in Table 1, which is a target short sample performance specification for that strand. The intersection of these curves predicts a maximum quench current of just over 16 kA. The nominal operating current to achieve the desired dipole and axial field strengths is 9.6 kA, which produces a peak magnetic field on the coil of 3.3 T.

Fig. 5.1. HSM01 37-turn load line (red) and measured 4.2 K short sample curve (blue).

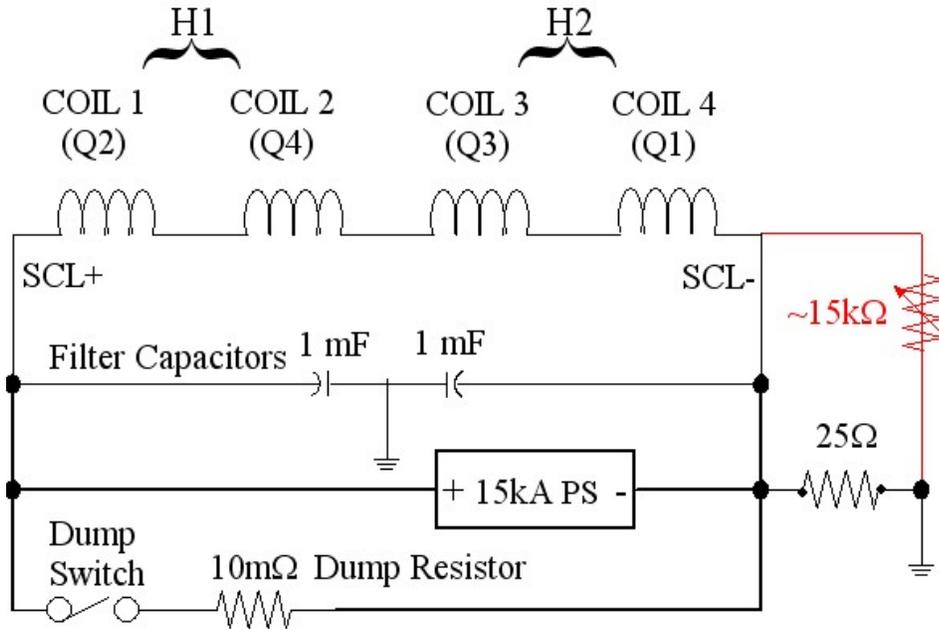
Figure 5.2 shows the electrical schematic for power system connections and instrumented coil segments in the HSM01 solenoid circuit. Note that the “Coil” labels differ from the “Quadrant” Voltage Tap labels given by the T&I electrical group (and captured in quench data). For this device, the only quench characterization voltage taps were at the “quadrant” level – thus, one can determine in which coil the quench originated – by voltage taps placed between coil layers and at the superconducting leads (SCL) where they enter the mechanical structure. Half coil signals H1 and H2 were useful for purposes of quench detection and locating the quench origin.

Fig. 5.2. Electrical Schematic for HSM01 Solenoid circuit at VMTF.

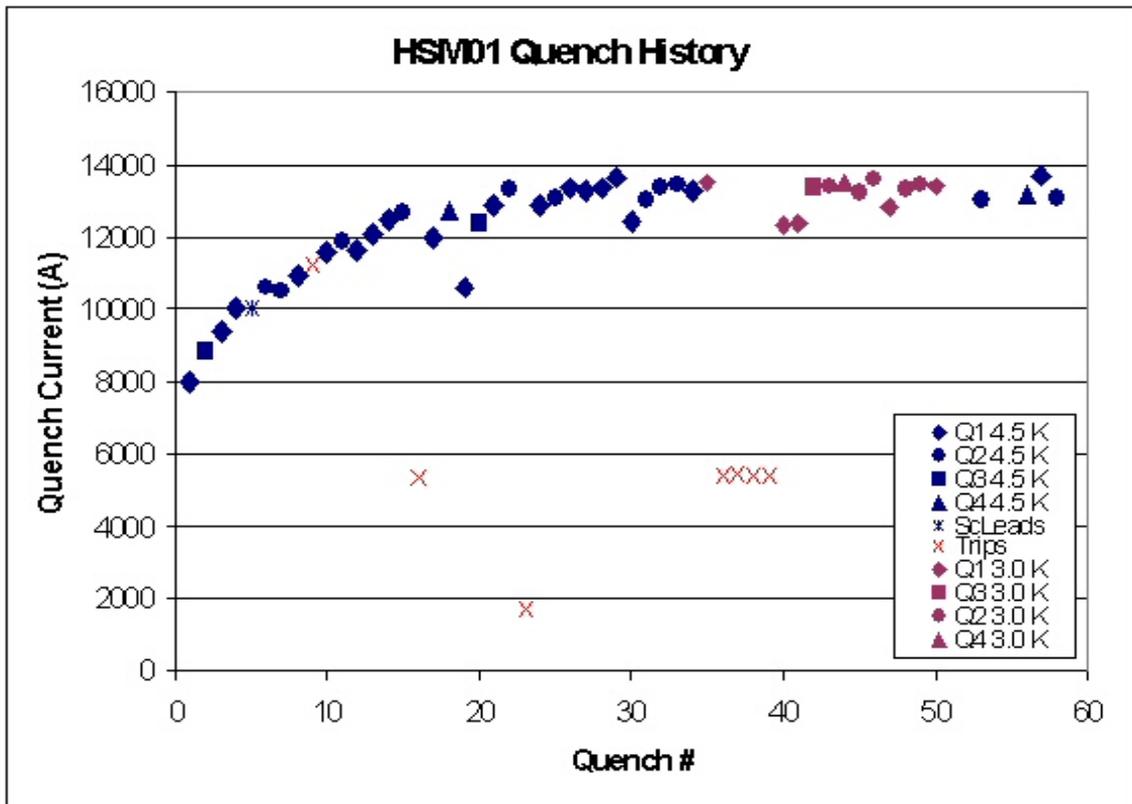
A summary of the quench history is shown in Figure 5.3. Numerous “trips” of the quench detection (QD) system occurred during the magnet training, in which QD circuits detected coil voltages which exceeded threshold, but data analysis indicated no actual quench had occurred. These were possibly due to problems with power supply regulation caused by the very low inductance load (however, see also section 5.f), in which the current ramp rate changed abruptly and caused an inductive voltage (or difference of two signals) that exceeded threshold. These occurrences were eliminated by changing the combination of power supplies in use (three of the six 5 kA PEI supplies in the CPS-3 system at VMTF were needed for the highest quench currents reached). The fifth quench

Figure 5.3 shows that in general the magnet trained steadily upward, but with some erratic jumps down, to a rather broad quench current plateau at around  $13 \pm 1$  kA. The temperature was lowered to 3.0 K (red points) to study whether the quench current would improve due to the increase of critical current and thermal margin at lower temperature, or if the plateau was mechanically limited. As the erratic quench performance and plateau level did not improve with lowered temperature, this suggests a mechanical origin for the quenches.

Figure 5.3. Quench history and quench locations at 4.5 K and 3 K of HSM01

The quench locations are coded in the symbols of Figures 5.3 and 5.4. A summary of all quench locations is shown in a frequency histogram in Figure 5.5: most quenches occurred in the coils at either end of the magnet, and most often at the end where the leads emerge. The highest quench current recorded was 13624 A in quench 29 at 4.5 K, which is roughly 85 % of the predicted maximum at that temperature. The broad quench plateau at  $13 \pm 1$  kA did not improve with lower temperature, indicating quench performance was mechanically (conductor motion) limited. No ramp rate dependence was discernable up to 150 A/s ramp rate.

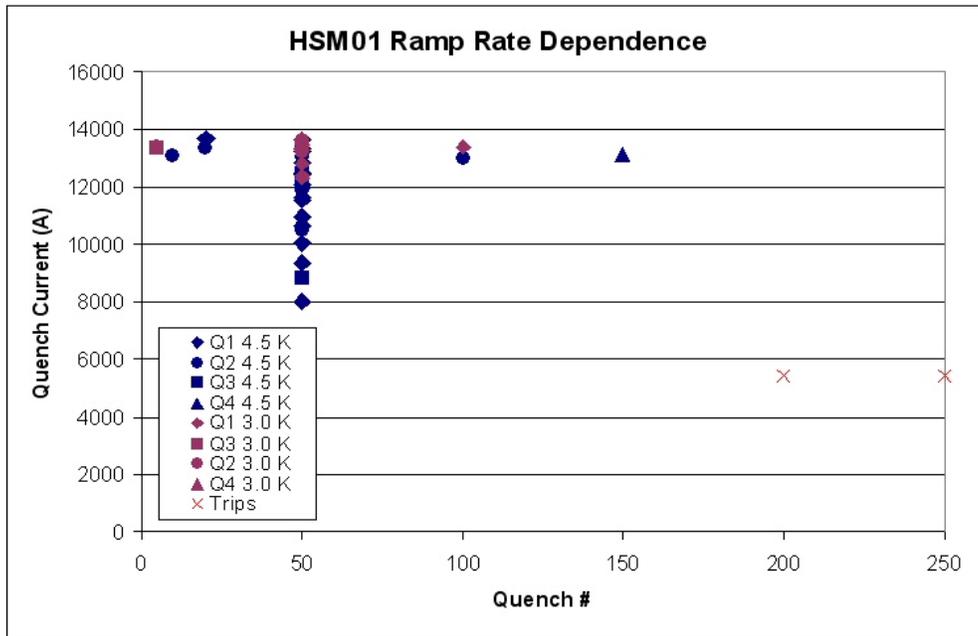
A few low ramp rate tests were made at 4.5 K prior to lowering the temperature. Since no improvement in quench current was seen at lower temperature, the quench program was completed by mapping the higher ramp rate dependence (performed at the intermediate 4.0 K temperature due to cryogenic plant difficulties mentioned earlier). Strong ramp rate dependence might be expected since the metal support structure is not laminated; however, Figure 5.4 shows that there is little dependence out to 150 A/s. At higher ramp rates, 200 and 250 A/s, power supply non-regulation again caused QD system trips that did not allow us to measure the actual quench performance.

Figure 5.4. Ramp rate dependence of quench current (all quenches, including training, are shown)

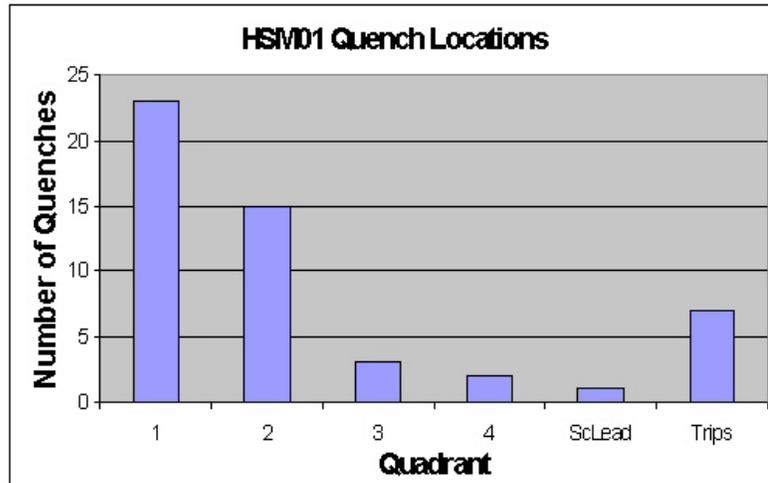
Figure 5.5. Frequency distribution of quench locations.

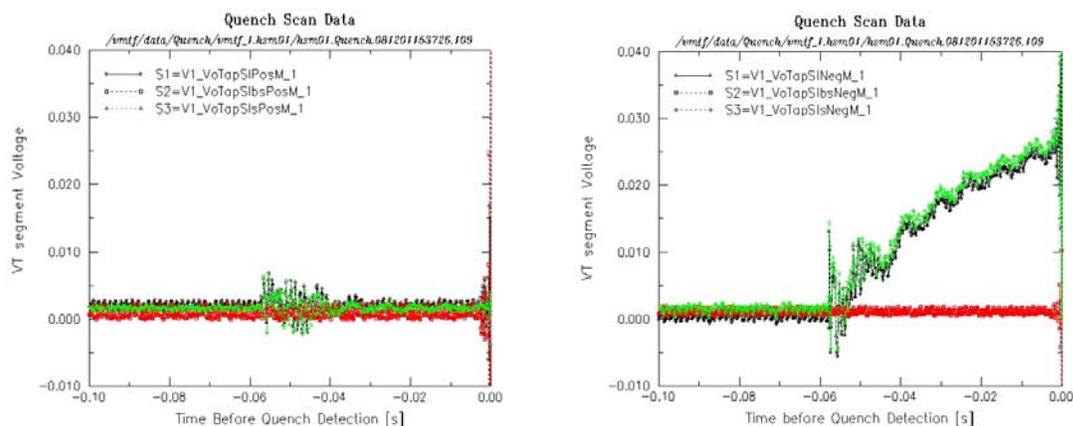
The fifth training ramp resulted in a quench of the negative SCL. Figure 5.6 shows the voltage traces for the SCL segments, which show a sharp oscillation in both leads at 6 ms followed by voltage growth and detection of the negative lead quench in the segment between the coil and the splice to the top plate leads. No other SCL quenches occurred. However, there were numerous events in the quench program which had obvious, anomalous and steady ground current of about 57 mA prior to the quench, starting with quench 27. The ground current had been watched carefully at the beginning of the test, and not observed; the ground current detection threshold was set at 100 mA, and did not trigger any slow ramp downs. As a result, these but they went un-noticed until quench 35 (first 3.0 K quench). Figure 5.7 shows the history of ground current versus time on 12/1 and 12/2. Once it turned on, the ground current seems to have grown proportionally to the magnet current; the behavior from ramp to ramp was somewhat irregular (see Figure 5.8). It is interesting that ramps which had PS regulation-induced trips at 5 kA also had large ground current; otherwise ground current did not develop until higher magnet currents were reached!

Figure 5.6. Training ramp 5 superconducting lead signals (S1 = entire lead, S1s=splice, S1bs=before splice), for positive (left) and quenching negative (right) leads.

What seems a likely scenario (based upon the post-test inspection of the leads area, described in <http://tiweb.fnal.gov/website/controller/468>) is that large Lorentz forces caused the inadequate (glass tape) SCL restraints to break on the fifth training ramp, which would result in rapid lead motion and can explain the oscillatory voltage signals and quench. On subsequent ramps the SC Leads would then move under these forces, until the negative SCL contacted the support rod bolt, and could erode layers of insulation (which would be subjected to large voltages to ground from the dump firing at 13 kA each quench).

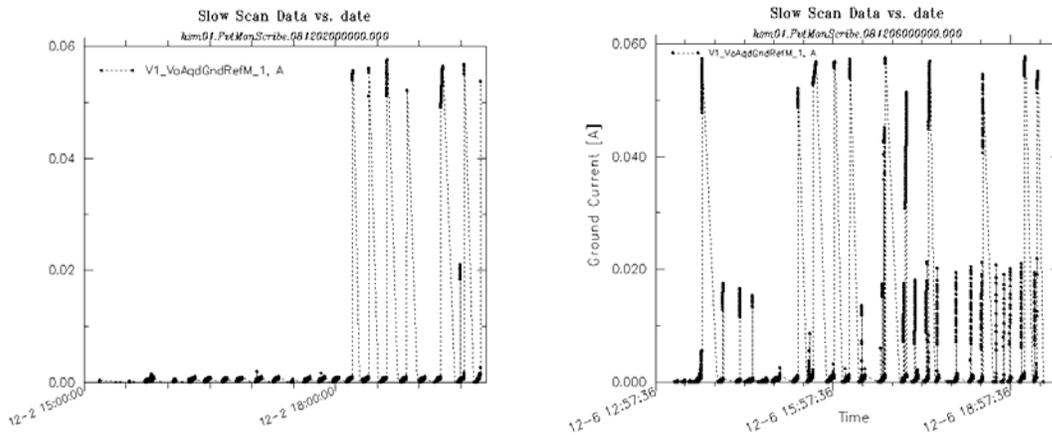
Figure 5.7. Ground current history on 12/2 (left) and 12/6 (right).

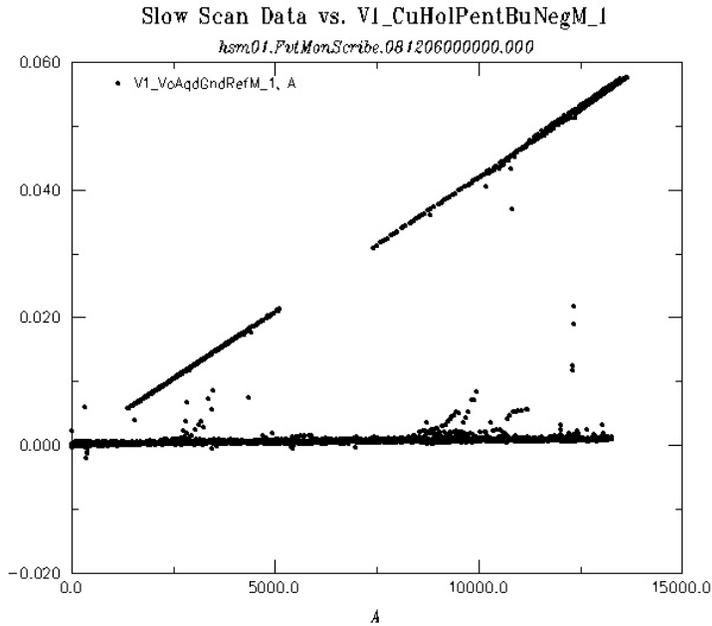
Figure 5.8. Ground current versus magnet current on 12/6 (3.0 K testing).

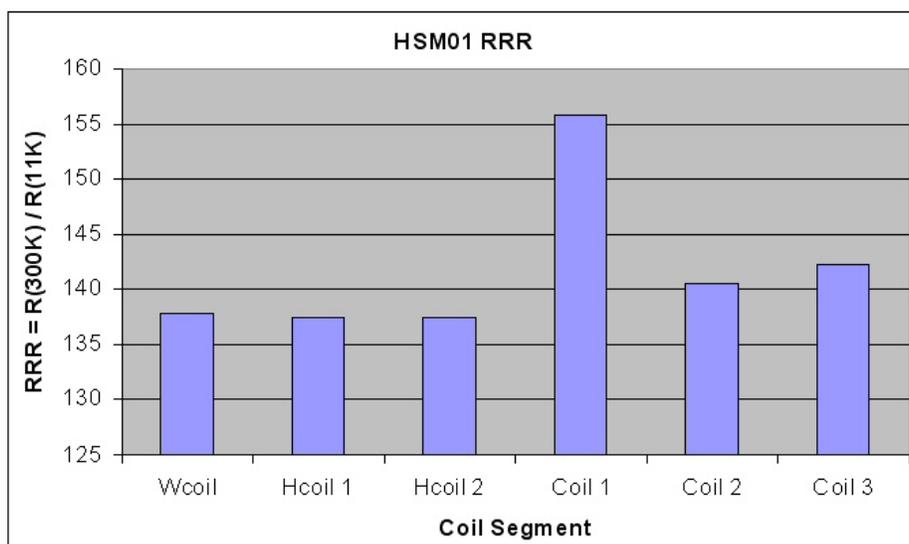
Following the cold test, on 12/8 the VMTF dewar temperature was warmed to just above the NbTi transition temperature. The magnet was at  $10.8 \pm 0.2$  K when coil voltage measurements were made at 13:30 using the Fixed Voltage Tap (FVT) data loggers, with isolation amplifier gains set for RRR mode (attenuations of 0.01 and amplification of 100, yielding actual gains of 1.0). The individual quadrant, half, and whole coil voltages were recorded using  $\pm 10$  A current through the magnet. After warm up to room temperature (300 K at 08:43 on 12/12), these segment voltages were captured with  $\pm 5$  A through the magnet. The readout of quadrant 1 (coil 4) failed due to a poor connection at the amplifier output, so there is no result for that coil. Furthermore, the cold quadrant voltage signals are quite small and the RRR measurements are limited by the logger resolution; half and whole coil results are better (and there is not much reason to suspect coil to coil variation, since these are wound from one continuous spool of cable). The resulting RRR ratios are plotted in Figure 7.1. From the half and whole coil data, the RRR value is about 137.5.

Figure 7.1. RRR values for HSM01 coil segments.

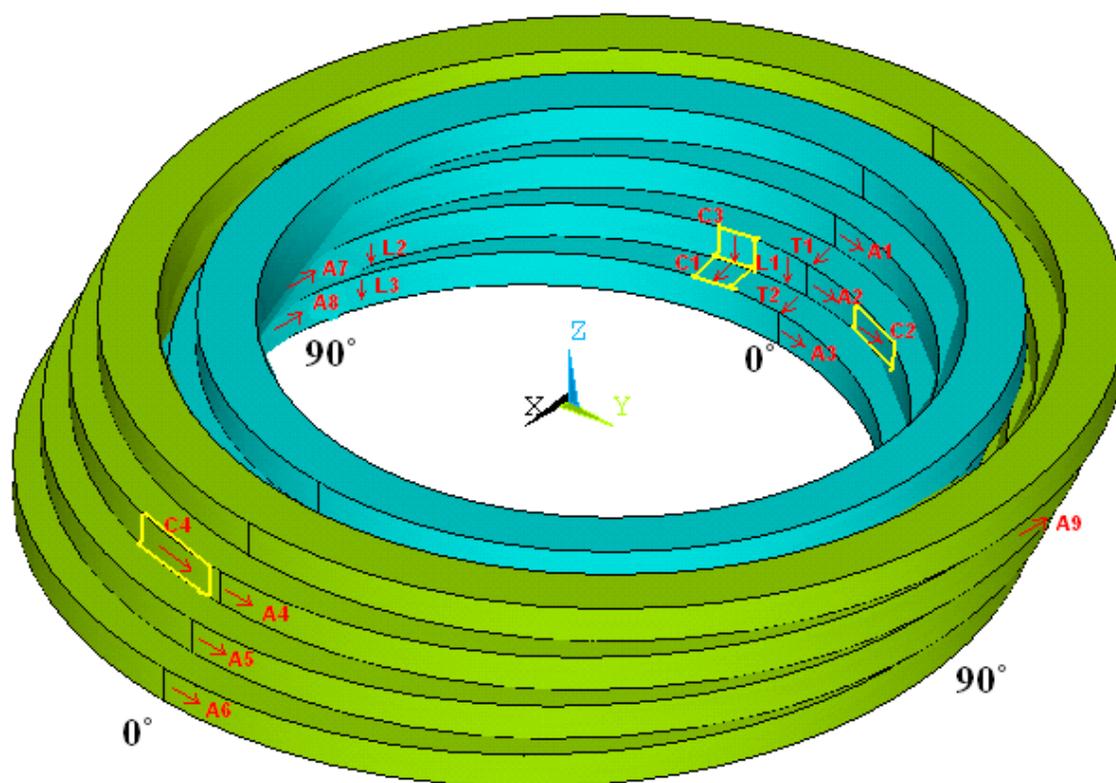
During the cool-down and magnet excitation, stress-strain is induced and the structure deforms. Strain gauges were used to monitor the strain changes on the inner and outer links and Fig.8.1 shows the locations of the gauges. T, A, L represent the strain gauges glued in transverse radial direction, azimuthal direction, and longitudinal direction respectively, and C represents compensation gauge. Strain gauge labeled with A10, which was glued on the top flange in azimuthal direction, was eliminated due to the readout being “open”.

Fig. 8.1 Locations of Strain Gauges (Coil 1 is on bottom, Coil 4 is at top)

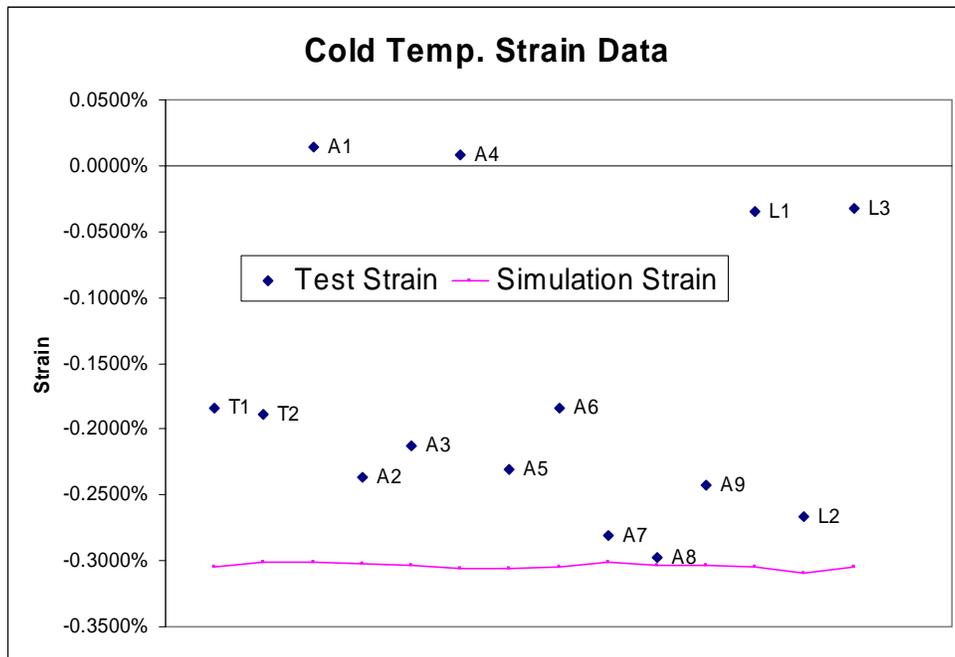
where  $\Delta R^m = R_{T1}^m - R_{T0}^m$ , is the reading change from room temperature to cold temperature of measuring strain gauge,  $\Delta R^c = R_{T1}^c - R_{T0}^c$  is the reading change from room temperature to cold temperature of compensation strain gauge, G is the gauge factor and  $\varepsilon$  is the strain. The compensated strains calculated from data are shown in Fig. 8.2 along with expectations from 3D FEM simulation.

Fig. 8.2 Strain Data at Cold Temperature
