**Test of Four Coil Helical Solenoid Magnet HSM01 TD-09-011**

M. Tartaglia, G. Chlachidze, V.S. Kashikhin, F. Lewis, M. J. Lamm, A. Makarov,  
I. Novitski, D. Orris, C. Sylvester, J. C. Tompkins, D. Walbridge, M. Yu

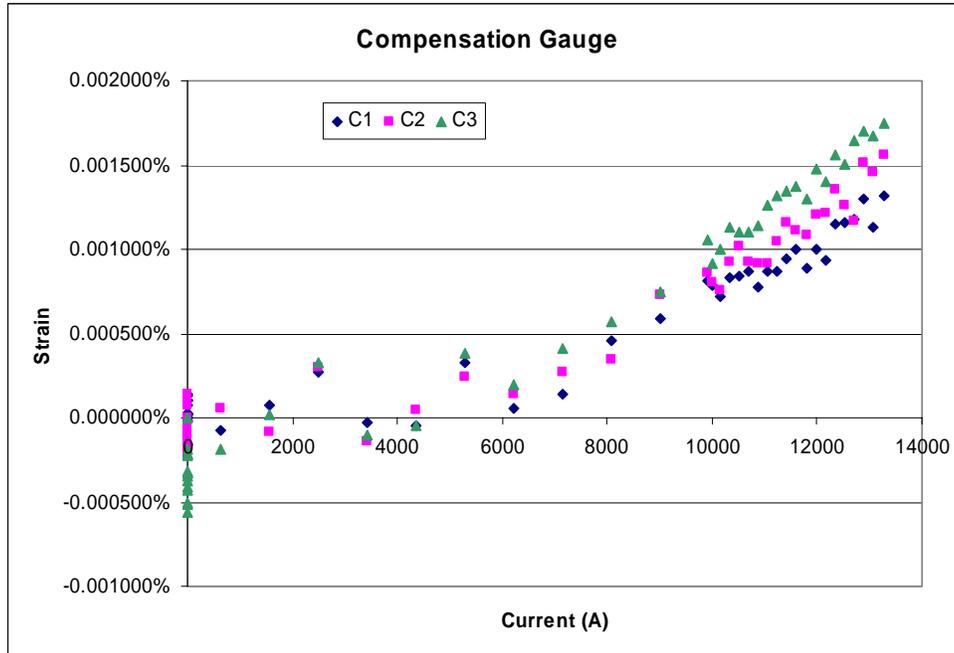
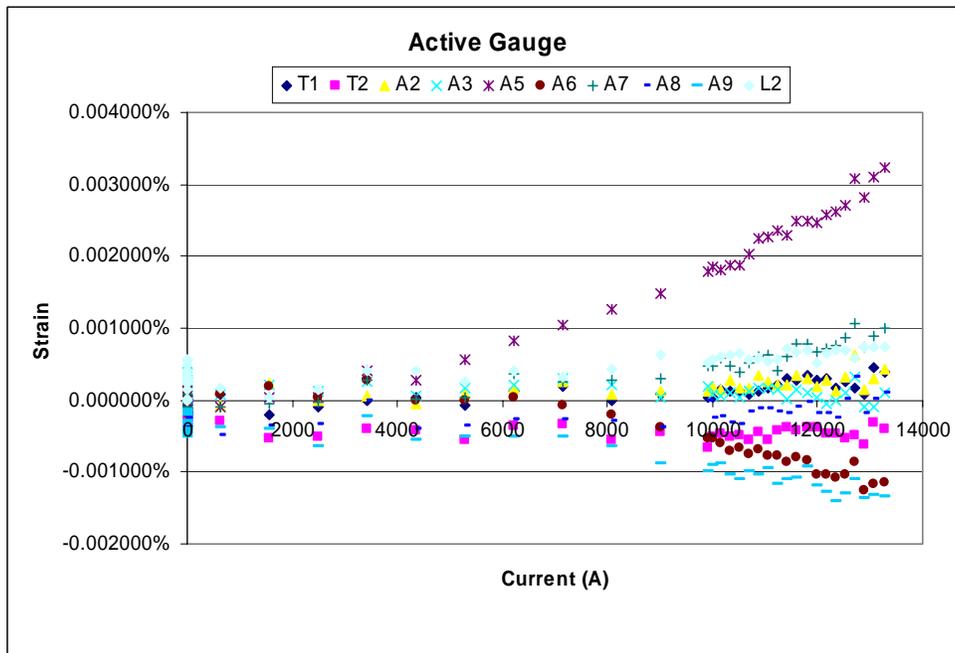
During the magnet excitation, Lorentz forces are generated simultaneously with the magnetic field. From the readings on compensation gauges shown in Fig. 8.3(a), as the magnetic field increases, the magnetic field effect on the strain gauges increases in a very small range. From Fig. 8.3(b), the readings on active gauges changed a little with maximum around 0.003%, while the simulation gives about 0.007%. Compared to the 0.2~0.3 % strain from cool down, the Lorentz force strains are relatively small and very consistent with prediction.

a. Compensation Gauges

b. Active Gauges

Fig.8.3. Compensation(a) and Active (b) strain gauge readings during excitation

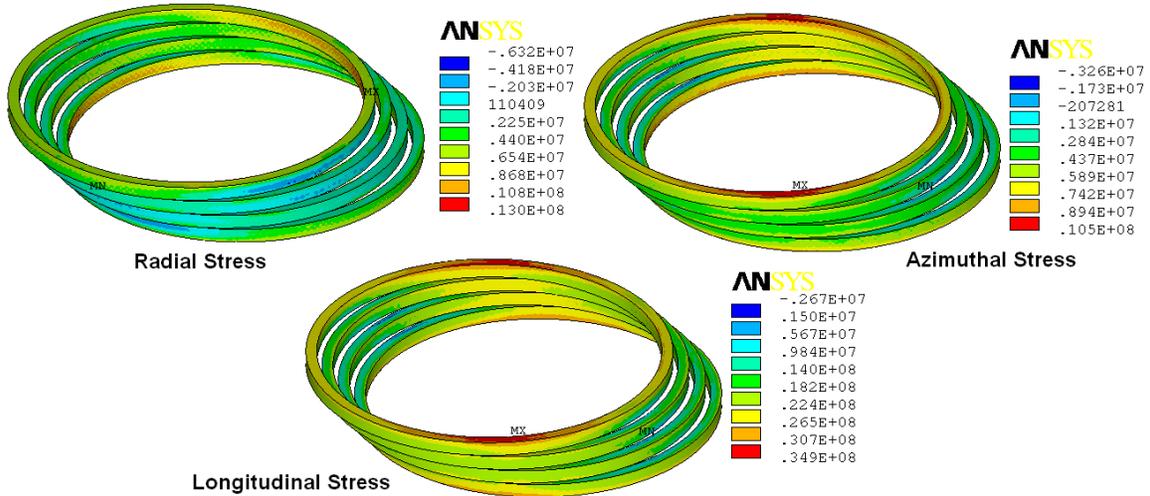
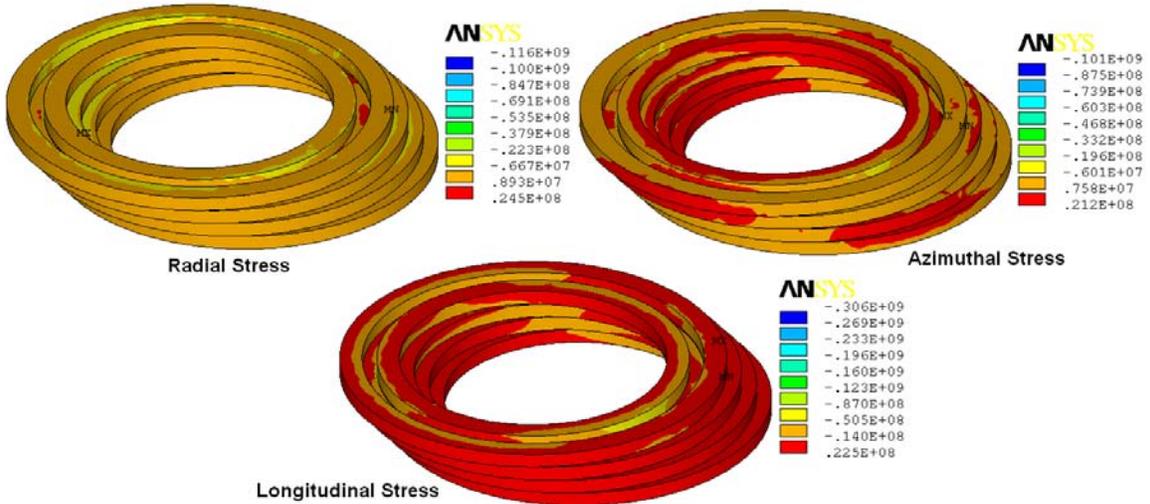
Figures 8.4 shows the modeled stress distribution on the coils and links. For the coils, the maximum stresses in three directions (radial, azimuthal and longitudinal) are 13.0 MPa, 10.5 MPa, and 34.9 MPa respectively. For the links, the maximum stresses in three directions are 116 MPa, 101 MPa, and 306 MPa respectively. These predictions are well within the allowable 50 MPa stress for NbTi cable, and 550 MPa stress for stainless steel 304. In conclusion, we can say that the radial thickness of the inner and outer links

a. Four Coils

b. Inner and Outer Links

Fig. 8.4. Stress Distributions in Coils (a) and Links (b)

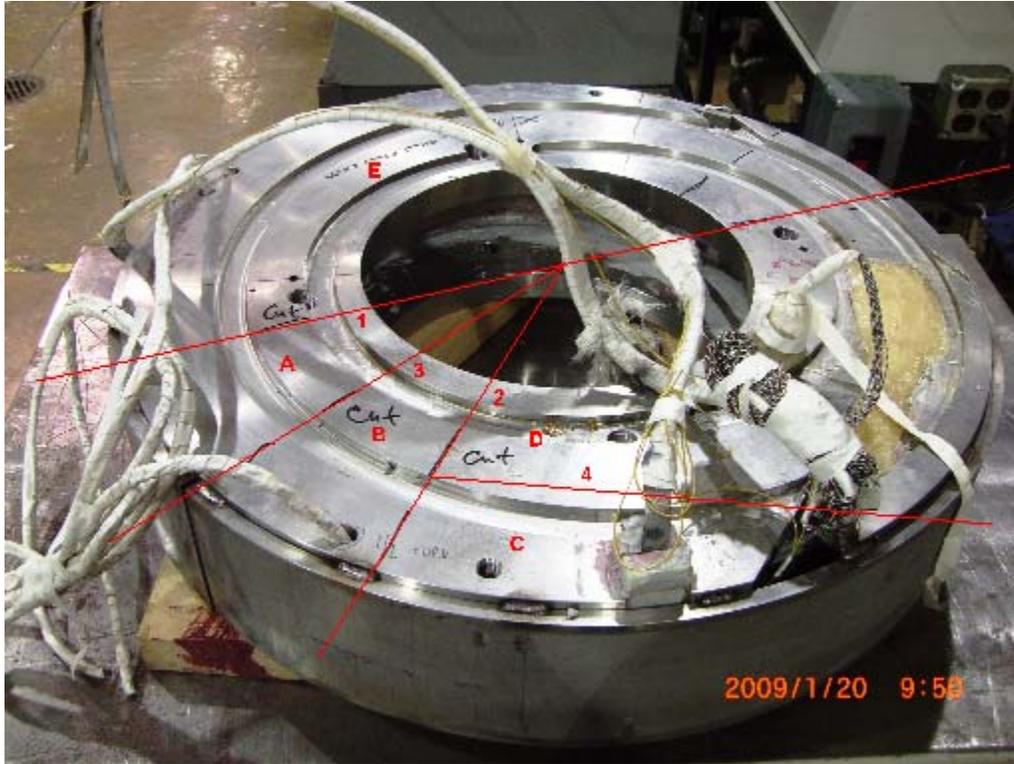
The model was cut following the number sequence (1-4) shown in Fig. 1, to find out if there is any mechanical limit around the coil, which may help to better understand the quench performance, etc. The purpose of cutting lines # 2 and 3 is to show the cross sections, close to the transition area, while the purpose of cutting line # 4 is to show the cross section of the lead end. Totally five pieces of cutting parts (A-E) were obtained.

Fig. 1 Autopsy Cutting Lines (1-4) and Parts (A-E)

After the model was cut and machined, electrical tests were made on Parts A, B and C (See Fig. 1). Using a good Ohm meter, measurements of resistance were made for every cable in each of these sections, to adjacent cables and to ground.

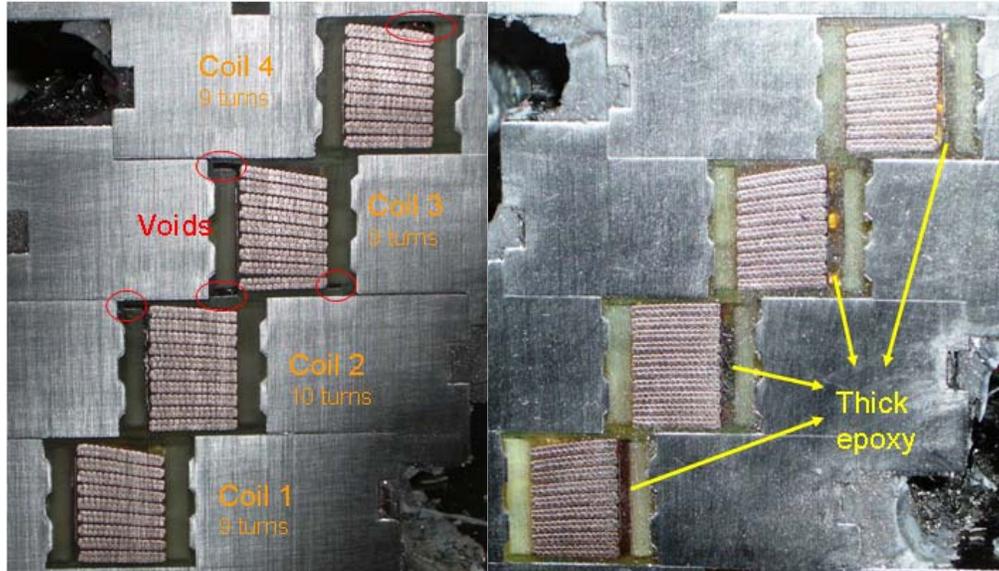
- From Fig. 2 left and Fig. 3, most of the voids are at upper and lower corners of the coils, between G-10 rings, as if epoxy did not penetrate.
- From Fig. 2 left, Coil#2 has 10 turns of cable, while the others have only 9 turns. The coils with 9 turns all have tilted cables, while Coil#2 with 10 turns did not obviously tilt. The keystoneed cable was wound with the thick edge on the outer diameter, which may lead to the observed tilt for those coils with one fewer turn, while the 10 turn coil is constrained by lack of space to be more flat.

- From Fig. 2 right, thicker epoxy was found between each coil and outer G-10 spacer. Thicker epoxy may crack and break down in the cold temperature more easily. The stainless steel ring grooves may have been fabricated somewhat elliptical, so that a wider gap in some regions was filled with a thicker epoxy layer.

Fig. 2 Both Cutting Surfaces of Part E  
Left: The Left Cutting Surface; Right: The Right Cutting Surface

In the following, all the observations from the cutting photographs and measurements are listed, and then possible reasons are speculated for these observations. Fig. 2 shows both cutting surfaces of Part E, Fig.3 shows the right cutting surface of Part B, Fig.4 shows both cutting surfaces of Part B, and Fig.5 shows one cutting surface of Part A.

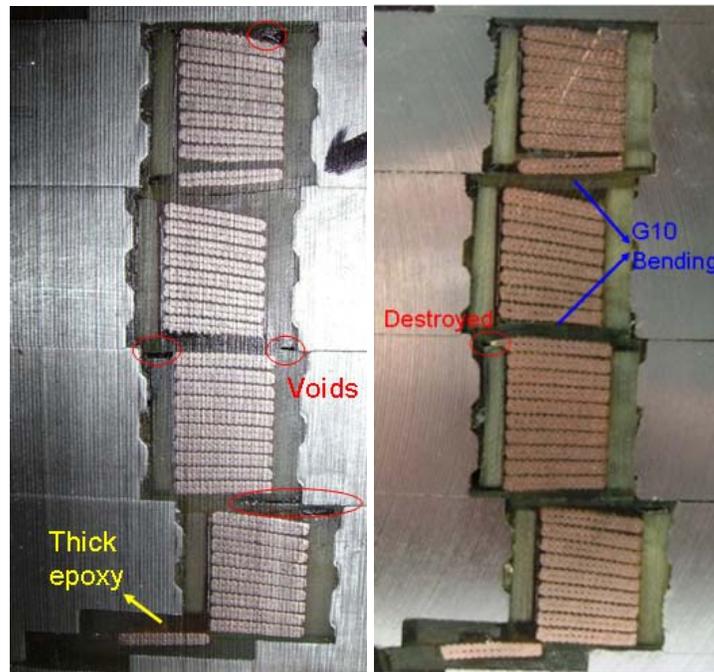
- From Fig. 3 right, the upper left corner of the cable in Coil#2 deformed a lot and into a void region, which cannot be seen from Fig.3 left; so, the deformation must have occurred during the final machining.

Fig.3 The Right Cutting Surface of Part B  
Left: Before Machined; Right: After Machined

- From Fig. 3 right, the G10 rings in the top and bottom of Coil#3 are bent a lot. Since there is one more turn in Coil#2, and surprisingly there are only 8 turns left in Coil#3 (details in the next bullet), Coil#2 has occupied some space from the adjacent Coil#3. Before solenoid potting, G-10 rings were compressed vertically during the winding, bending the G-10 rings.

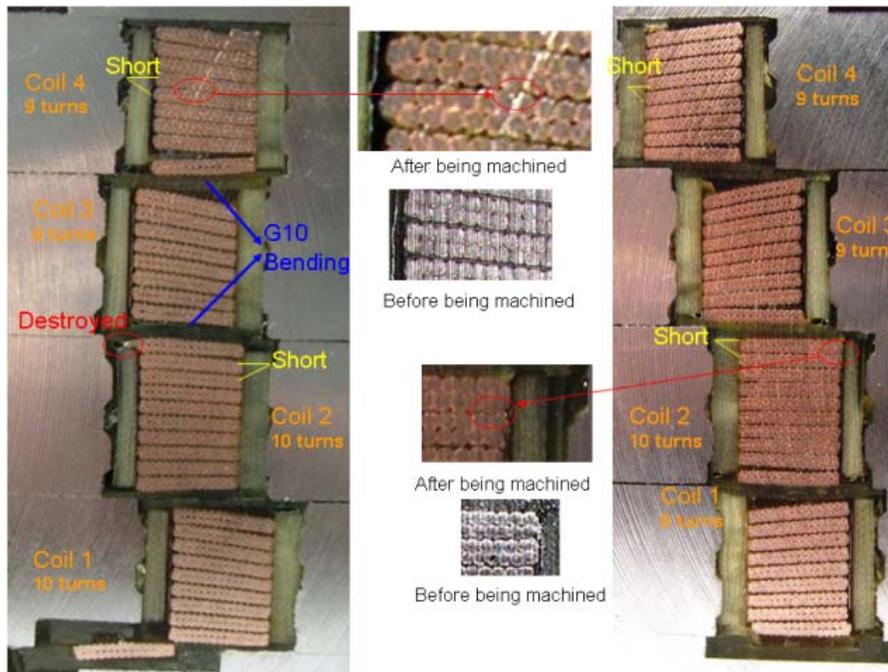
- From Fig. 4 left, Coil#1 (including lead end cable) and Coil#2 have 10-turn cable, Coil#3 has only 8 turns and Coil#4 has 9 turns, while on the right side, Coil#2 has 10-turn cable, and the others have 9 turns. Since both surfaces belong to Part B and different small pieces of G-10 spacers were used in this special transition area, the possible reason is that these G-10 spacers were placed improperly, causing the cable misallocation in Coil#1, 2 and 3 in the transition area, which can be confirmed from the resistance measurement results (next bullet).

Fig.4 Both Cutting Surfaces of Part B  
 Left: The Right Cutting Surface; Right: The Left Cutting Surface

- The cables were found to be insulated from each other except two pairs of adjacent cables in Part B shown in Fig. 4. In Coil#4, both sides' measurement results show short between the fourth cable and the fifth cable (counted from the top). Strangely, in Coil#2, both sides' measurement results show different short locations, one side short between the second cable and the third cable, and the other side short between the first cable and the second cable. Form Fig.4 left, it can be only explained that the first cable in Coil#2 should belong to Coil#3 which currently has only 8 turns, and then the first cable in Coil#1 should belong to Coil#2, making 10 turns for Coil#2 and 9 turns for Coil#1, which is consistence with the other cutting parts. After comparing the pictures taken before and after final machining, it is believed that the cables were deformed during the machining, causing the turn to turn short problems.

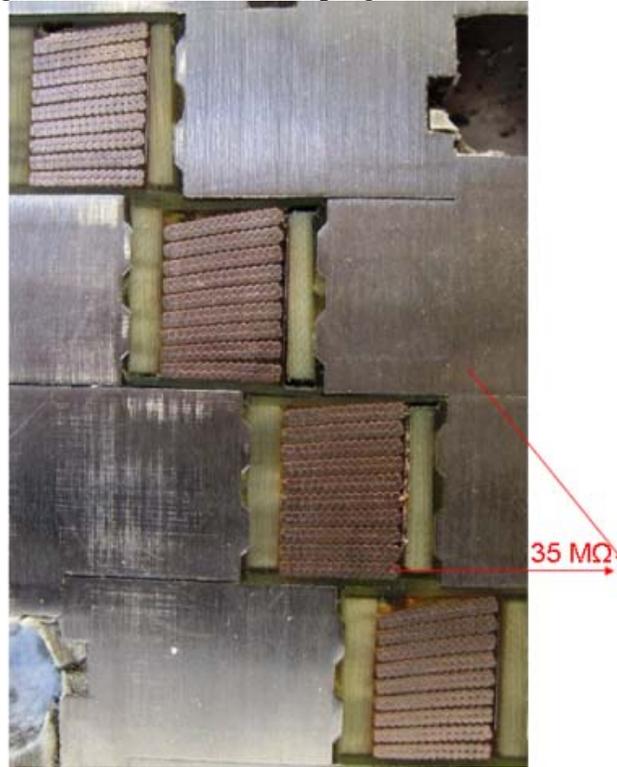
- The cables were found to be insulated from ground, with one exception: As shown in Fig.5 the bottom cable (first turn) of Coil#2 in Part A showed a reading

of  $\sim 35 \text{ M}\Omega$  to ground, (measurements with both polarities were consistent). Another measurement was taken with the same result after this surface was carefully polished using fine sand paper. At 250 V, this would yield  $\sim 7 \text{ }\mu\text{A}$  leakage current, about the right order of magnitude to be consistent with hipot results during the warm and cold test program.

Fig. 5  $\sim 35 \text{ M}\Omega$  Found in Part A, between the First Turn of Coil#2 and the Ground
