EDDY CURRENT SCANNING AND VISUAL INSPECTION REPORT OF 94 SQUARES FOR 5 ILC CAVITIES TO BE PRODUCED AT AES

TD-05-050
November 16, 2005

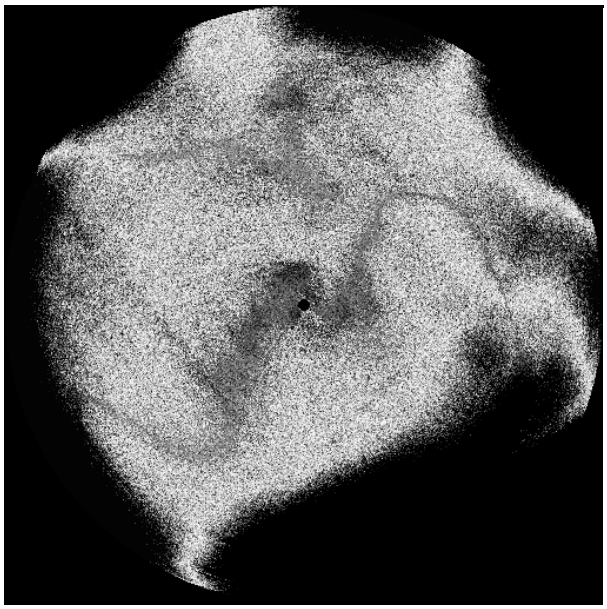
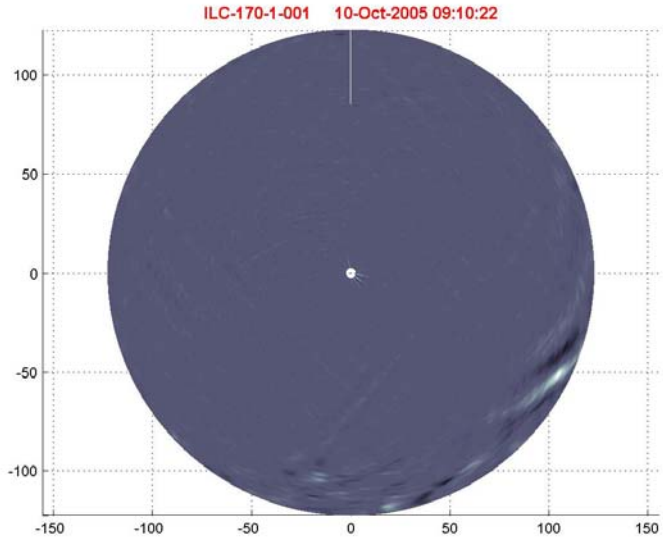
Square 170 side 1 scan left, Filter right

Squares 170, 194, 217 and 232 showed strong signals on the scan results but no correlation with surface features. This is the first case we observe this type of defect at FNAL. In order to obtain more information on this issue, the four samples were sent to outside microscopy labs for further investigations.

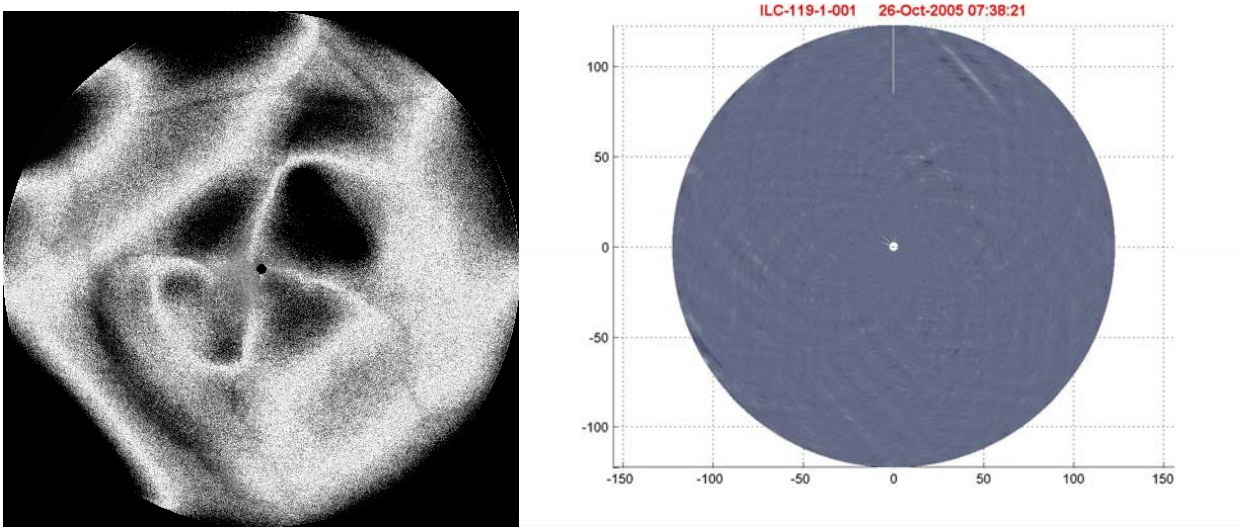
Square 119 side 1 scan left, Filter right

Square	comment	Recc.
119	S1: Light Surface Scratches ,Tiny Pits Throughout , Pit on scanner S2: Light Surface Scratches ,Tiny Pits Throughout , Black Spec at 330 deg. O	S1: NO S2: OK
121	S1: OK S2: OK	S1: OK S2: OK
127	S1: Light Surface Scratches ,Tiny Pits Throughout , Ding at 45 deg. MR S2: Light Surface Scratches ,Tiny Pits Throughout , Scratch at 45 deg MR , C	S1: NO S2: OK
128	S1: Light Surface Scratches ,Tiny Pits Throughout , OK S2:Pits and scratches	S1: OK S2: NO
149	S1: OK S2: Light Surface Scratches , OK	S1: OK S2: OK
152	S1: Pits Throughout , Ding at 45 deg. MR and 75 deg. MR S2: Tiny Pits Throughout, Light Surface Scratches , OK	S1: NO S2: OK
153	S1: Scratch at 0 deg. MR , OK S2: Light Surface Scratches , OK	S1: OK S2: OK
154	S1: OK S2: Scratch at 300 deg. MR , OK	S1: OK S2: OK
155	S1: Tiny Pits Throughout, Light Surface Scratches , OK S2: Tiny Pits Throughout, Light Surface Scratches , Scratch at 270 deg. MR , OK	S1: OK S2: OK

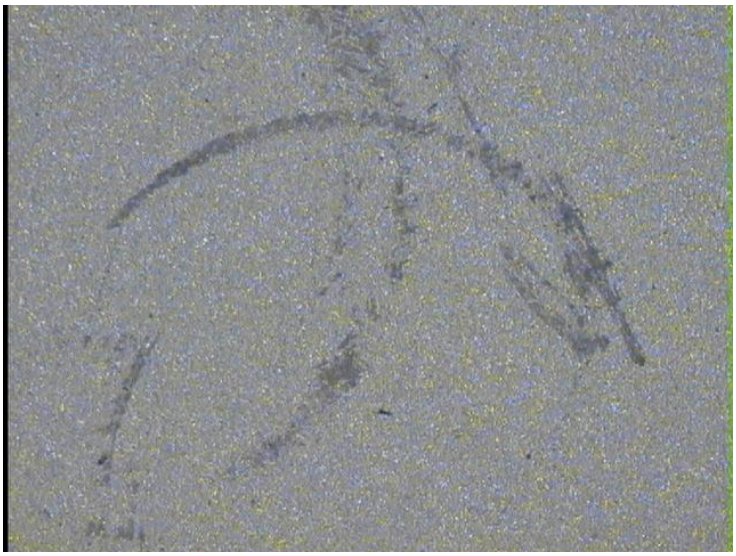
Figure 3 Clamp marks present in 2 or 4 spots in each side of the squares

The table below contains the results of the eddy current inspection of the 94 squares. The results of a visual inspection using a simple magnifying glass are also reported. The indicated numbers are approximate angle coordinates on the square, where the angle is counted clockwise from the middle point of the top edge when the side number is positioned on the top right corner. OR stands for "outer rim", that is the ~5 mm band at the outer rim of the disc. It is to be assumed that this area will be removed during subsequent production steps. MR stands for the ring in the middle, which will also be stamped out. HR stands for "half radius" and scratches, dents and pits in this area are more serious because this area will be used in the cavities. Most of the squares have a bevel along the edge as a result of the stamping or shearing process. Moreover most of the scans on side two show a pit in the MR which is related to an imperfection of the rotating table. These features have not been mentioned explicitly in the table below. All the 94 squares present markings as shown in Figure 3. Probably they are indentations left from a clamp used during the cutting process.

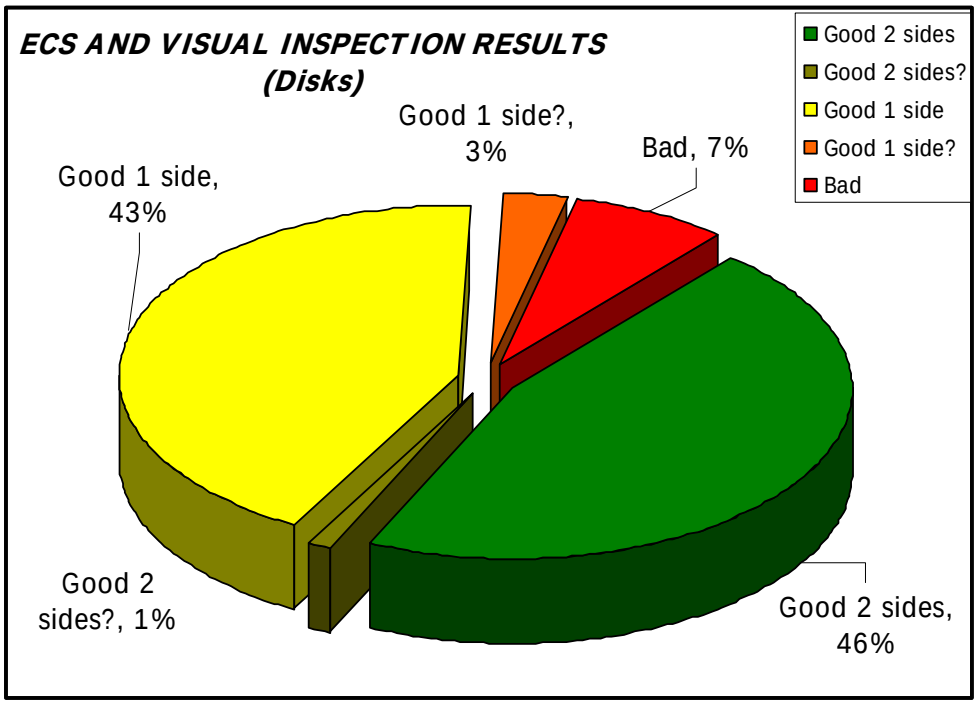
Figure 4 ECS and Visual inspection results on disks

The above table can be summarized as follows: out of the 94 squares, 43 (46%) have no signal (**OK**), 40 (43%) give signals on one side only and 7 (7%) give a signal on both sides (**NO** or **NO**). In terms of signals: 111 sides show no signal, 30 sides show signals on the scans, 30 show surface features through the visual inspection only and 17 show some surface irregularities.

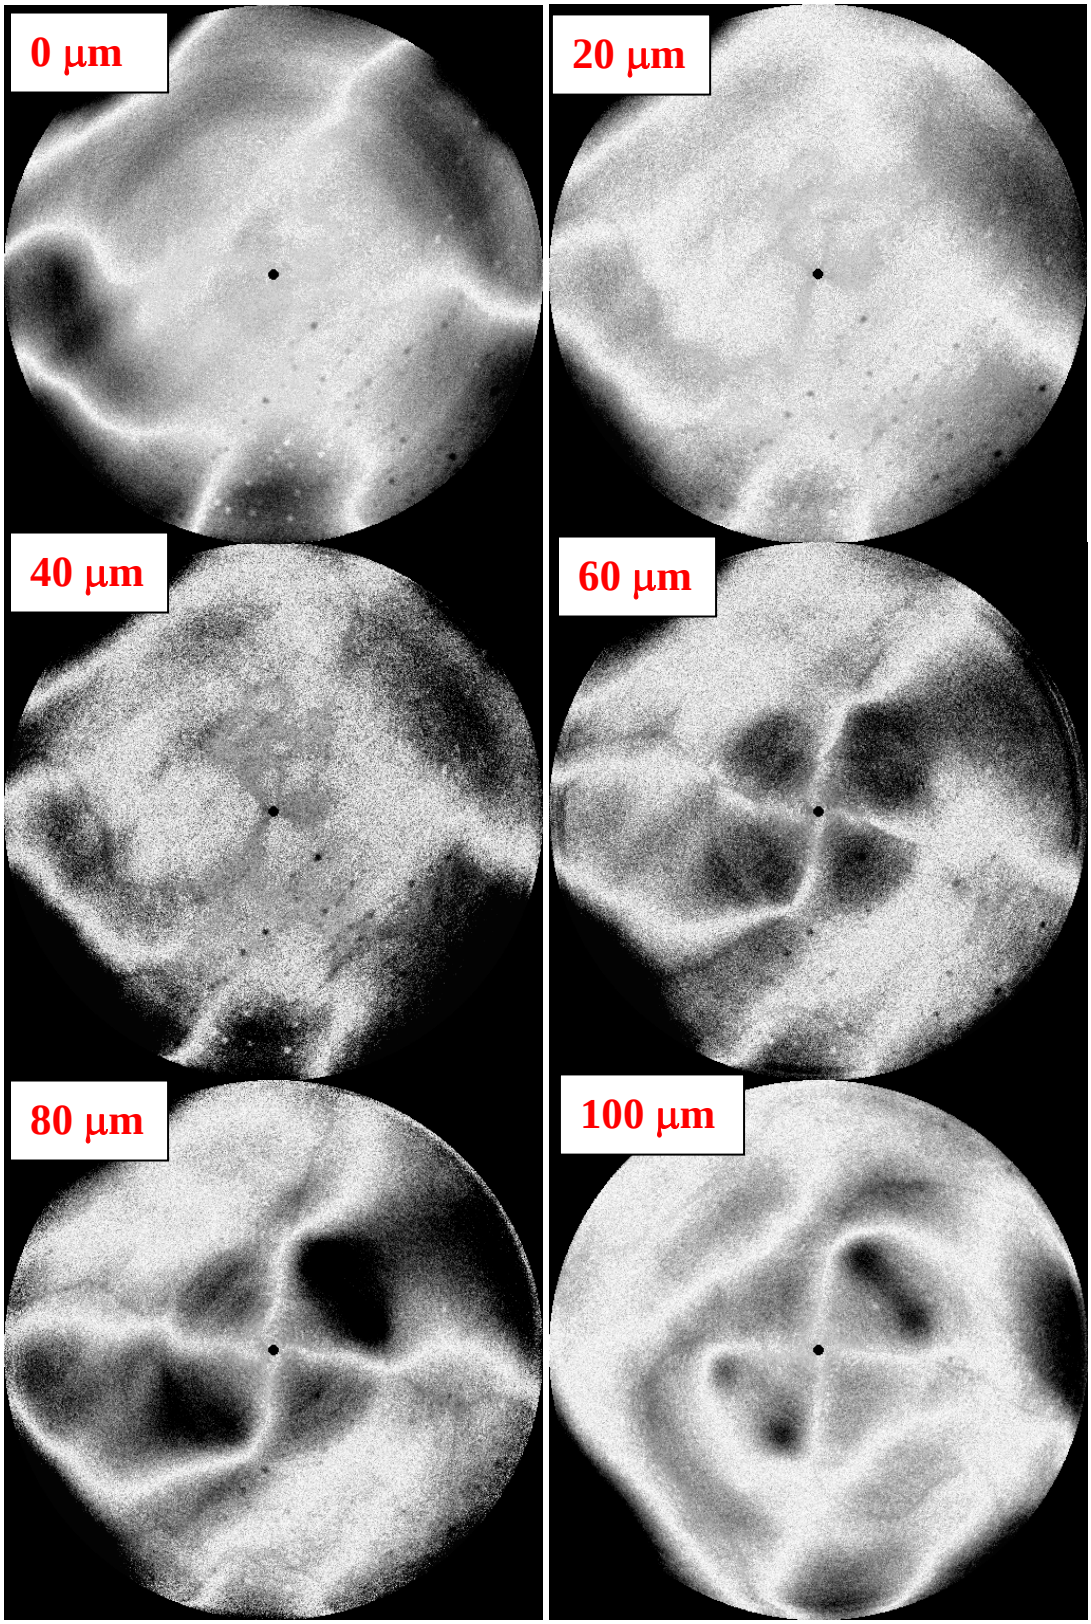
Figure 7 Square 223 step by step etching 0 to 120 um

Square 223 showed strong signals on the scan results and the visual inspection confirmed the presence of many deep pits. Usually when pits show up in the scan results there are concerns that the material processing will not recover them. Studies have been performed in the past to understand this issue and are reported in TD-05-032. Square 223 was etched 120 um at 20 um steps and between the etching steps it was scanned to check for changes in the surface features. Figure 7 shows the ECS results for each step.

After the 120 um removal some pits are still present in the scan results confirming, as in the previous results, that even a deep BCP etch may not remove completely pits that are visible in the ECS images.

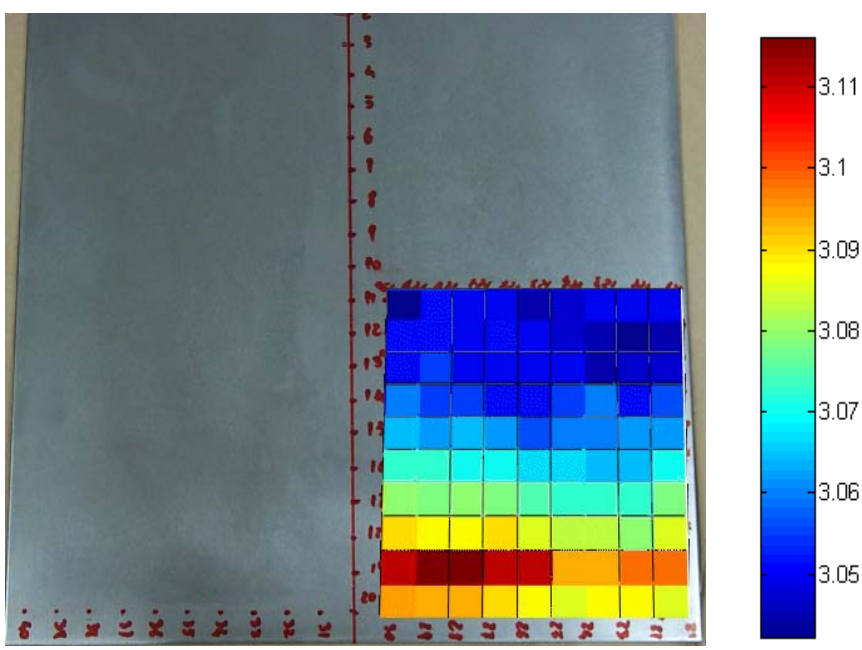
Figure 8 Square 162 color map of the thickness over one quarter of the surface

Square 162 was very difficult to scan due to flatness irregularity. This sample did not look flat and did not adhere perfectly to the vacuum clamping system. In order to understand better additional thickness related effects, the square was measures using an ultrasound thickness measurement device. One quarter of the square was marked with points distant 1/2" and a measurement was taken at each point.

Results of the measurements are shown in Fig. 8. The square had an average thickness of 3.068 mm over 130 points with a standard deviation of 0.019 mm, the highest point was 3.116 mm and the lowest 3.042 mm. This measurement confirms that the squares are within the expected tolerance of 0.1 mm for the material thickness, but also that the material is thicker than expected.

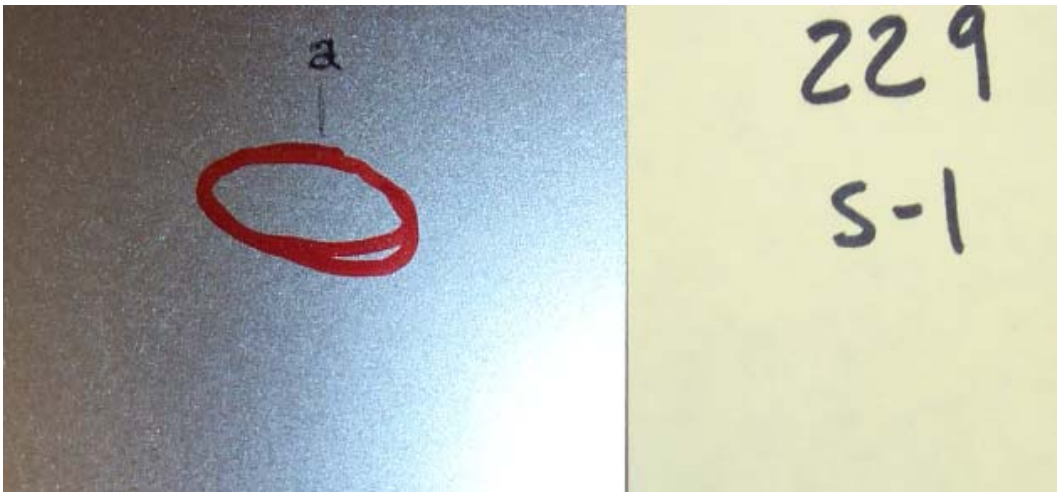
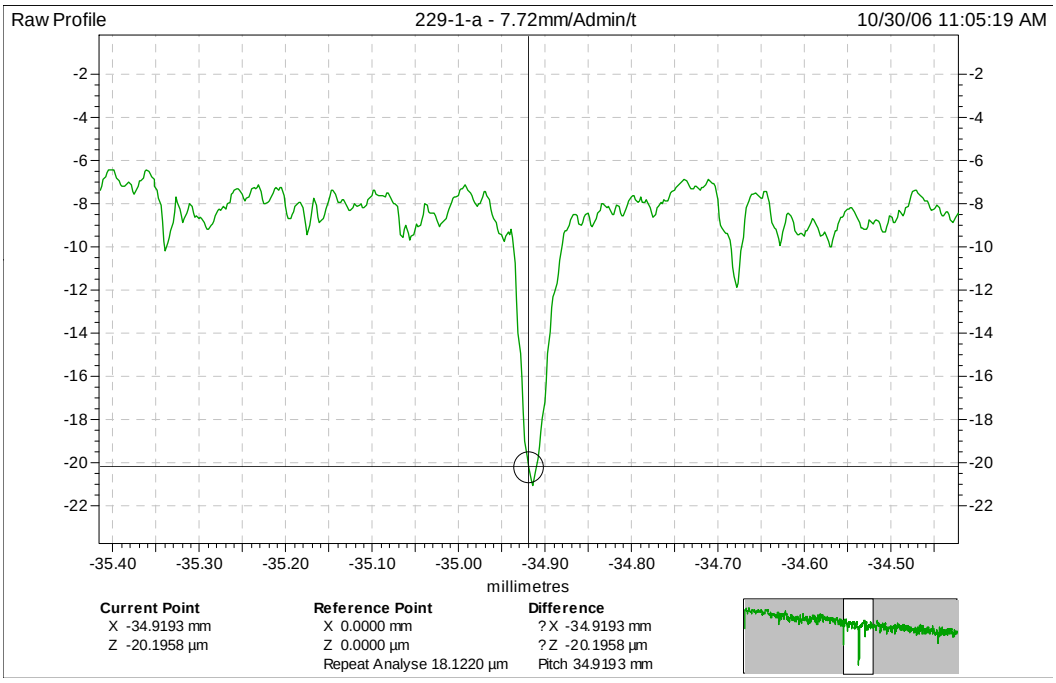
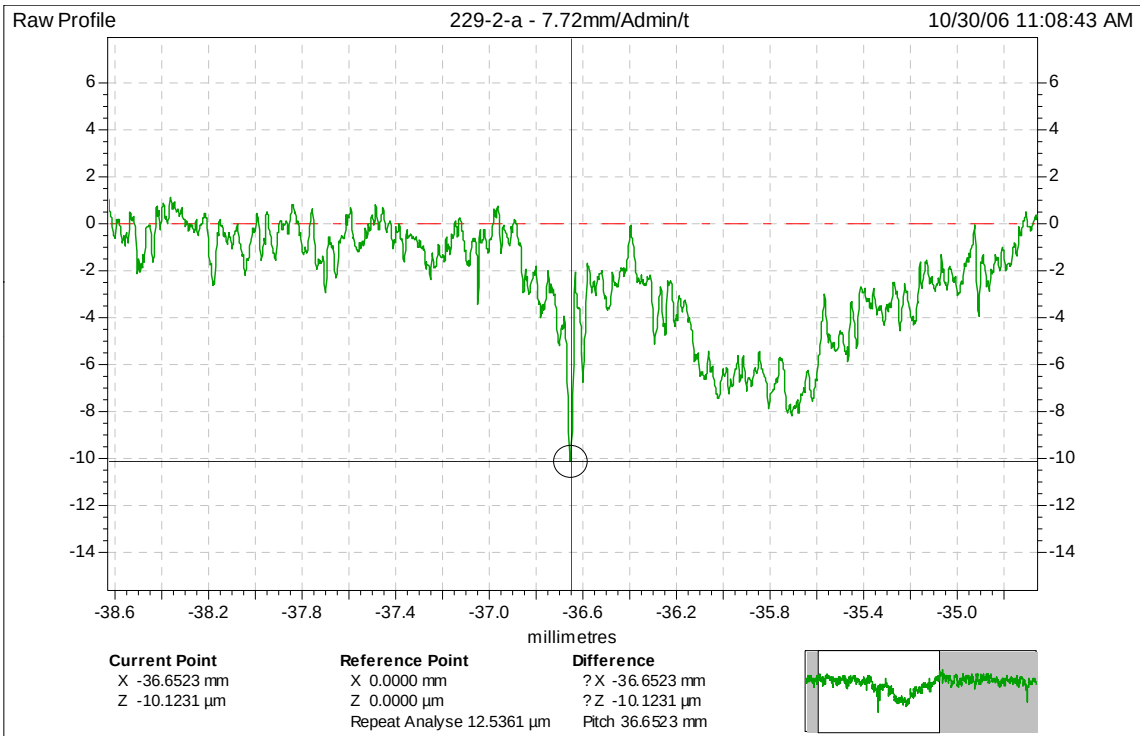
a
229
S-2

In the effort to better understand the relevance of scratches and pits on the Nb surface, squares 214 and 229 were measured with a Taylor-Hobsen profilometer. This technique allows detecting the deepness of pits and scratches. The scratches are more extended with respect to pits and most of the times do not show up in the scan results. The measurements shown below confirm that the scratches are less deep than the pits and will probably be removed during the material processing.
