Fermi National Accelerator Laboratory
PO Box 500
Batavia, IL 60510
TD-06-011
June 2006

Report on Batch 1 of Polycrystalline Niobium for ILC Cavities to be Fabricated at AES

April 27th 2006

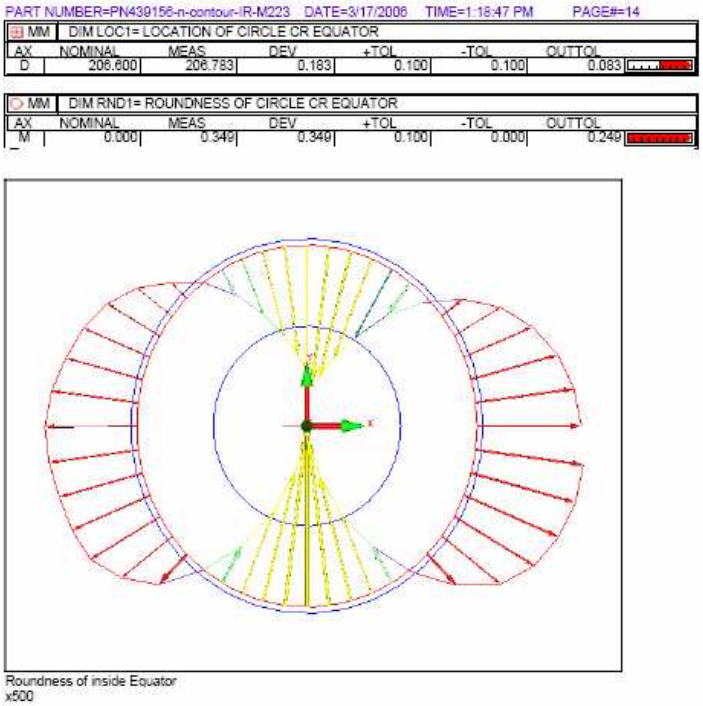
As illustrated in the example in Figure 1 the first batch of six half-cells hydro-formed at AES[1] are not round at the equator as they should be (specified max error: 0.1 mm). The deviation from the nominal diameter is up to ±0.25 mm (~0.1% on a ~23 cm diameter), such that the equator footprint was strongly elliptical. One should also note that this result was obtained after 6 consecutive forming steps (rather than the usual 1-2). AES informed Fermilab about the difficulties with the forming and the observation of non-isotropic behavior of the material during forming. In one case it appeared like there was one area of a blank that was significantly harder then the surrounding material.

Figure 1: Result of geometrical measurement of equator of one of the initial half-cells formed from the batch 1 Wah-Chang sheet material. The deviation from the specified, circular shape are exaggerated in this plot (Courtesy of R. Riley - Fermilab).

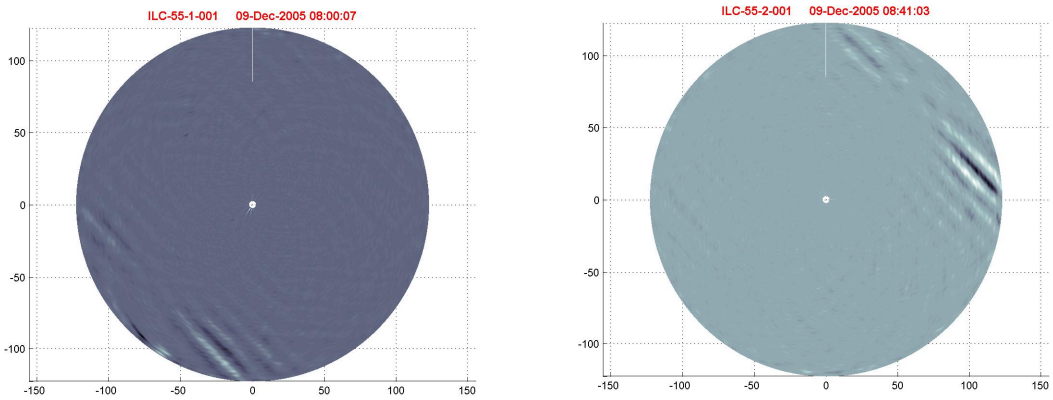
The Eddy current scanning of these niobium sheets also revealed a new feature, "stripes" running parallel to the sheet edges (and thus presumably parallel or perpendicular to the rolling direction), such as shown in Figure 2. These stripes have since been shown to be topological features, i.e. a surface ripple with peak-to-peak amplitudes of ~4 μm and spaced ("wave-length") by a little less than 1". Figure 3 shows the result of a profilometric stylus measurement across and along these features on sheet 137, clearly showing the small ripple in the "across" case on top of a longer range height variation,

Figure 2: Results of eddy-current scan

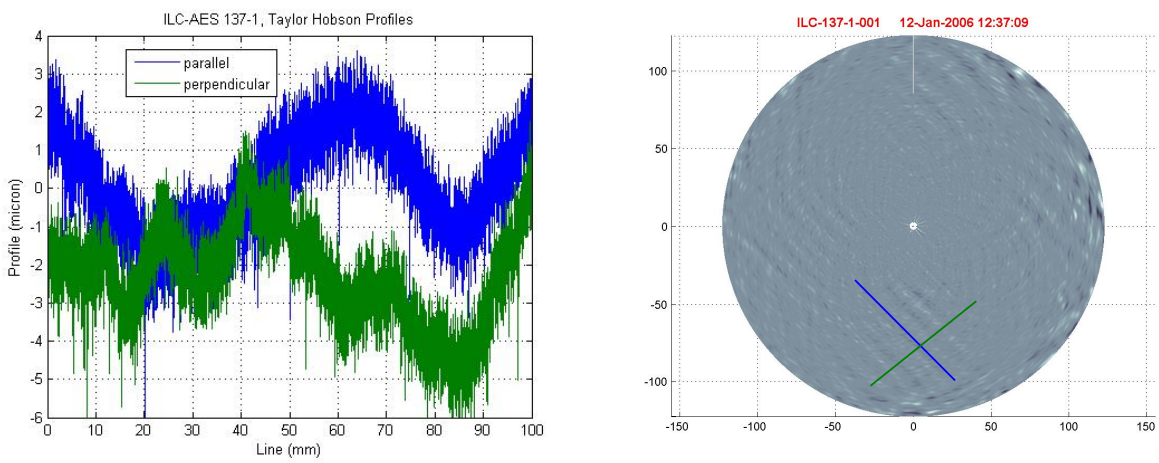
Figure 3: Profile parallel and perpendicular to "stripes" in scans on sheet 137.

which exists in both directions. This issue is discussed further in TD-06-010. Note that all these height variations do not violate the specification for the rolled sheets and are expected to be benign from the cavity performance point of view. Having uncovered the origin of the "stripes", we are now uncertain about their relation to the forming problem.

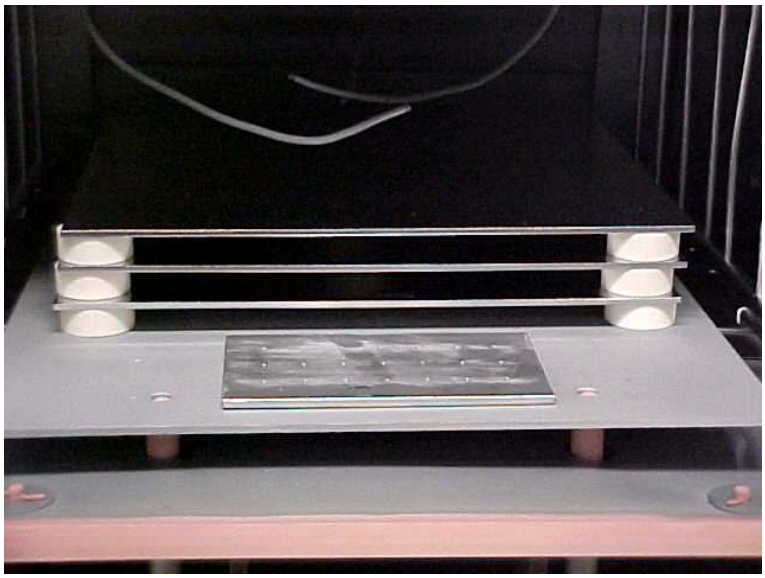
Figure 4: ILC sheets in small vacuum furnace.

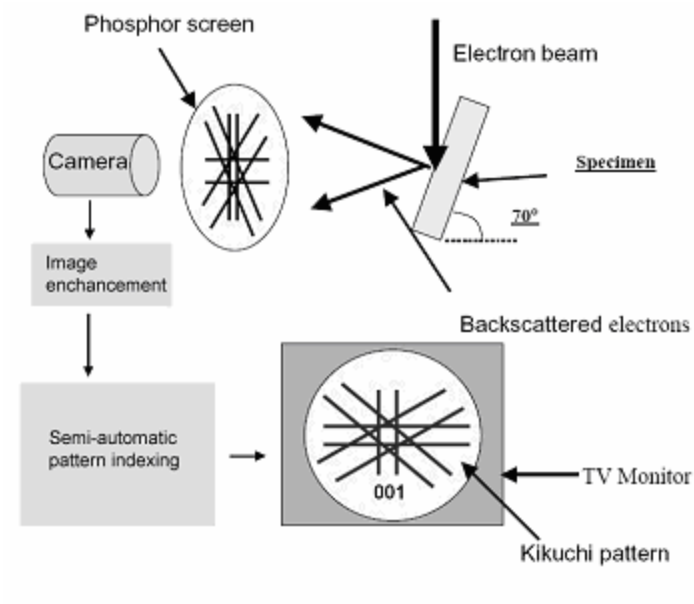
Figure 5: Schematic of Orientation Imaging Measurements.

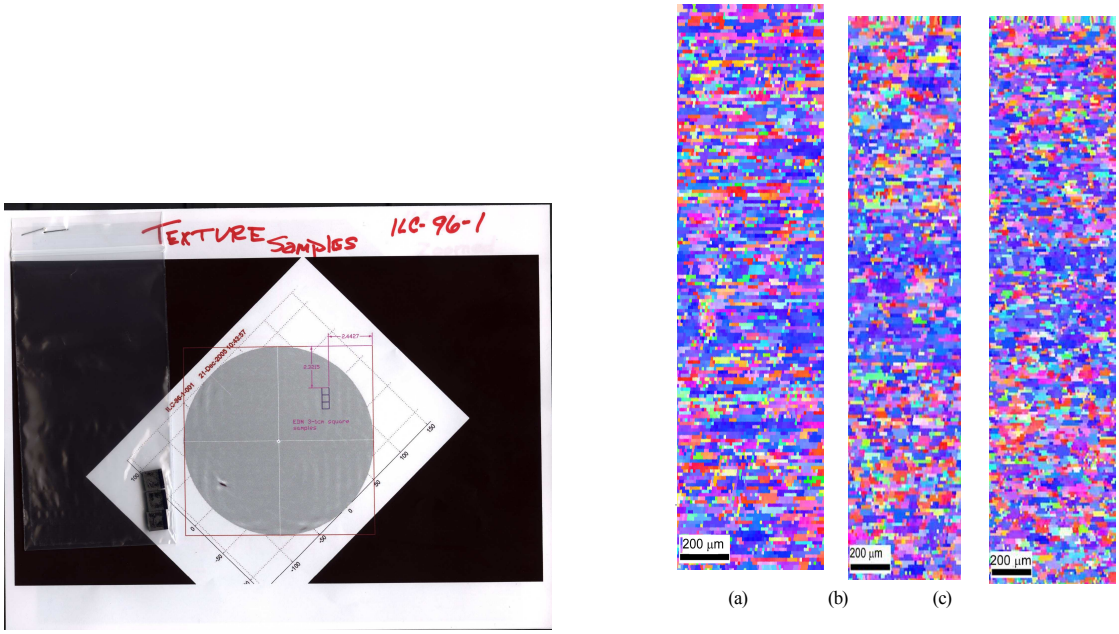
The texture analysis in the before heat treatment condition shows that the material is only partially re-crystallized with grains being elongated (aspect ration around 2:1). The case in Figure 6, showing the texture in two cross-sections that are perpendicular to each other, indicates that the elongation is more or less similar in both rolling directions. The grains thus are "pancake-shaped" (flattened along sheet normal, elongated in sheet plane). Furthermore, as clearly visible in Figure 7, there are also some bands of larger grains, differing from the finer grains in the rest of the cross-section. This is a worrisome feature in what refers to the forming characteristics of the material. The texture inhomogeneity through the thickness is pronounced in the before heat treatment samples. The grain orientation is not completely random. The 111 orientation is preferred for rolling. There is also more than desired texture in the 001 orientation, which is not ideal for forming.

Figure 6: texture samples cut from areas giving a "stripe" in the Eddy current scan. Samples (a) inside the stripe (b) outside the stripe (c) perpendicular (across) to stripe

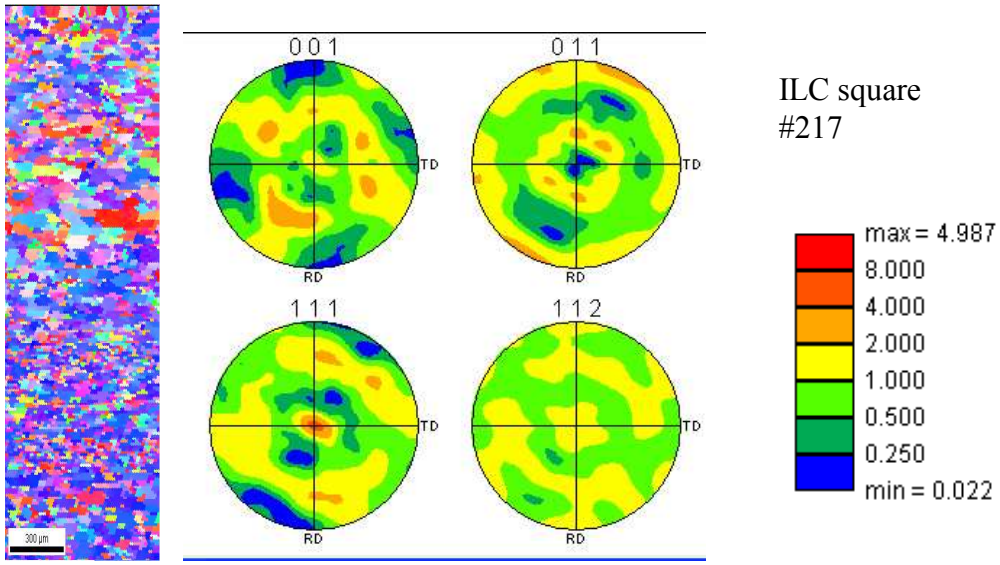
Figure 7: Texture measurements before (left, sheet 217) heat treatment. 111 peak is small and 001 orientation peaks are larger than desired.

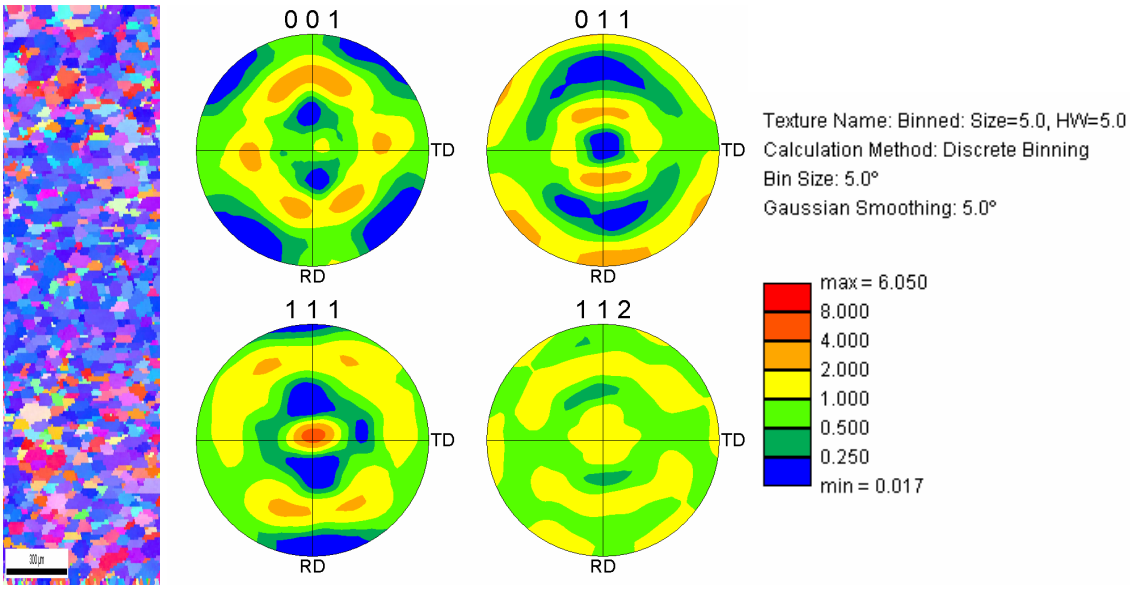
The texture after the heat treatment is clearly different: grains are now larger and more equi-axed. Also the texture has changed, with the 111 peak being more pronounced and the 001 texture weakened.

Figure 8: Texture measurements after (right, sheet 55) heat treatment. Pole figure indicates reduced texture in 001 and increased 111 orientation.

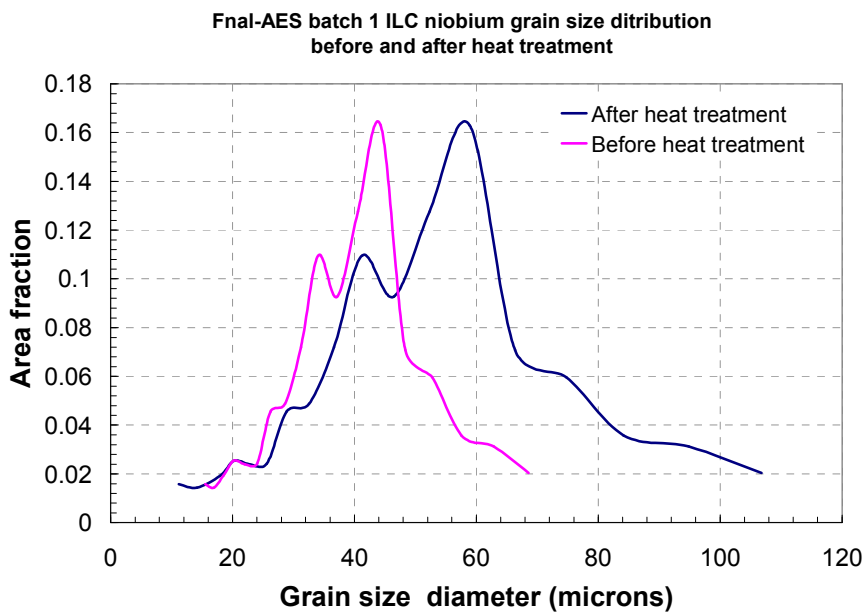
Figure 9 shows the grain size distributions in several samples (before and after heat treatment). The grain sizes measured before heat treatment correspond rather to ASTM 6&7 than the specified ASTM 4-5. The grain sizes after heat treatment are therefore (and luckily) close to those specified.

Figure 9: Grain size before and after heat treatment.

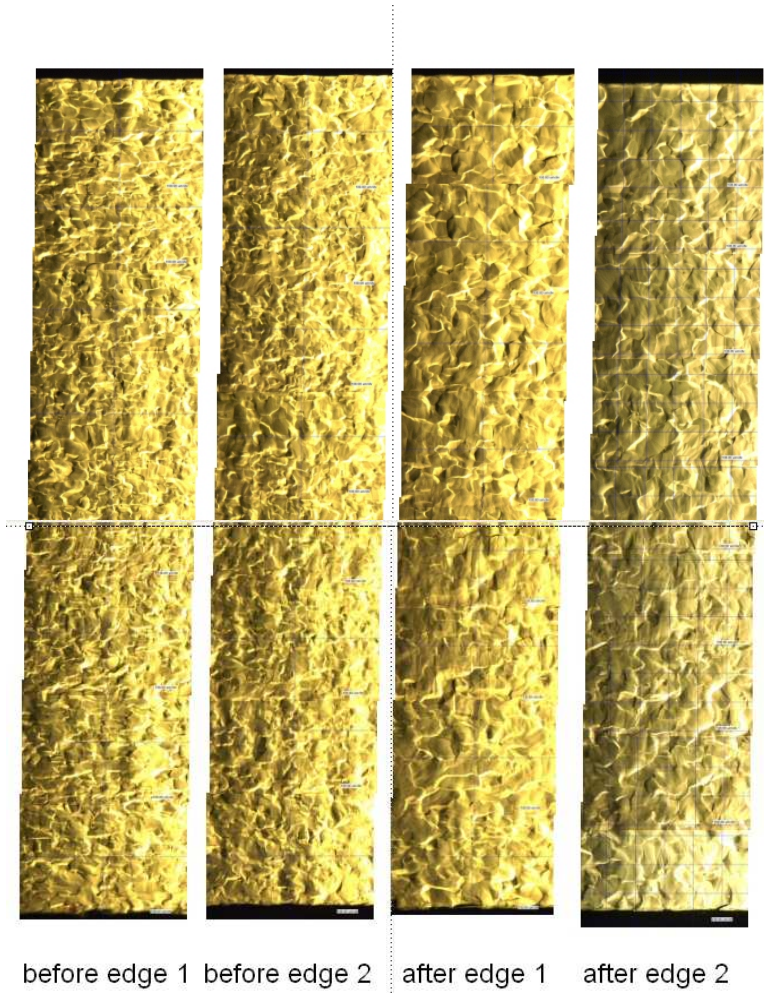
The change in microstructure from the before to the after heat treatment condition is also clearly revealed in the following metallo-graphical analysis performed at Fermilab. Sections across the sheet thickness in two perpendicular orientations (parallel to the two sheet edges) are shown in Figure 10. As with the samples sent to MSU for OIM the before heat treatment sample was cut from sheet 217. The after heat treatment sample was cut from sheet 55. The first picture for the before heat treatment case shows horizontally elongated grains. After the heat treatment the grains are larger and more equi-axed, with no more elongated grains along any of the two perpendicular directions

Figure 10: Micrographs across the sheets parallel (left, edge 1) and perpendicular (right, edge 2) of before (from sheet 217, left two picture) and after (from sheet 55, right two pictures) the heat treatment (similar scales).

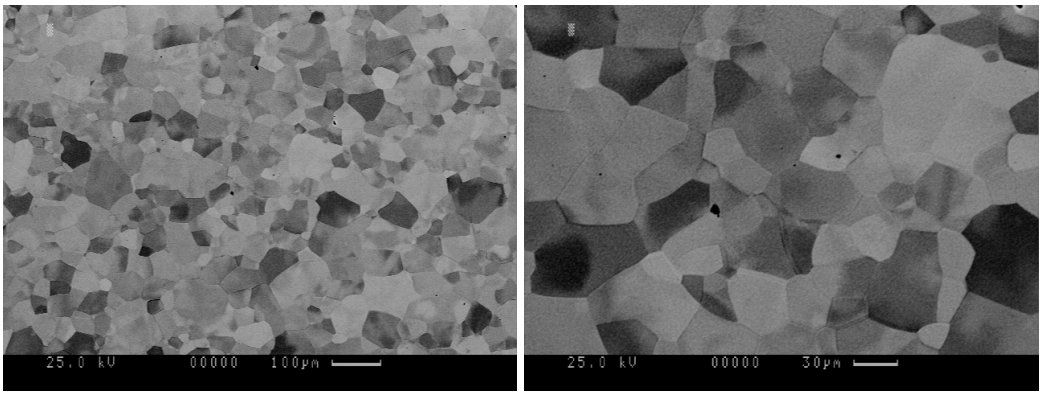
sampled. Figure 11 gives a higher resolution micro-graph of one of the samples after heat treatment.

Figure 11: MSU micrographs of one texture sample after heat treatment.

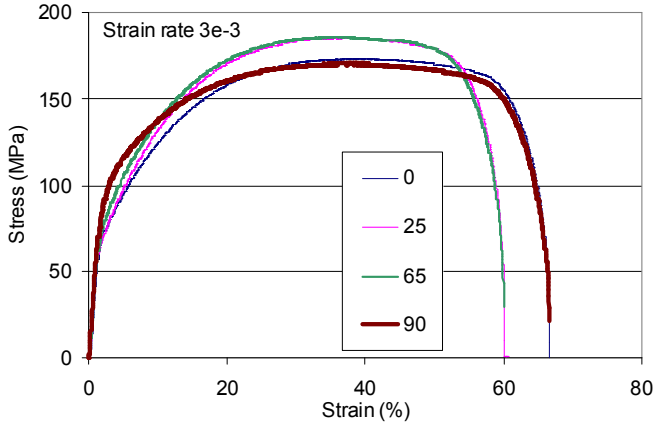
Before the heat treatment the yield strength varied by up to 22% between the different directions. Most importantly for the formability of the material, however, the strain hardening coefficient varied by 30% between the different directions. That maybe caused by the inhomogeneous grain size and non-ideal (001) texture of the material. After the heat treatment the yield strength dropped by ~20 MPa, an expected softening of the material following further re-crystallization. Although the 25°direction gave a yield strength that was higher than that of the others, the strain hardening coefficient now varies much less (Table 1). As expected from the reduction in yield strength the strain-hardening coefficient has also increased. This corroborates the findings from the microstructure analysis and indicates that the formability of the material should have been improved by the heat treatment. The mechanical measurements, however, also indicate that some of the mechanical anisotropy is still present in the material.

Figure 13: Stress-strain measurements before the heat treatment conducted at room-temperature (sheet 217) at MSU (Courtesy of H. Jiang, T. Bieler). Samples were cut at different angles to the sheet edge (see Figure 12).

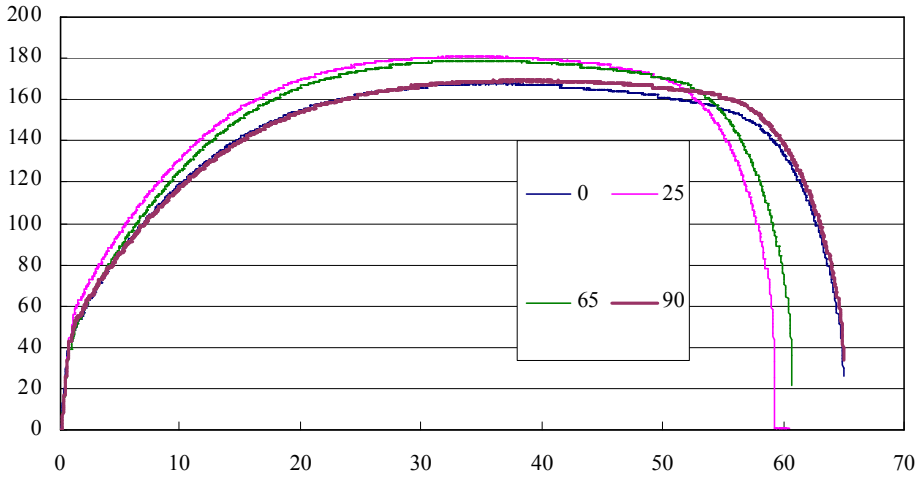
Figure 14: Stress-strain measurements after the heat treatment conducted at room-temperature (sheet 55) at MSU (Courtesy of H. Jiang, T. Bieler). Samples were cut at different angles to the sheet edge (see Figure 12).
