12/06/06
Rev. 07/27/07
TD-07-016

HFDM06 Test Summary Report

The $\text{Cos}\theta$ dipole mirror magnet HFDM06 was made in the “standard” mirror configuration, using a coil manufactured using the RRP 108/127 Nb_3Sn strand (exactly the same as was used in SR03). It was tested in November 2006 at the Fermilab vertical magnet test facility (VMTF) where it was mounted to the 30 kA “HFM” top plate assembly. Data acquisition scan configurations were prepared using new configuration and version control tools; thus the preparation took several days longer than usual, and led to some minor difficulties during the test. Scans were started following electrical checkout and warm measurements on Tuesday November 7; pre-cooling with liquid Nitrogen began on 11/8. The VMTF dewar was filled with helium early on Thursday 11/9, followed by cold electrical checkout, quench/power system checks, and the first training quench that day. Quench training and ramp rate studies were conducted at 4.5 K, 2.2 K, and 3.5 K. These were followed by heater protection tests, during which an SCR in the dump switch failed and the magnet absorbed the full quench energy, resulting in a quench integral of about 18.5 MI

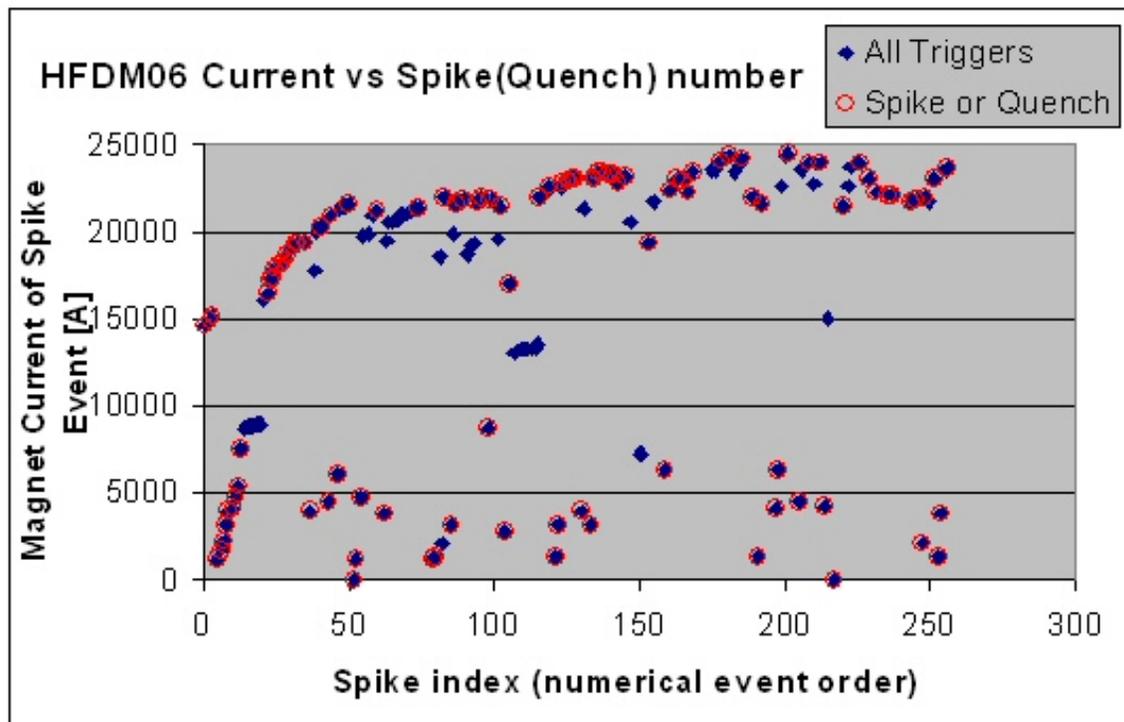
The Voltage Spike Detection System (VS DS) captured spike data (individual half coil voltages, and magnet current) for all ramps at a threshold (on the half coil difference voltage) of from 15 to 17 mV, and it was quite clear that the **spikes associated with this conductor are not very numerous and are generally of small amplitude** (power supply noise triggered the capture of most “events” at this low threshold). Spikes for each ramp were studied “by hand” using simple MATLAB event display tools. For those that appear to be actual half coil voltage excursions (rather than just noise), the peak pulse height and some estimate of the pulse duration have been recorded. In most quench events, the quench development was also captured by the spike system: in almost all cases there is **no evidence for a voltage spike preceding the quench**, and in those few cases the “spikes” are small, narrow, and likely to be power supply (SCR) noise. Figure 6 shows the history of magnet currents at which data were triggered. Figure 7 shows the pulse duration versus amplitude for the “actual” spikes, and Figure 8 illustrates that the widest pulses all occur at relatively low magnet current.

Figure 6. Current for spike system by event number, for “all” triggers (dark diamonds) and actual “spikes” or “quenches” (red circles); power supply noise is clearly exacerbated in middle and high current ranges.

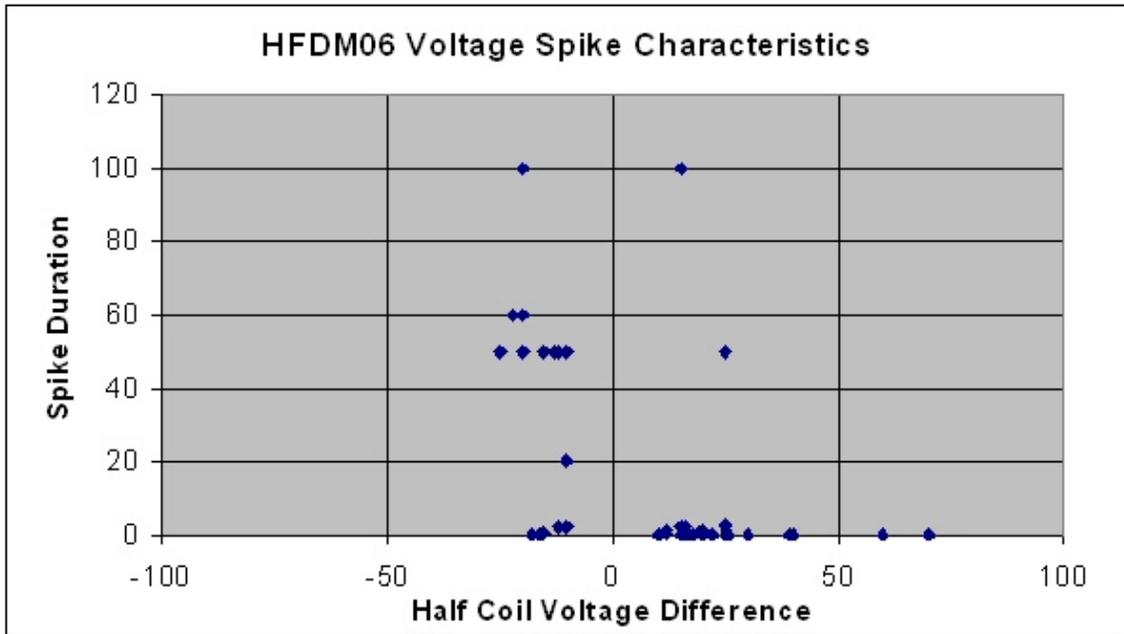
Figure 7. Duration versus peak amplitude for actual spikes

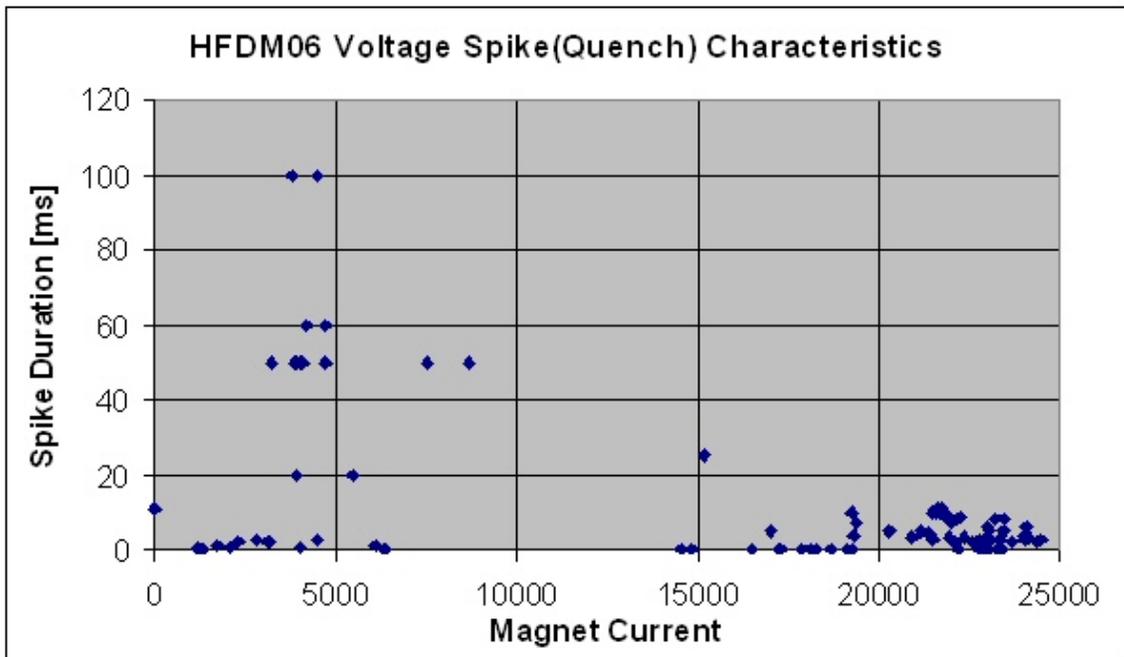
Figure 8. Spike duration versus magnet current for actual spikes (or quenches)

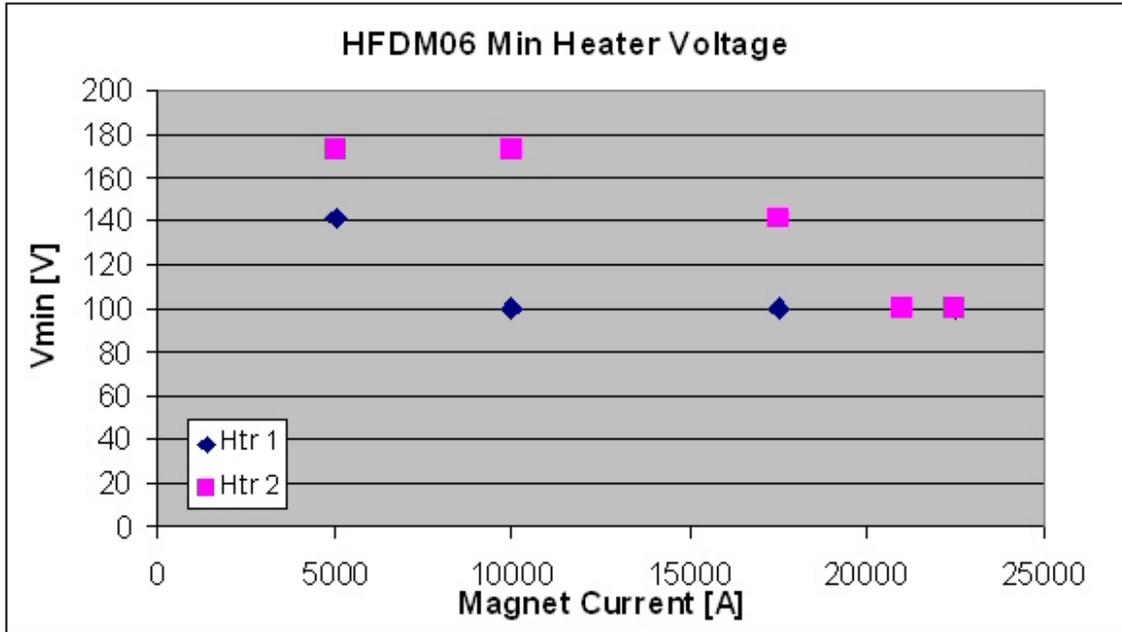
Figure 10. Minimum heater voltage required to induce a quench for HFDM06 strip heaters 1(pole) and 2(midplane), as a function of magnet current.

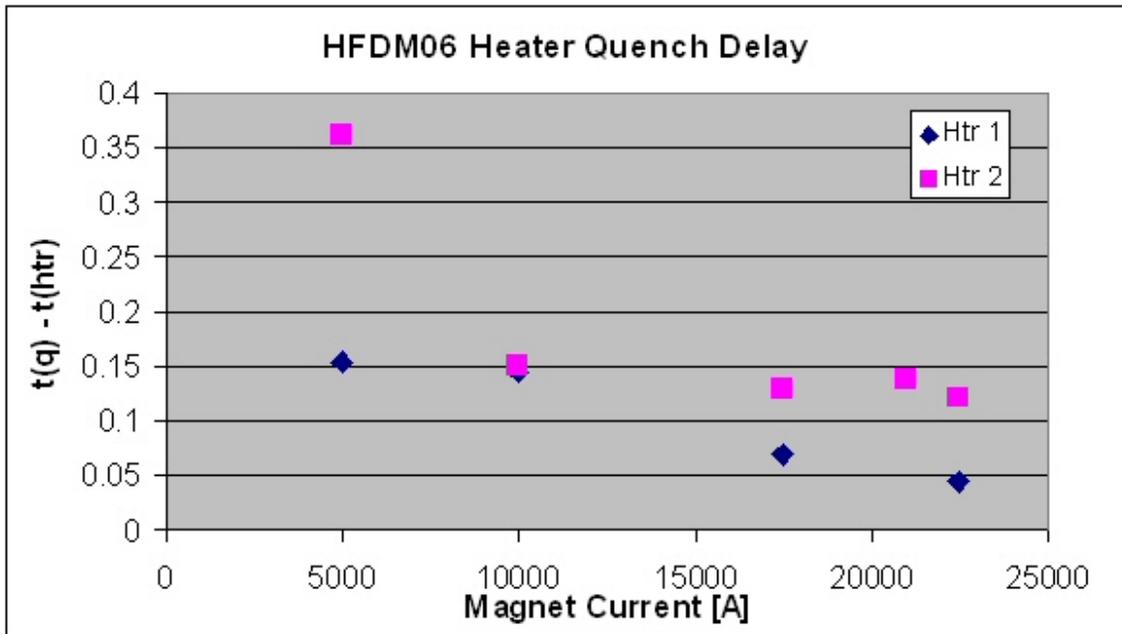
This magnet had two sets of strip heaters installed, both which spanned the full magnet length along both sides of the outer coil. As shown in the cross section view of Fig. 9, one heater set (Heater 1) covered the “pole” turn region, while the other (Heater 2) covered the “midplane” region. Heater parameters are included in Table 1 (quenches 64-71, 78): at each magnet current, corresponding to $I/I_c = \{0.2, 0.4, 0.7, 0.9\}$, the minimum heater voltage required to induce a quench was determined separately for each heater (shown in Fig. 10); also the heater delay was measured, defined as the time between when the heater was fired and when resistive voltage began to appear (Fig. 11). In all cases, the quenches developed in the outer coil.

Figure 11. Time for quench to start for HFDM06 strip heaters 1(pole) and 2(midplane), as a function of magnet current.

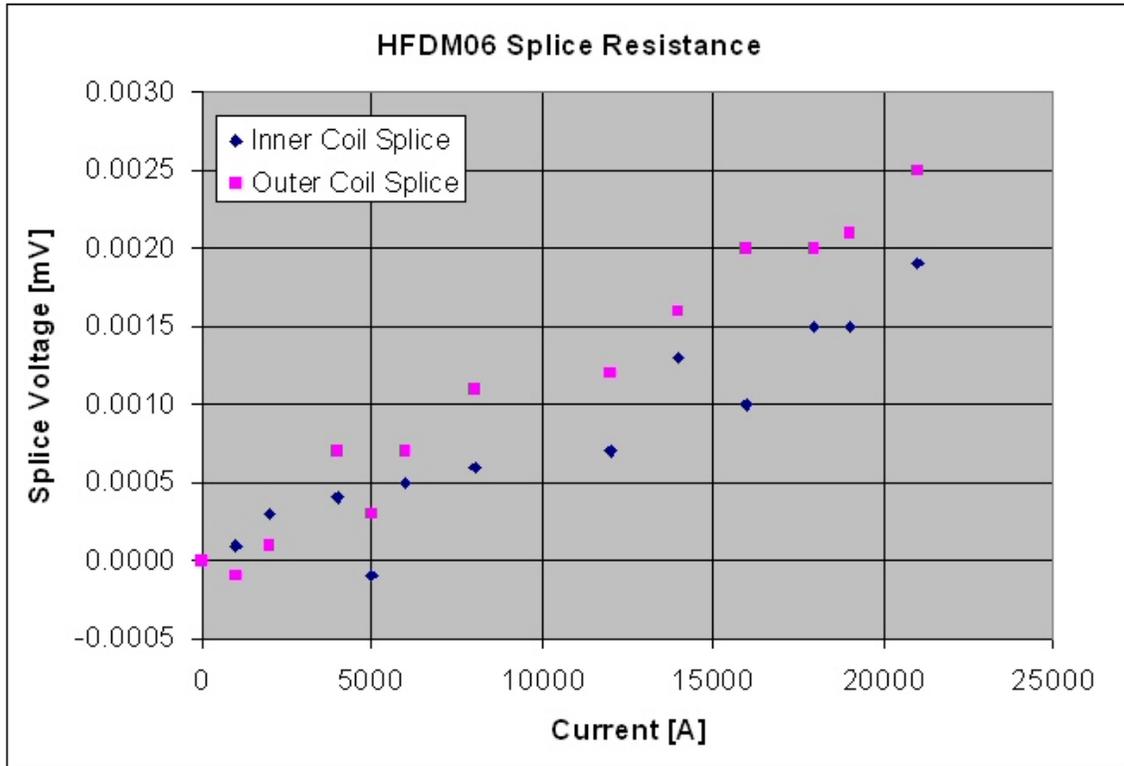
Following the quench performance and heater protection studies, the splice voltages were measured as a function of magnet current to determine their resistance. A calibrated Hewlet-Packard 3458 DVM was used to digitize the raw (unamplified) splice voltages; 60 Hz noise components were reduced by programming the DVM to integrate over 40 power line cycles. Both splices were measured at the same time by using the front and rear inputs to the device. Table 4 shows the current and raw voltage data (after subtraction of individual thermal voltage offsets), which are plotted in Figure 12. Both splices were found to have very nearly the same resistance value of about 0.1 n Ω , which is unusually good.

Figure 12. Splice Voltage versus Magnet Current

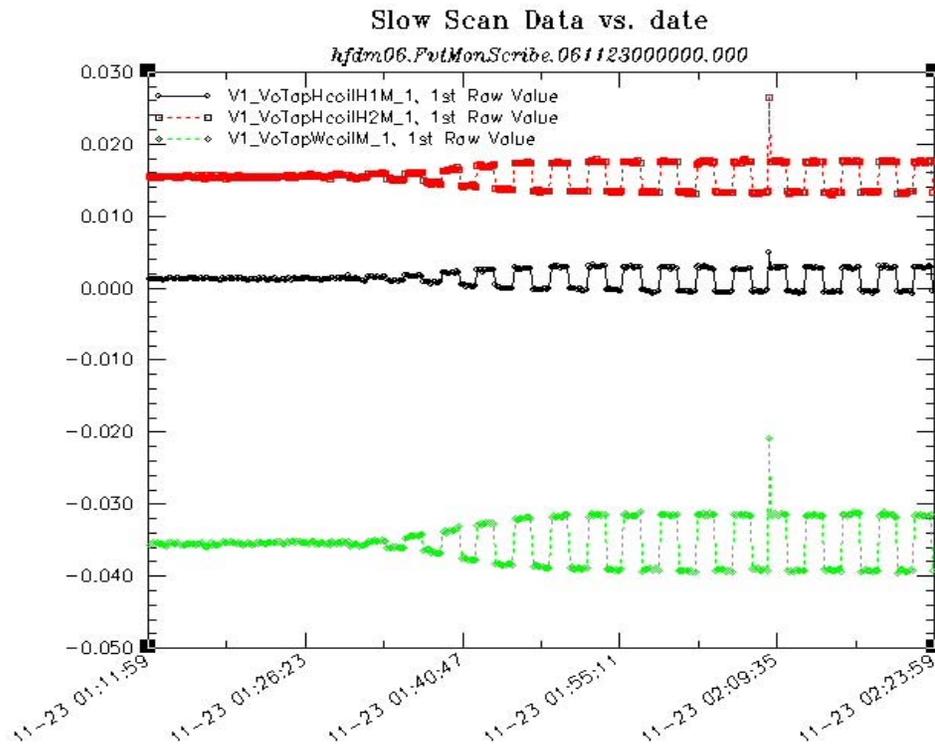
The cold RRR measurement was performed on 11/23/06 with the transition to normal appearing complete at about 02:00. The magnet was gradually warmed up and the coil voltages were recorded while applying ± 10 A across the magnet through transition. The coil made a transition to normal conducting at a temperature of 17 to 18 K (Figure 13). Warm measurements at 300 K were captured on 11/29/06. In Fig. 14, the whole and half coil voltages are shown during the transition, and in Fig. 15 the warm coil voltages are shown. From these data, reproduced in Table 5, the RRR of all segments are consistent with the value 172 ± 3 .

Figure 14. Transition temperature whole coil voltage and resistance values.
