12/04/06
TD-06-066

SR04 Test Summary Report

The small racetrack magnet SR04 was the first high field magnet built using Nb3Al conductor manufactured by the Japanese National Institute for Material Science (NIMS). The magnet construction and instrumentation plan were otherwise identical to previous small racetracks in the series. It was fabricated in June 2006 and tested in September 2006 at the Fermilab vertical magnet test facility (VMTF) where it was mounted to the 30 kA “HFM” top plate assembly. Data acquisition scans were started following electrical checkout and warm measurements on Friday September 8; pre-cooling with liquid Nitrogen began on 9/9. The VMTF dewar was filled with helium early on Monday 9/11, followed by cold electrical checkout and quench/power system checks. The test plan was essentially performed twice, first with large amplitude (300A p-p) 180 Hz current ripple (as with previous magnets), and then again with the ripple amplitude reduced by a factor of 5 to 6 (by using a different power supply regulator module). The repeated elements included quench performance at 4.5 K and 2.2 K, ramp rate and temperature dependence, and energy loss. The quench performance

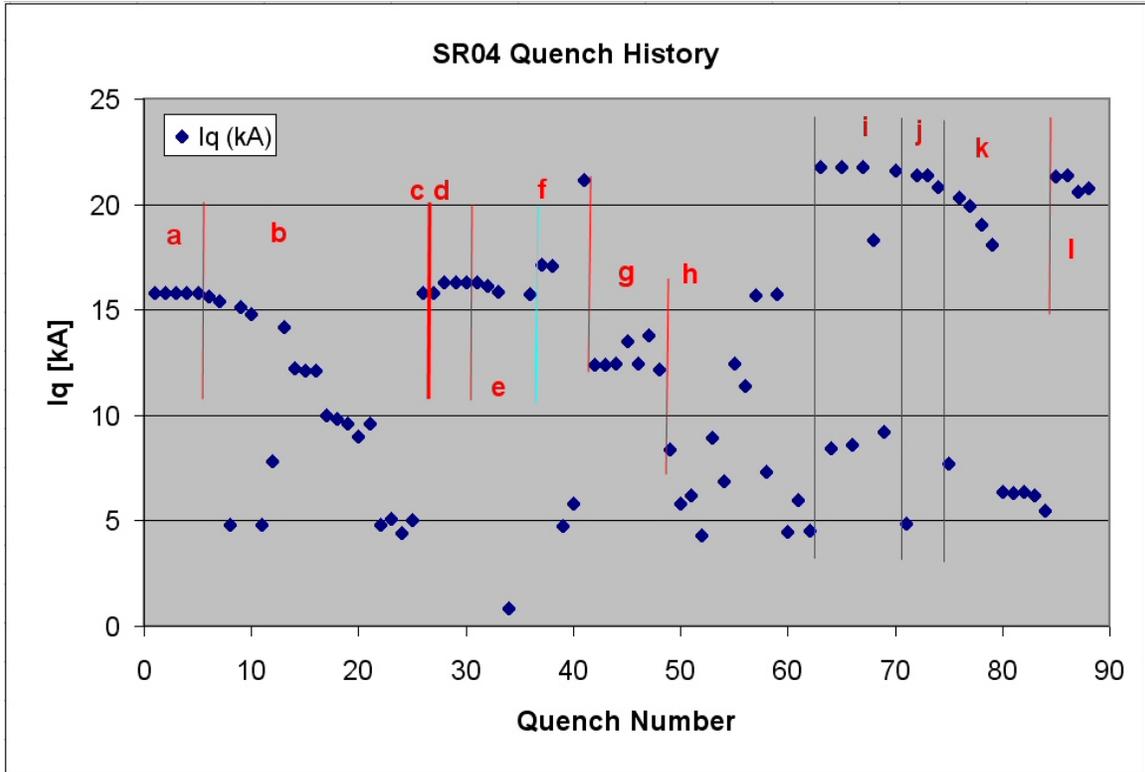
Figure 1. Quench history, starting from first “real quench” on 9/14. History followed the sequence: a) 4.5K 20A/s training, b) 4.5K ramp rate dependence, c) energy loss, d) thermal cycle, then 2.2K 20A/s training, e) temperature dependence, f) power system noise studies, then 3.5K 20 A/s (trips) and 4.5K 20A/s quenches, g) 2.2K 20A/s repeated, h) 2.2K ramp rate dependence, i) temperature dependence repeated, j) 4.5K 20A/s repeated, k) 4.5K ramp rate dependence repeated, l) more power supply regulator studies.

The full list of quench data files is presented in Table 1. The quench current history is plotted in Figure 1.

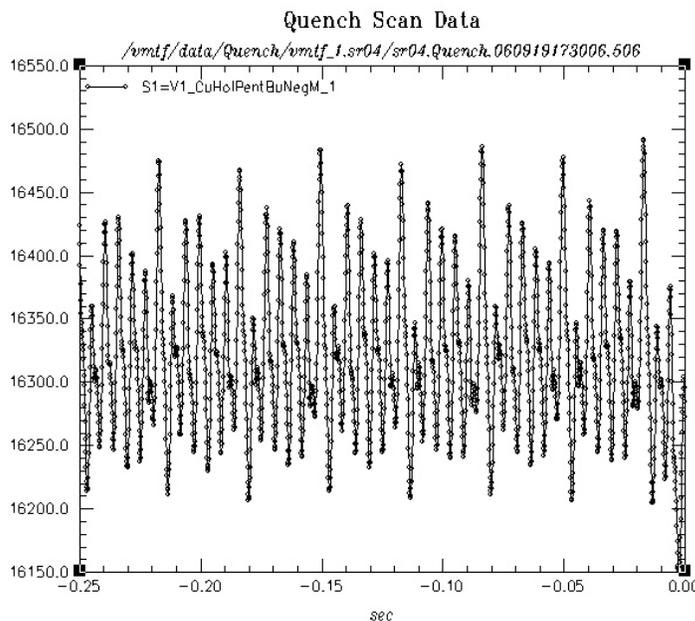
Figure 2. Large ripple current at start of the test.

Power systems engineer Alex Yuan investigated the situation with current ripple in small inductance magnets connected to the CPS-3 power system in a number of ways. First, measurements showed the ripple to be dominated by 180 Hz noise. Then, circuit modeling showed that the power supply LR filters, which were designed to be effective for higher inductance magnets (above XX mH), interact with the low inductance load to actually amplify the noise. Further testing showed that the source of the 180 Hz noise was the power supply Voltage Regulator module. It turns out that MTF has four such modules, two of which generate large 180 Hz noise and two of which have much lower levels. Figure 2 shows the ripple at the 16300 A quench current when a noisy regulator (number 2) was used; Figure 3 shows the current just before the AQD LEADS trip at 17 kA after the noise level was reduced. Studies of active noise cancellation, by providing fast feedback to the voltage regulator using a special national instruments/labview circuit, were made with this magnet by summer student Sasha Mamrashev, and gave promising results for future power supply regulation and control.

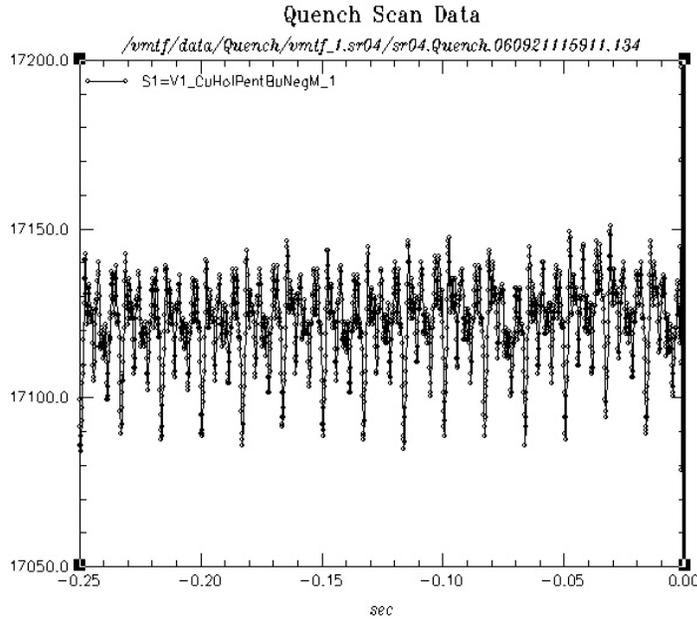
Figure 3. Ripple current reduced by factor of 5, from quench 37 onward.

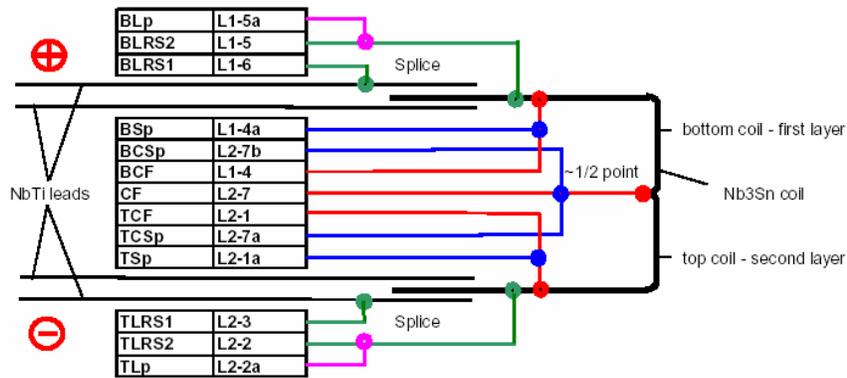
Figure 4. Voltage Tap positions and labels for SR04

The small racetrack magnets have very few voltage taps for quench characterization. Figure 4 shows the schematic: basically there are splice segments, and (redundant) half coil segments for each coil. A very short segment between the splices and half coils exists, but is probably not meaningful. For many quenches voltage development is seen in both coils. For some of the low current quenches, development was so slow (more than one second) that the origin is not observed in the data logger quench window. The locations, insofar as they have been studied and identified, are listed in Table 2 below, which summarizes all of the known quenches (there are many more ramps and quench files, as seen in Table 1, due to the power supply noise causing confusion, and later, files produced during noise studies).

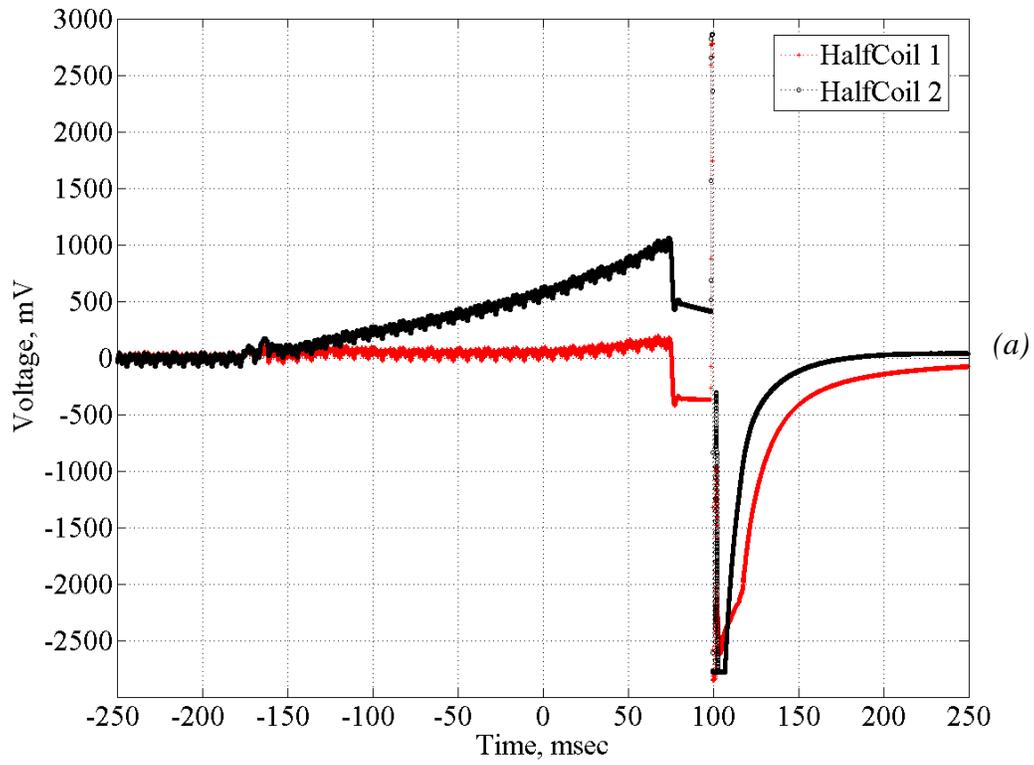
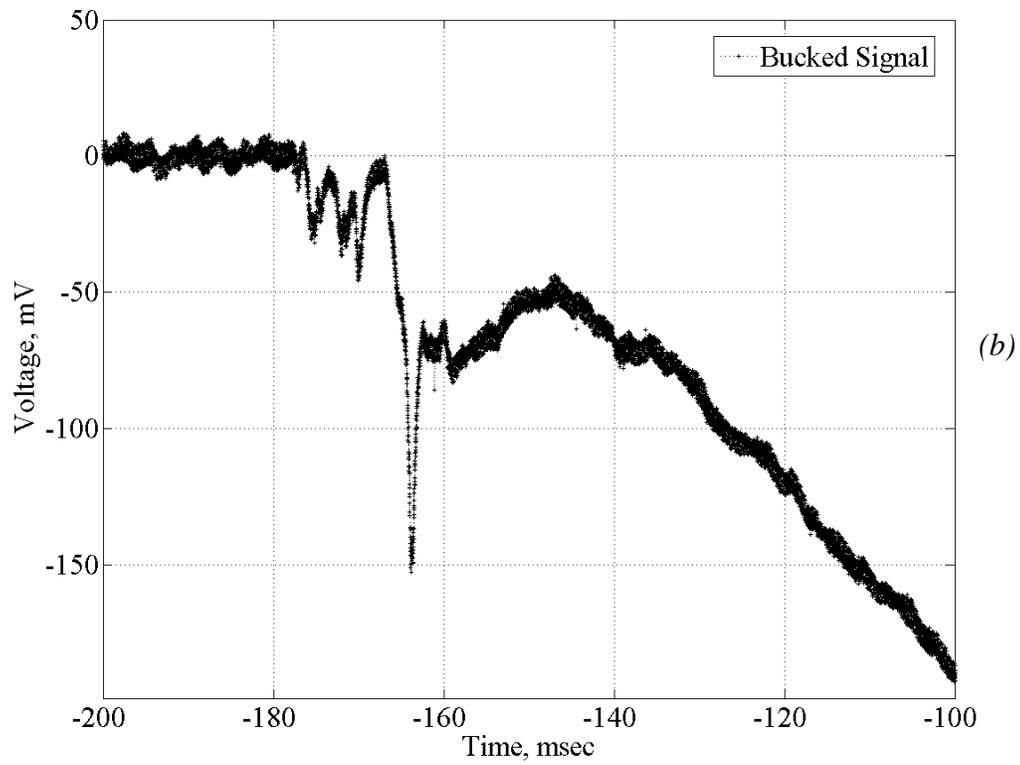
Fig. 5. Quench signals during ramp no. 86 (quench no. 75): *a*) half coil signals; *b*) bucked signal

An example of spike initiating the quenches is shown in figures 5, 6, and 7. Fig. 5a shows the half coil signals recorded by the VSIDS (500 msec), in fig. 5b is the bucked signal in a smaller time window (100 msec) showing the voltage spikes that initiated the quench. The voltage spike can not be observed clearly in the raw half coil signals (fig. 6a) because of the high noise; nevertheless the spike is very clear once the half coil signals were cleaned by applying the matching filter technique (fig. 6b). Within the same time window that the voltage spike occurred, the current signal did not have any glitch (fig. 7). This means that these voltage spikes were not generated by the power supply; more likely they were produced by thermo-magnetic instabilities.

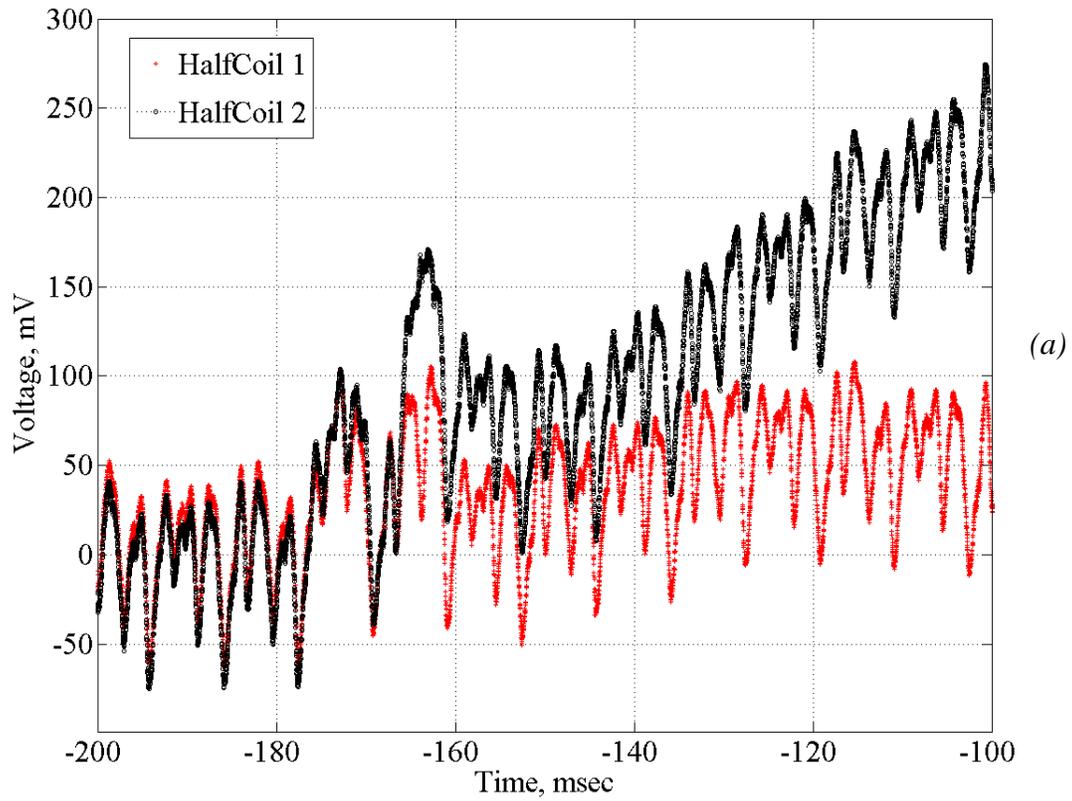
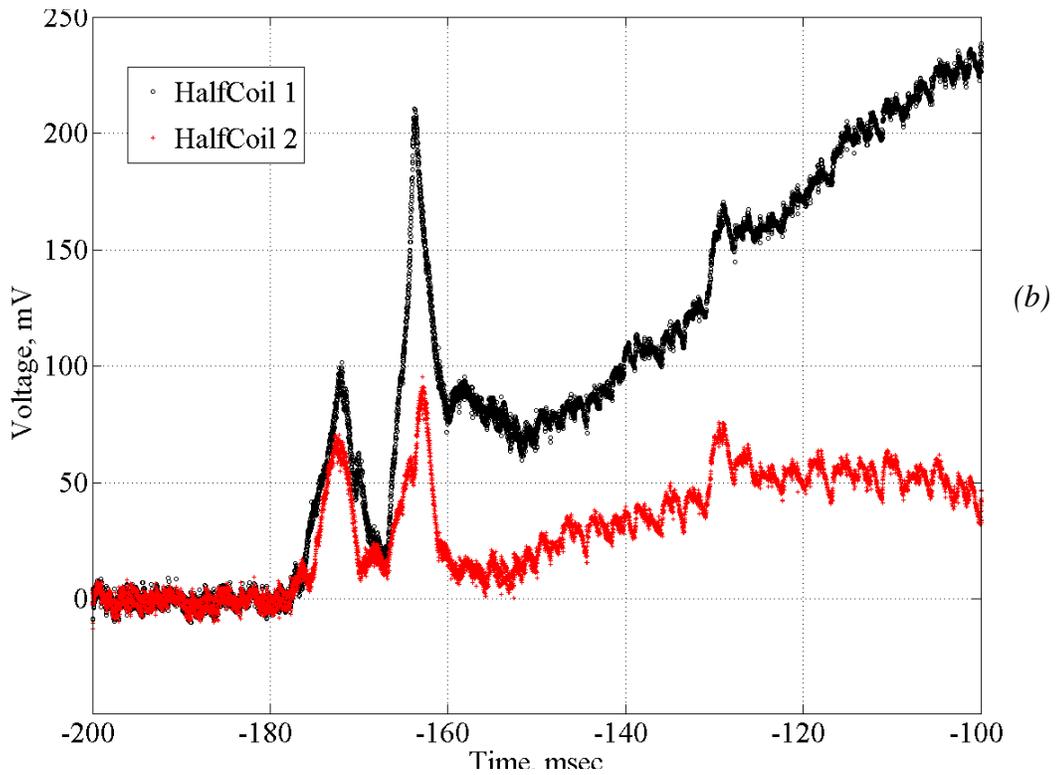
Figure 6. Voltage spike initiating the quench during ramp no. 86 (quench no. 75): *a)* half coil signals; *b)* half coil signals cleaned using the matching filtering

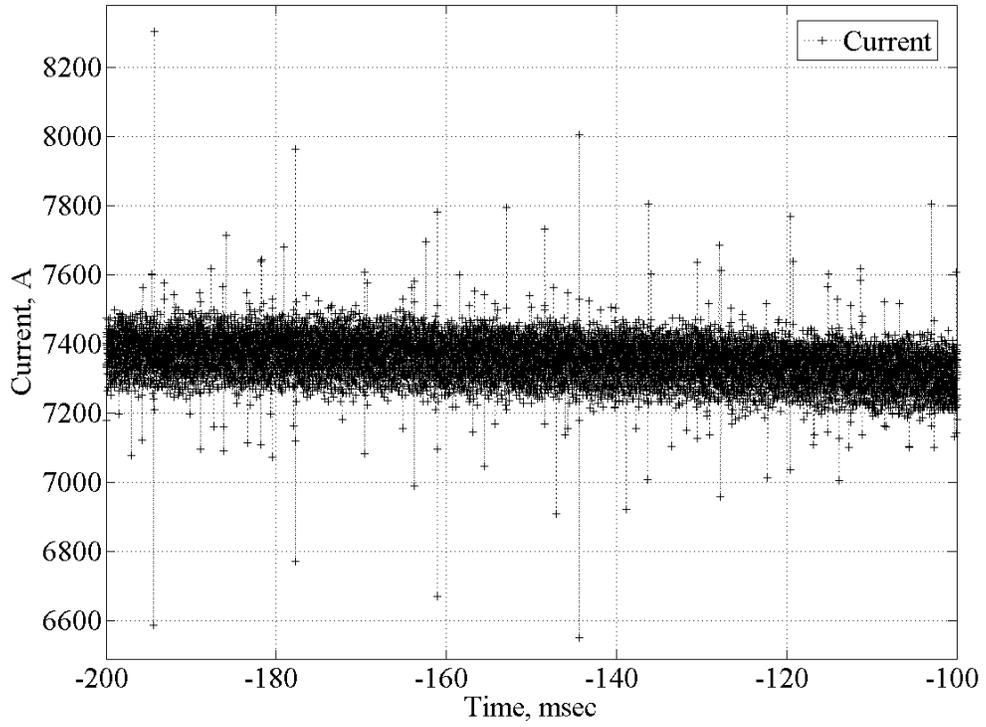
Figure 7. Current signal during the voltage spike initiating the quench in ramp no. 86 (quench no. 75)

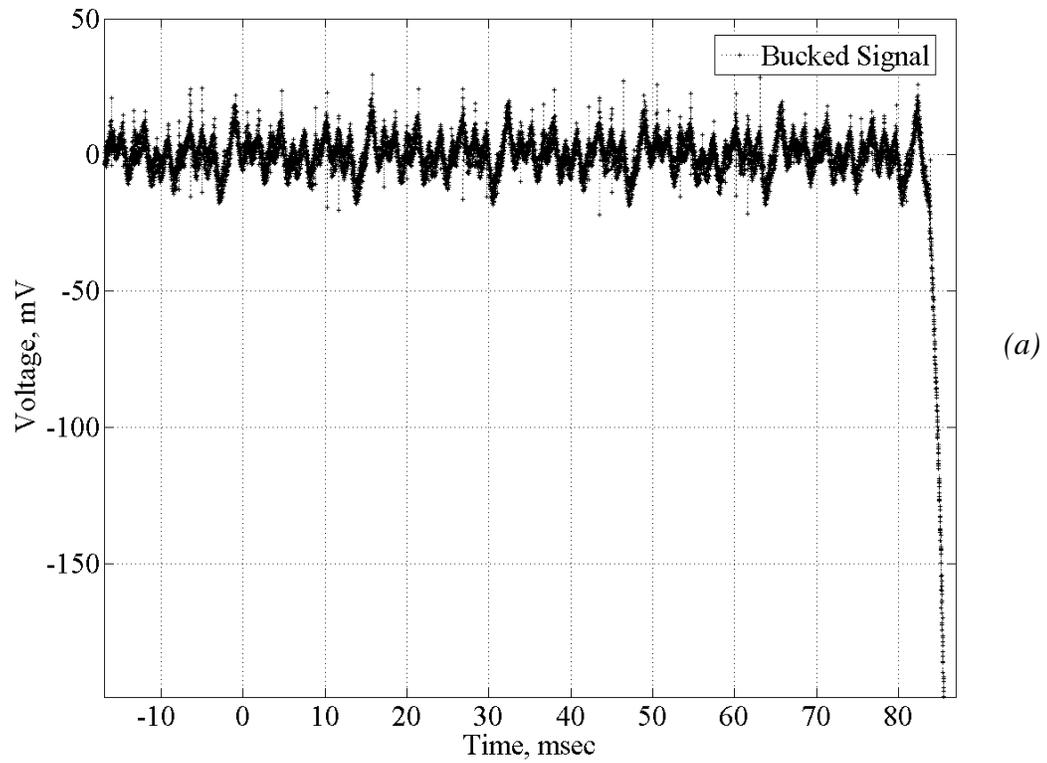
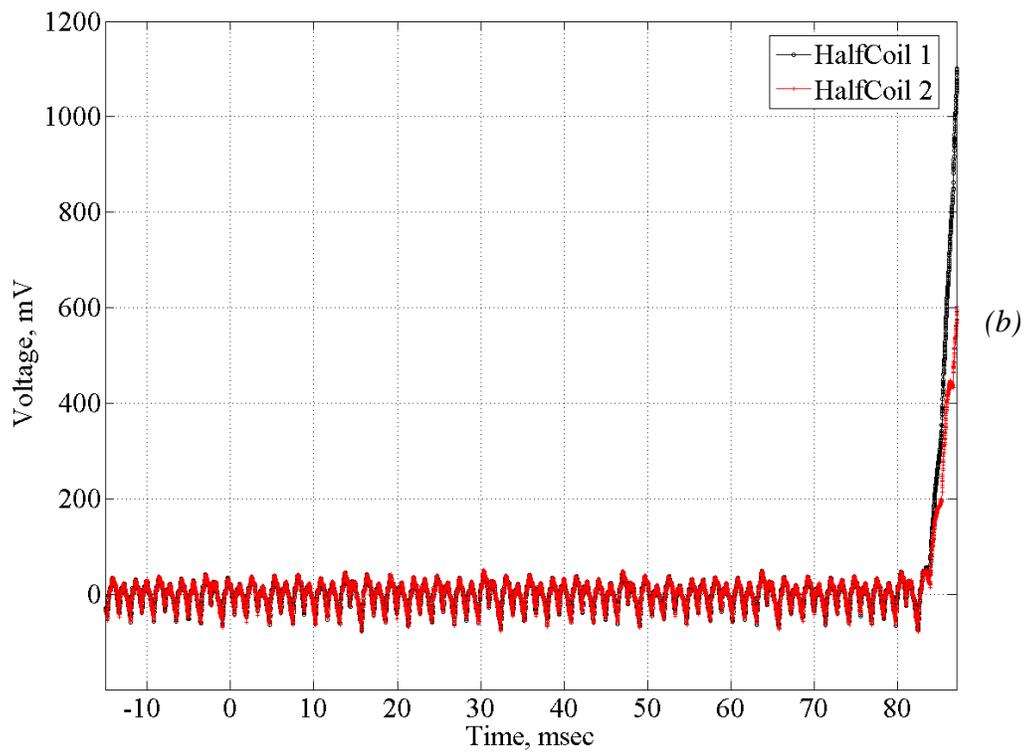
Figure 8. Quench signal during ramp no. 83 (quench no. 72): *a*) bucked signal; *b*) half coil signals cleaned using the matching filtering technique

Fig. 8 shows an example of quench signals during a quench at high current: no spikes were found to have initiated the high current quenches.

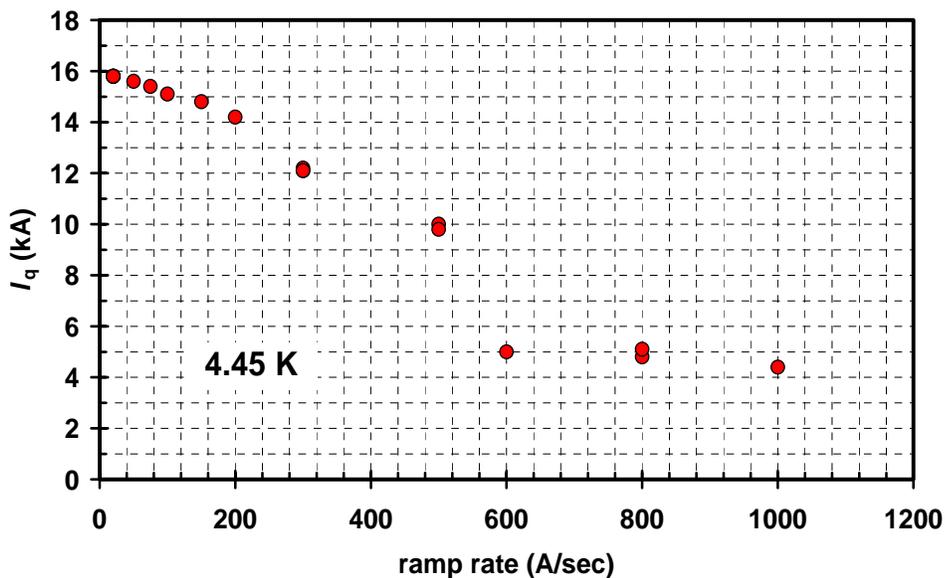
Figure 9. Current ramp rate dependence with high amplitude ripple at 4.5 K.

The default current ramp rate was 20 A/sec. Ramp rate dependence study at 4.5 K is summarized in Fig. 9 for the high amplitude ripple case, and in Fig. 10 for the low amplitude ripple case at 4.5 and 2.2 K. With low ripple the performance drops dramatically above 200 A/s, whereas the drop occurred above 500 A/s with high ripple.

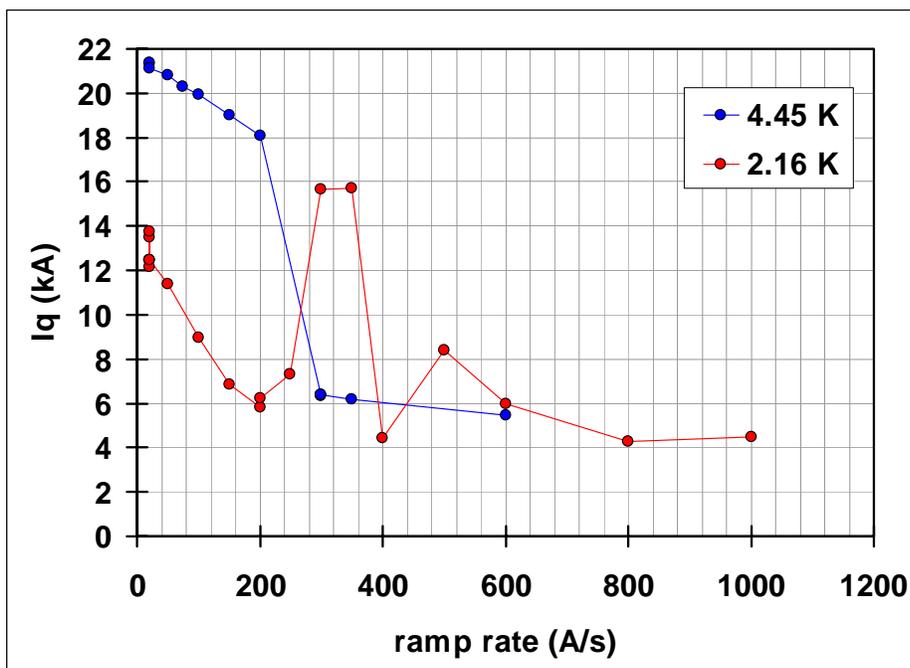
Figure 10. Current ramp rate dependence with low amplitude ripple at 2.2 K and 4.5 K.

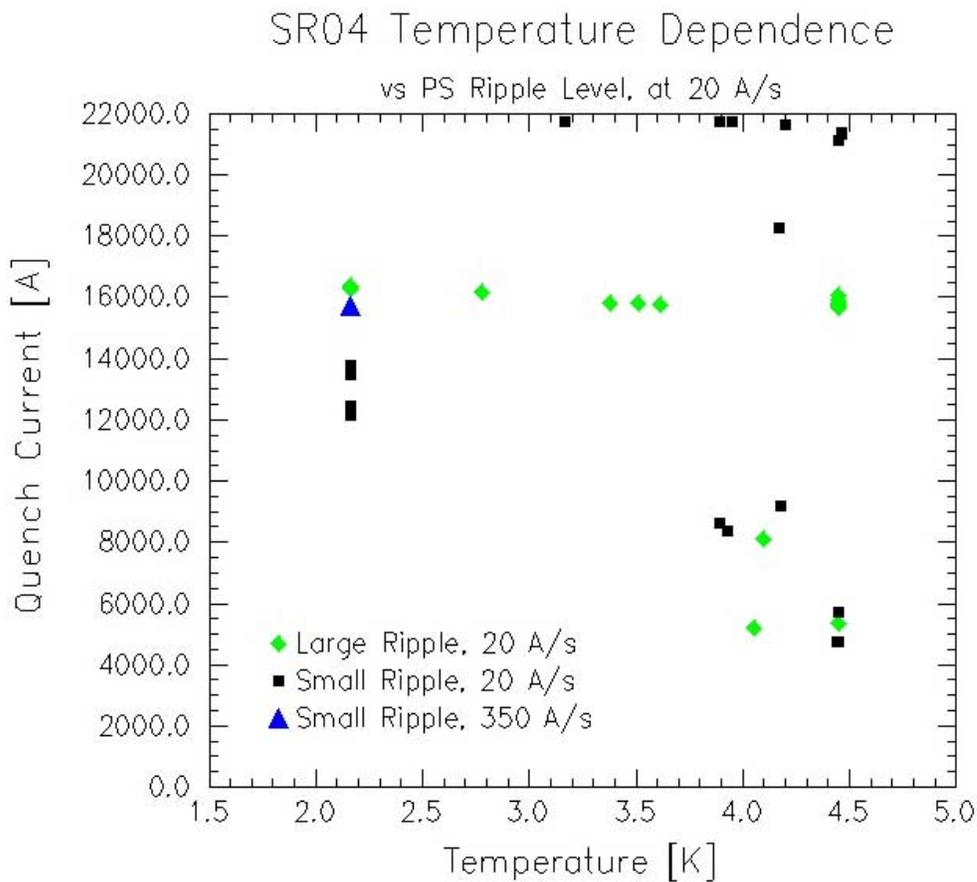
Figure 11. Temperature dependence for initial large ripple current data at 20 A/s is shown by black square data points; Green circles are quench current with reduced ripple at the same 20 A/s ramp rate. The blue triangle shows 350 A/s peak quench current at 2.2K.

The temperature dependence is shown in Figure 11.

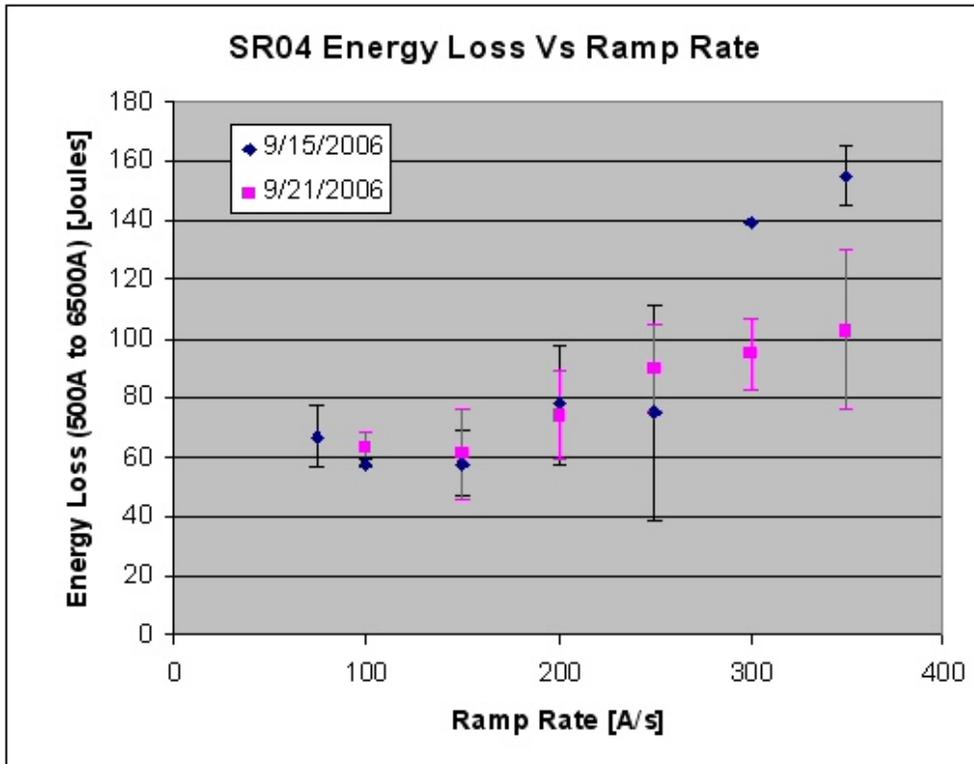
Figure 12. Average energy loss vs. ramp rate, measured with large (9/15) and small (9/21) ripple.

Fig. 12 shows the overlay of average energy loss for both data sets, with large and small current ripple. The energy loss measurements and fits made after reducing ripple are shown in Figures 13 and 14.

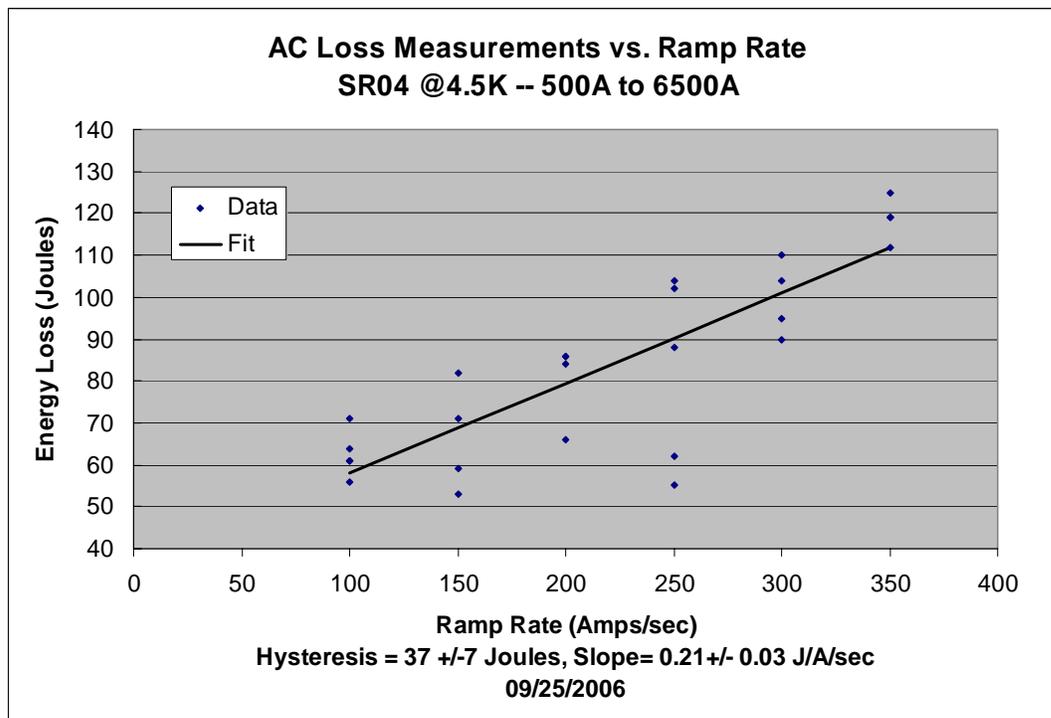
Figure 13. Hysteresis loss in 500 to 6500 A current loop, from small ripple data.

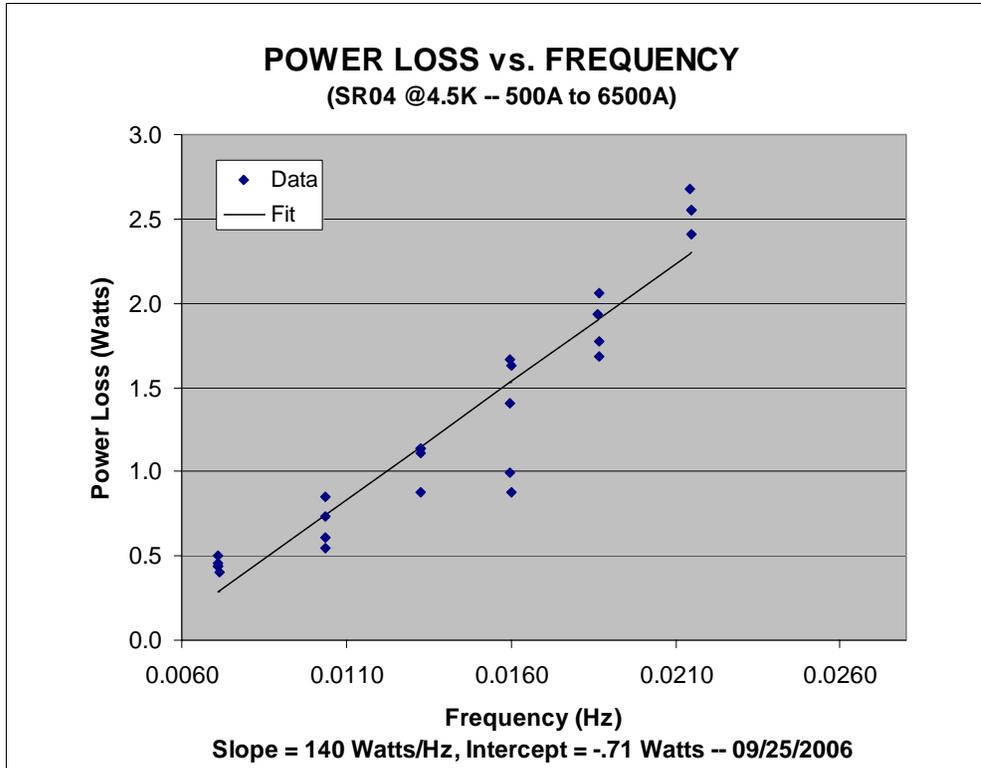
Figure 14. Power loss versus frequency, from small ripple data.

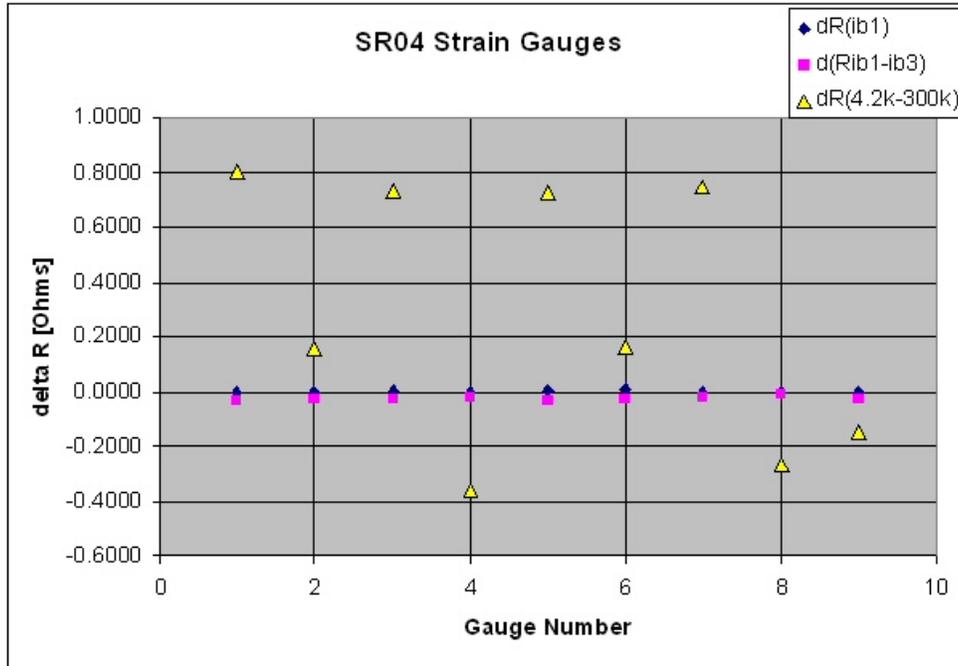
Figure 15. Change in gauge resistances from room temperature to 4.5 K Gauge 9 is the compensating gauge.

The strain gauges haven't been studied, except to see that they were working, that the resistance values changed with temperature (Fig. 15), and (active gauges) showed some dependence on current-squared (Fig. 16).

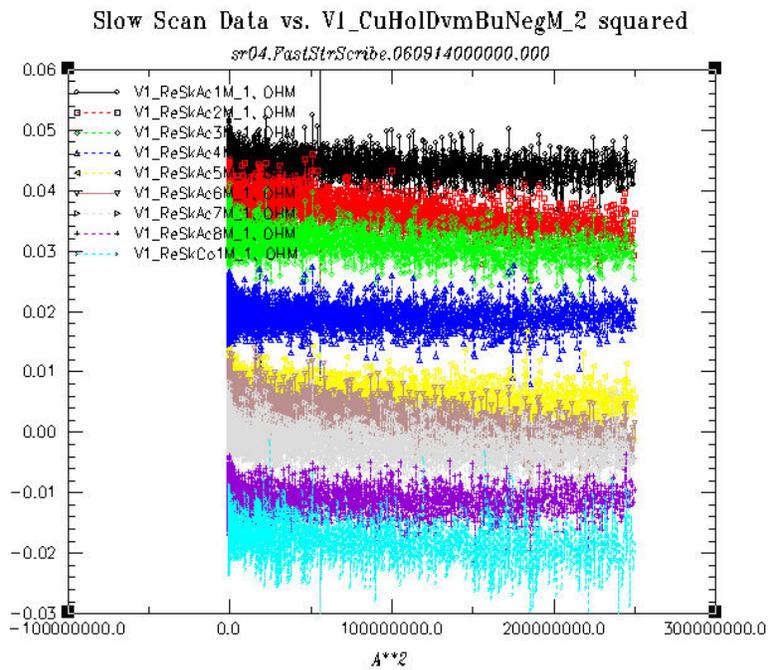
Figure 16. Change in gauge resistances versus current squared (offset for visibility)

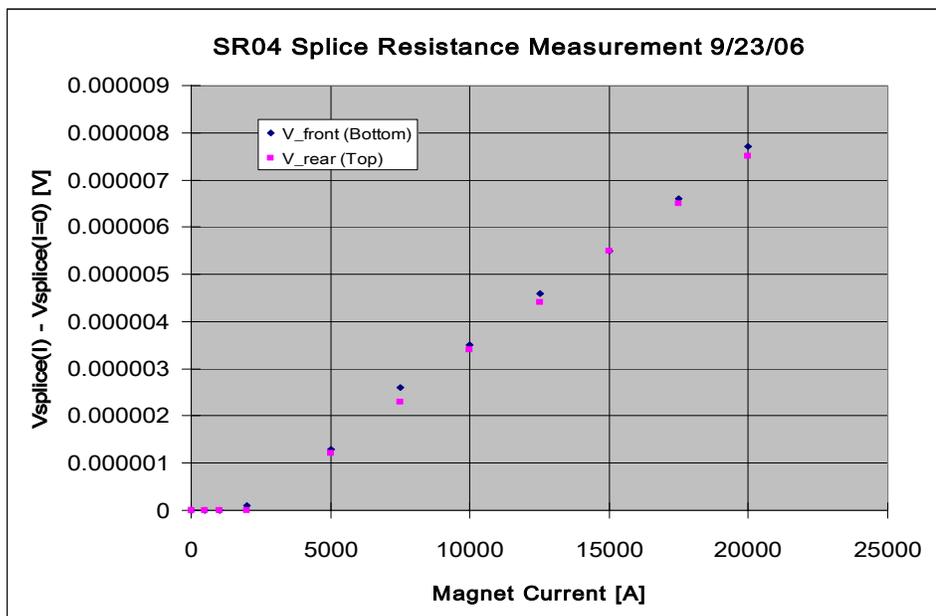
Figure 17. Splice Voltage versus Magnet Current

Following the quench performance and energy loss studies, the splice voltages were measured as a function of magnet current to determine their resistance. A calibrated Hewlett-Packard 3458 DVM was used to digitize the raw (unamplified) splice voltages; 60 Hz noise components were reduced by programming the DVM to integrate over 40 power line cycles. Both splices were measured at the same time by using the front and rear inputs to the device. Table 4 shows the current and raw voltage data (after subtraction of individual thermal voltage offsets), which are plotted in Figure 17. Both splices were found to have very nearly the same resistance value of about 0.38 nΩ.

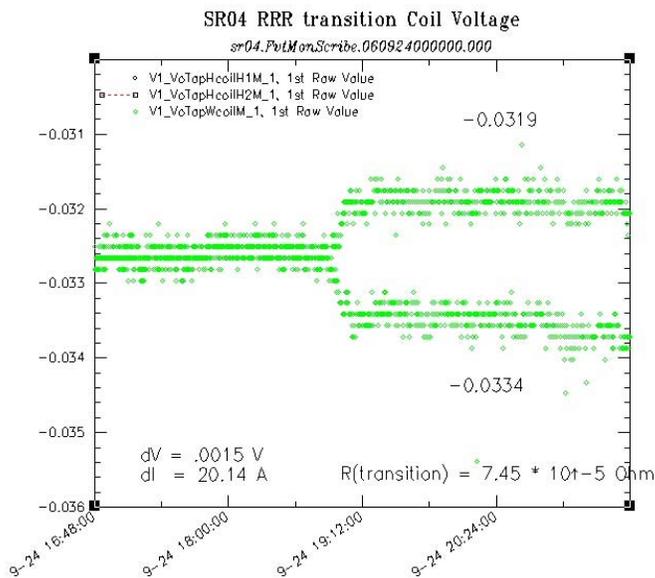
Figure 18. Transition temperature whole coil voltage and resistance values.

The cold RRR measurement was performed on 9/24/06. The magnet was gradually warmed up and the coil voltages were recorded while applying ± 10 A across the magnet. Warm measurements at 300 K were captured prior to the initial cool down, on 9/8/06. The coil made a transition to normal conducting at a temperature of 17 to 18 K, as predicted by Akihiro Kikuchi. In Fig. 18, the whole coil voltage is shown during the transition, and in Fig. 19 the warm whole coil voltage is shown. From these data, the RRR value is calculated to be $0.01815/0.0000745 = 244 \pm 20$, where the estimated error is dominated by the uncertainty of the coil voltage at the transition temperature.

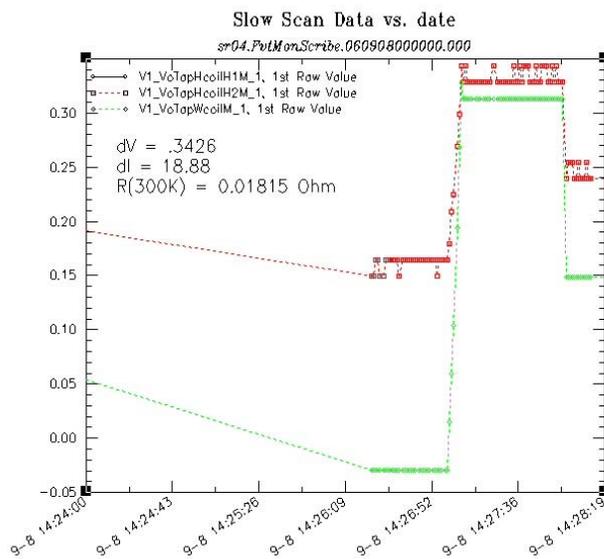
Figure 19. Room temperature whole coil voltage and resistance values.
